## I. GOALS AND OBJECTIVES

The Facilities and Apparatus Needs Analysis Subcommittee was tasked with evaluating the assets of the Garden City Fire Department (Fire Department). The intent of the analysis was to provide a status assessment of the facilities and apparatus and identify actionable recommendations for the Village. Where possible, quantifiable financial commitments have been estimated for recommendations.

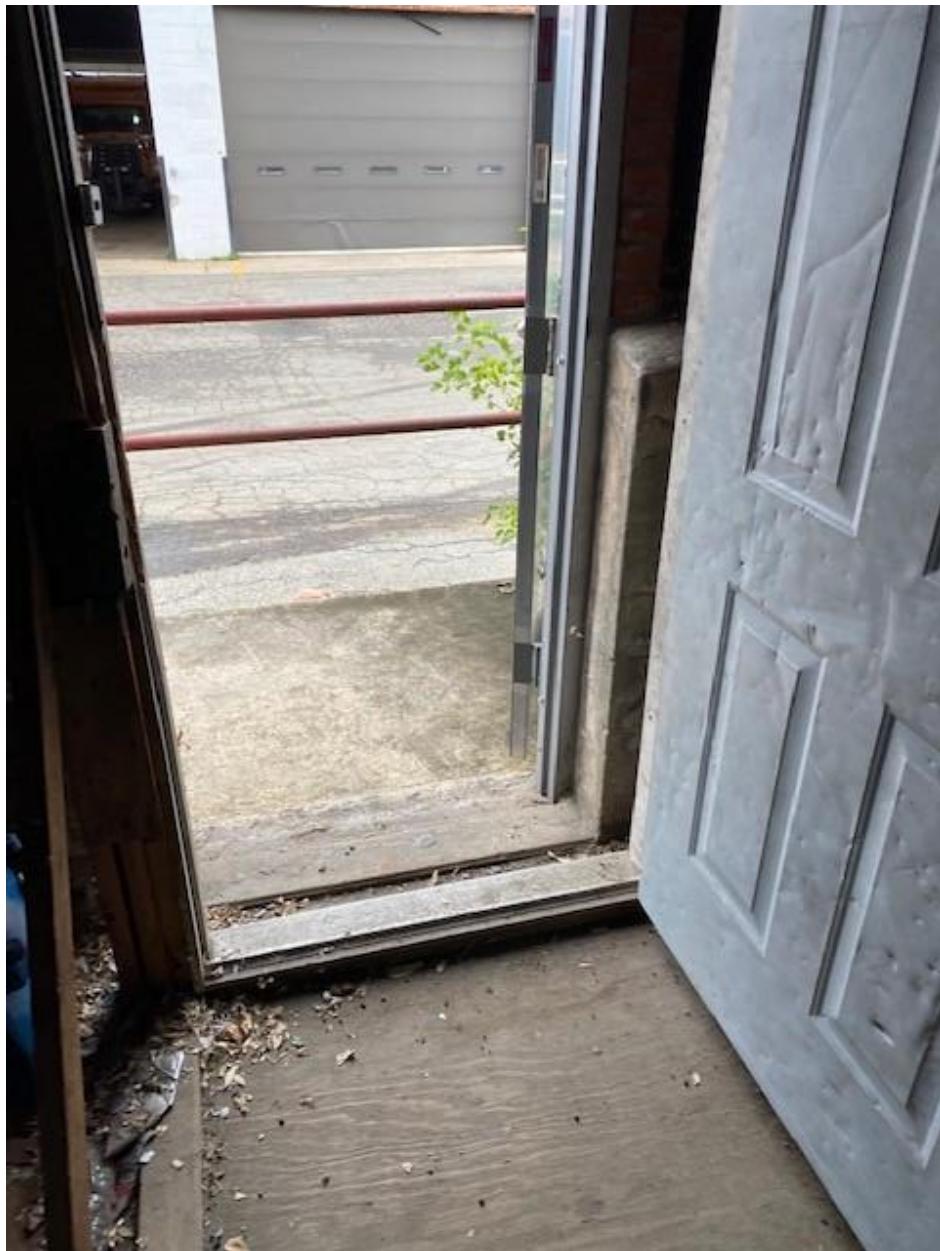
Unlike the actual stations, the village yard has not been reviewed by any design professionals to generate an existing conditions assessment. Therefore, a comprehensive understanding of the structure and systems is not available. However, based on our professional background there are exterior envelope deficiencies allowing water and pest intrusion and there are several OSHA and Fire Code compliance issues.

The following image illustrates the intrusion of pests.

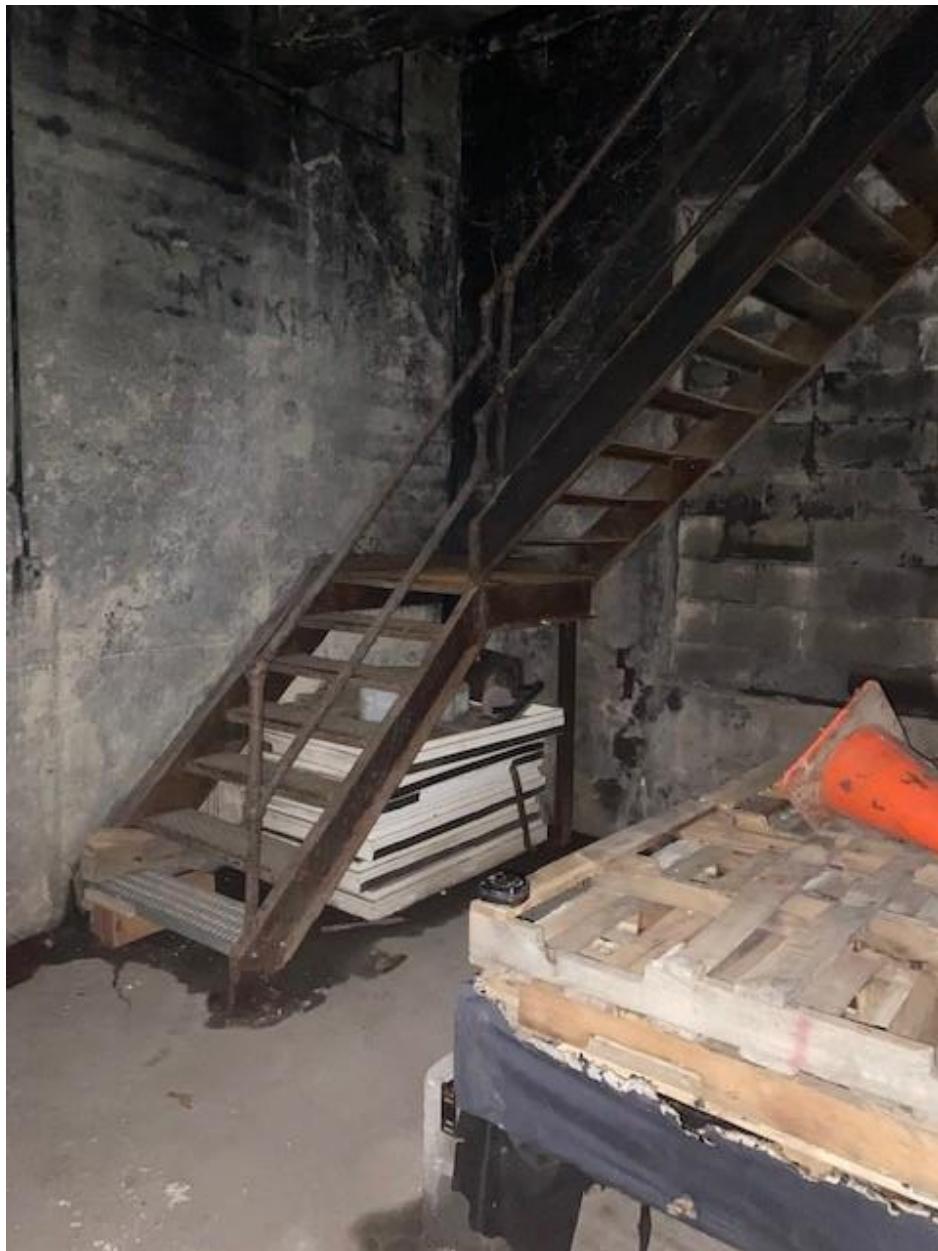
Two issues requiring immediate action are upgrading the stairs within the facility to comply with OSHA standards and removing the storage of LPG, which is not permitted indoors by the Nassau County Fire Prevention Ordinance (2017).

The stairs do not have guards, handrails, treads or risers complying with the current Building Code or Fire Code as illustrated below:

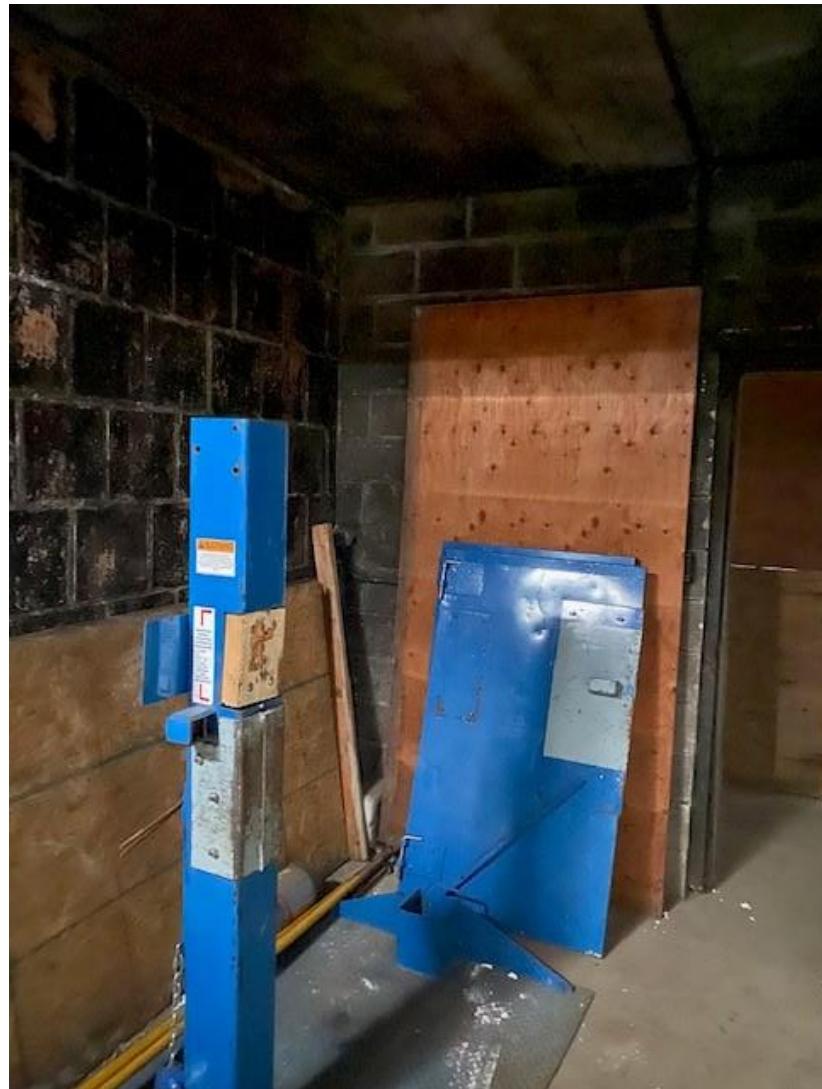
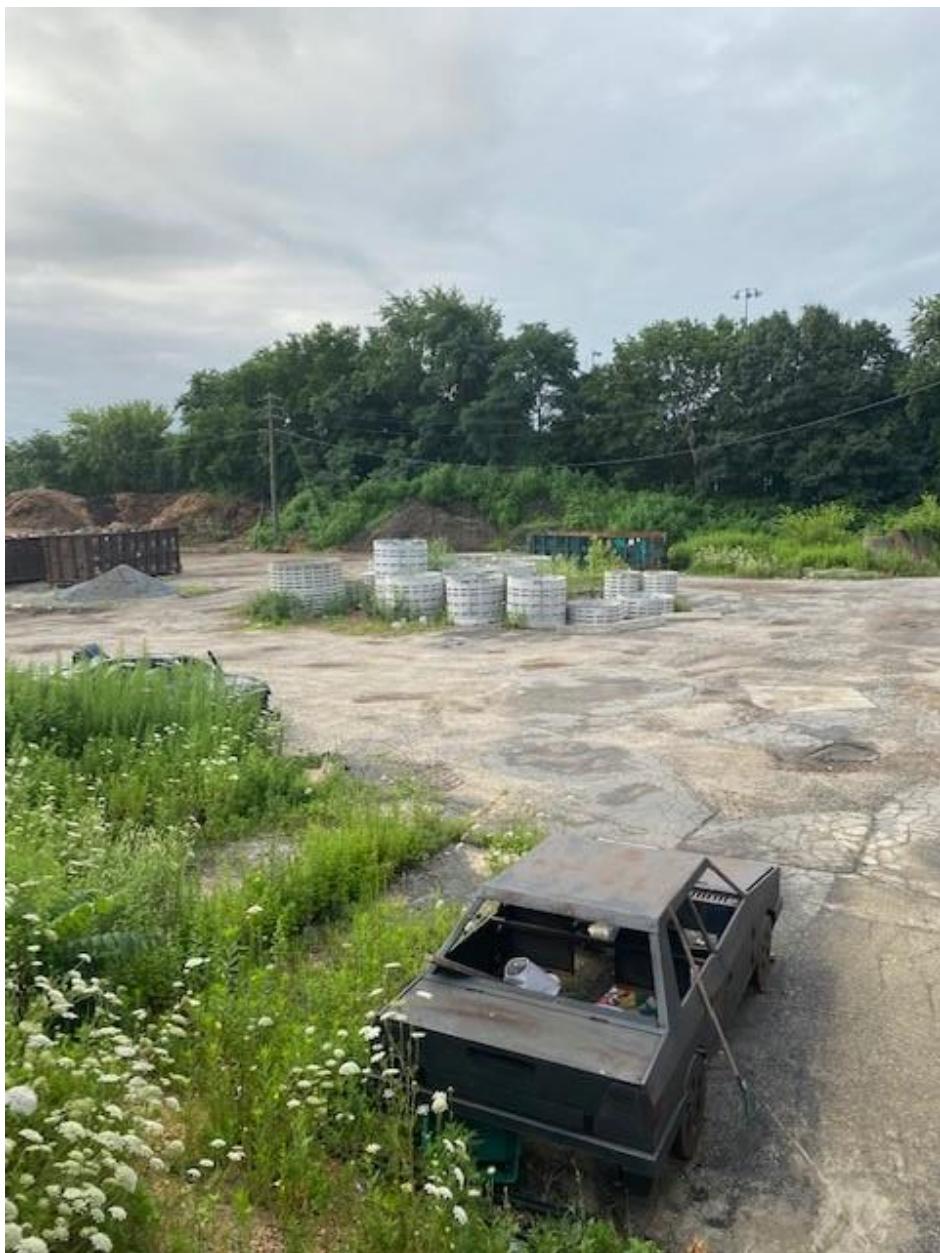
- ii. Deficiencies in structure and surrounding access points (i.e. exterior stairs, doors and windows).
- iii. More than 50% of the space is used for training resource storage as indicated in the following images and certain equipment has to be stored outside, which will decrease the life of the Village investment:

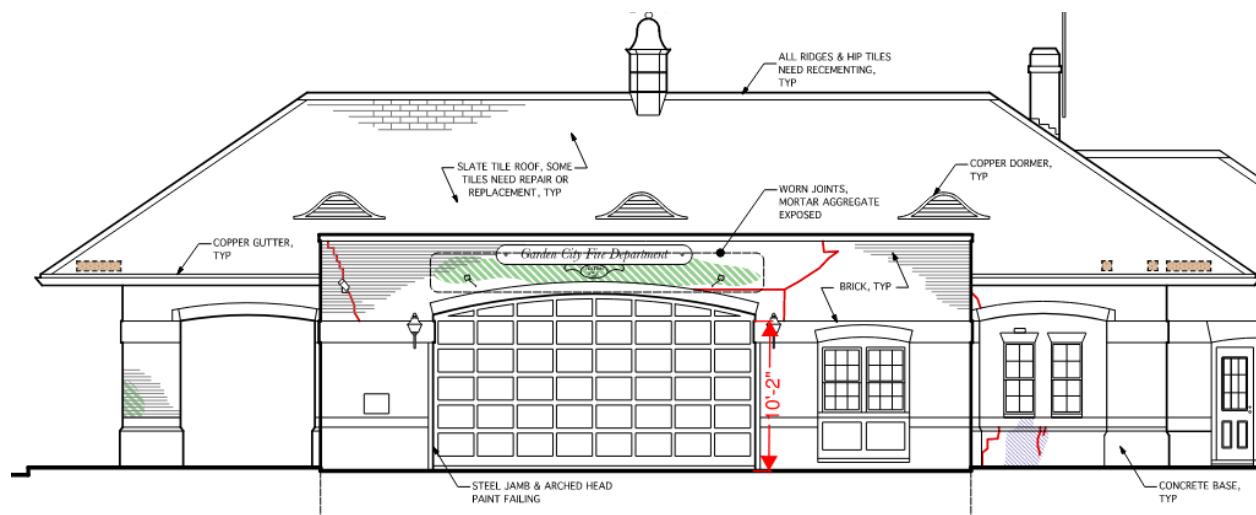
a. Company 3

As currently constructed, the apparatus bay cannot accommodate the height of a ladder truck due to the curved bay door. With a height of approximately 10 feet, the opening would need to be modified to accommodate ladder heights of approximately 11 feet, by increasing the clear height to a minimum of 12 feet.

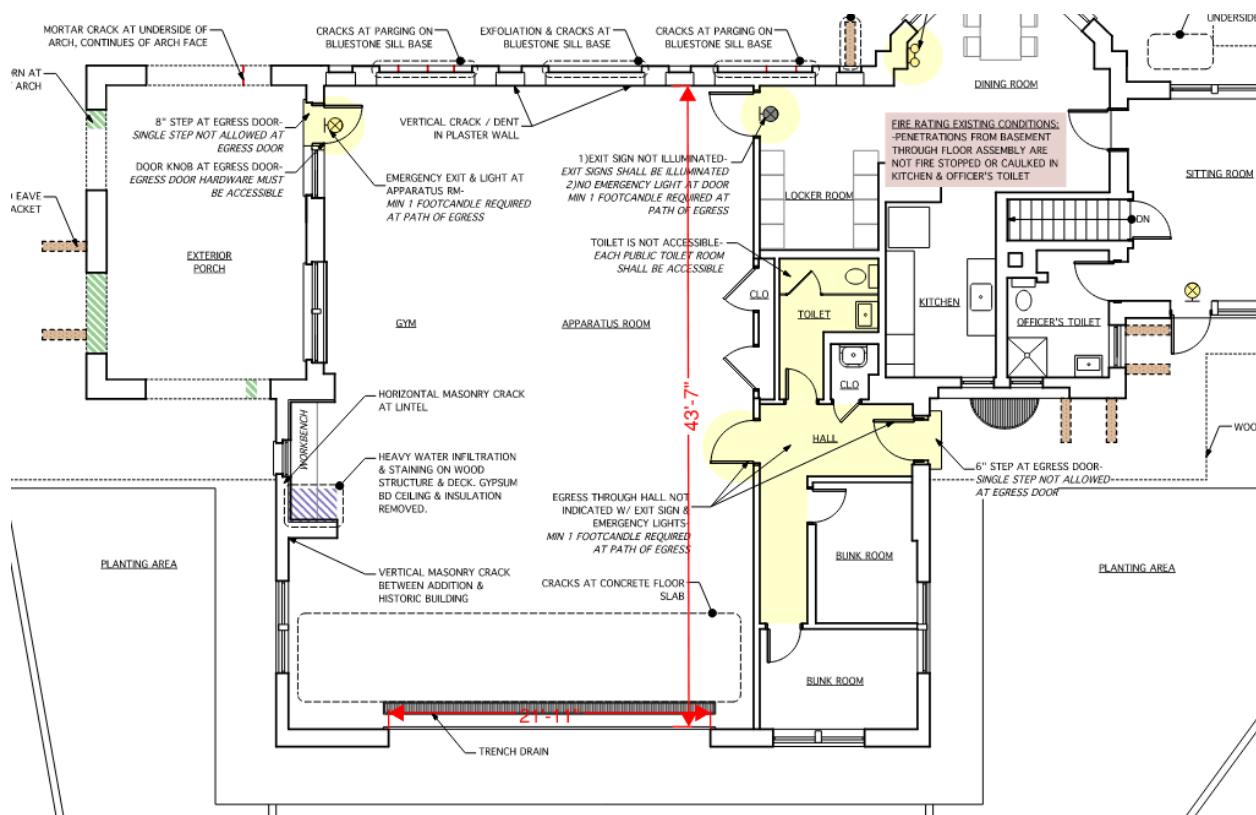
Modification of the building enclosure may not be necessary due to the current depth of the apparatus bay; however, should an extension be necessary, this should be capable on the current lot since the rear of the bay is set back from the dining room projection.

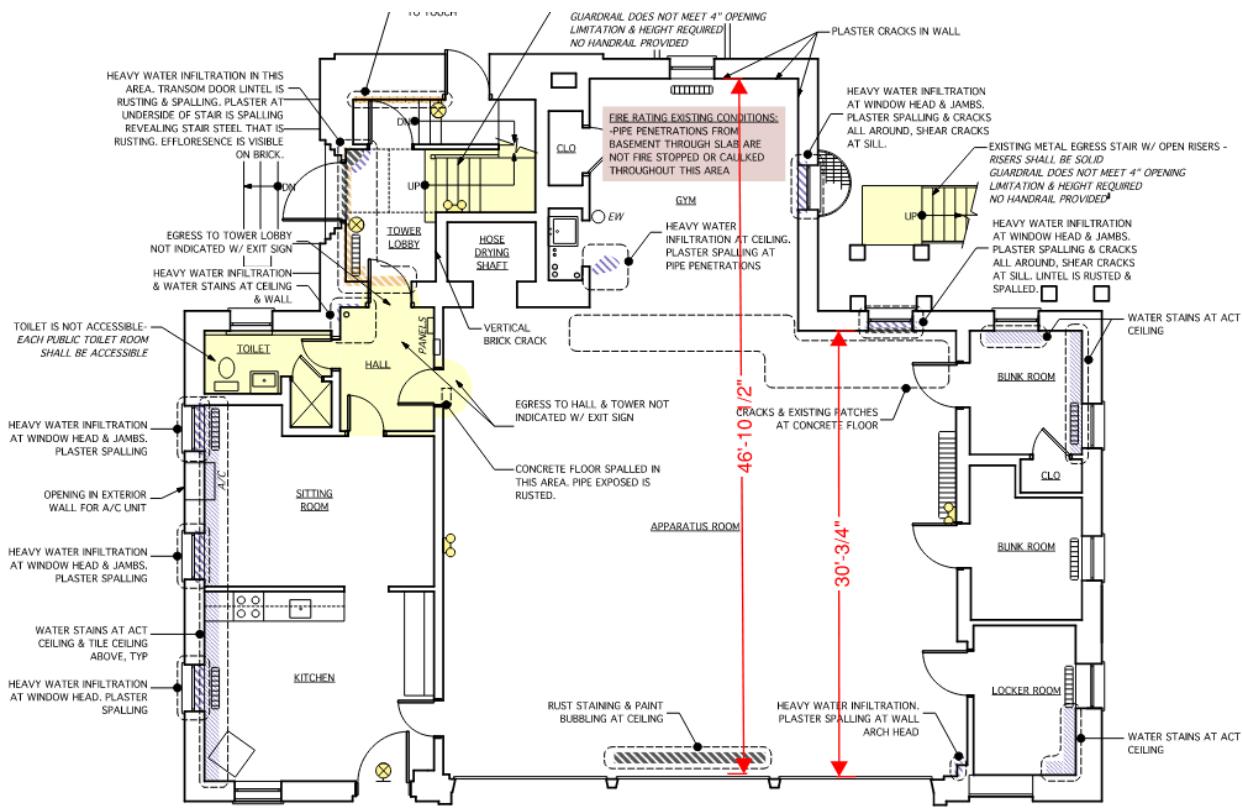
b. Company 2

Modifications to Company 2 will likely accompany a more significant overhaul of the building. However, these alterations will need to incorporate two significant changes to the apparatus bay to accommodate the other Subcommittee's recommendation. This includes increasing the bay door heights, or a minimum of one door to approximately 12 feet. In addition, the center portion of the bay was previously extended to a length that will accommodate a ladder truck; however, the remainder will not accommodate an engine:

A second modification must be incorporated into the alterations to create approximately 40 feet of depth in another apparatus position. This will accommodate current and future engine apparatus dimensions.
