# Building Stabilization Plan Review

## St. Paul's School Garden City, NY

Issued for Review: December 17, 2010  
L&M File No.: 10-0929-00

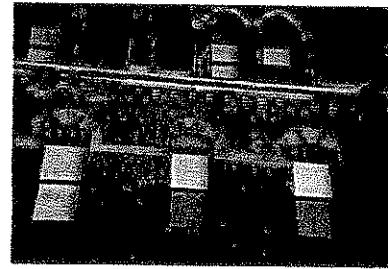
In addition, localized areas of cracked and displaced masonry were also noted (figures 8 and 9). The cause of this damage is typically exposure and age. The extent of damaged brick masonry is limited and vast areas of brick replacement will not be required.

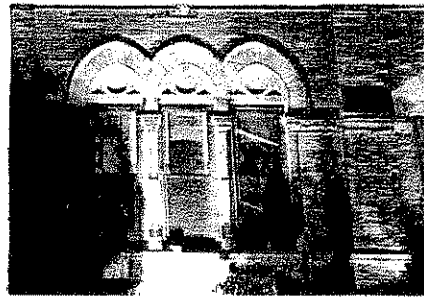
The windows are aluminum, double hung, insulated replacement windows. The exact age and time of installation is not known by this office, but based upon our experience, the age is estimated to be in excess of twenty-five (25) years old. A limited number of windows were operated by LM and their condition documented. Generally the integrity of most of the replacements is intact, however, difficulty of operation was noted and racked/broken sashes (figure 12 and 13).
