Photo documentation of the Low Slope Roof Replacement Scope of Work at Saint Paul School

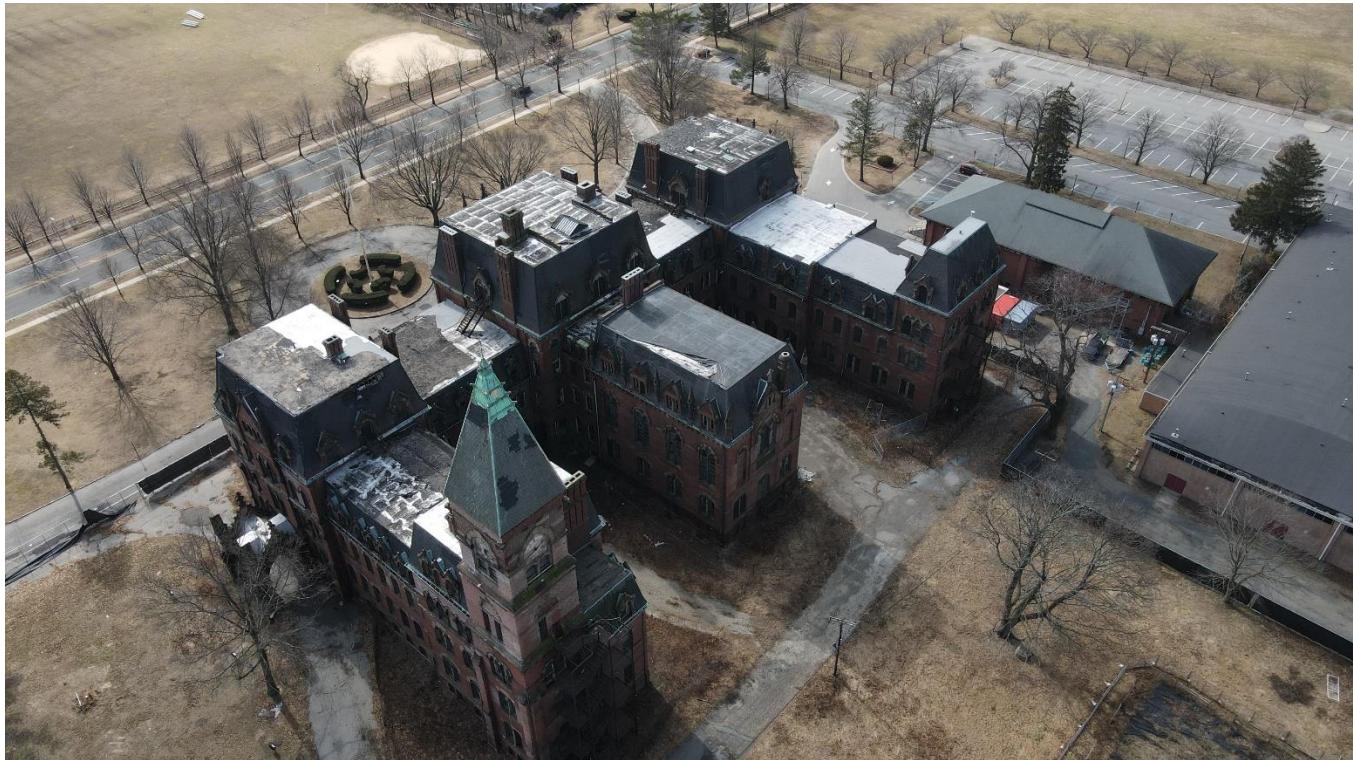
General overview of existing roof conditions

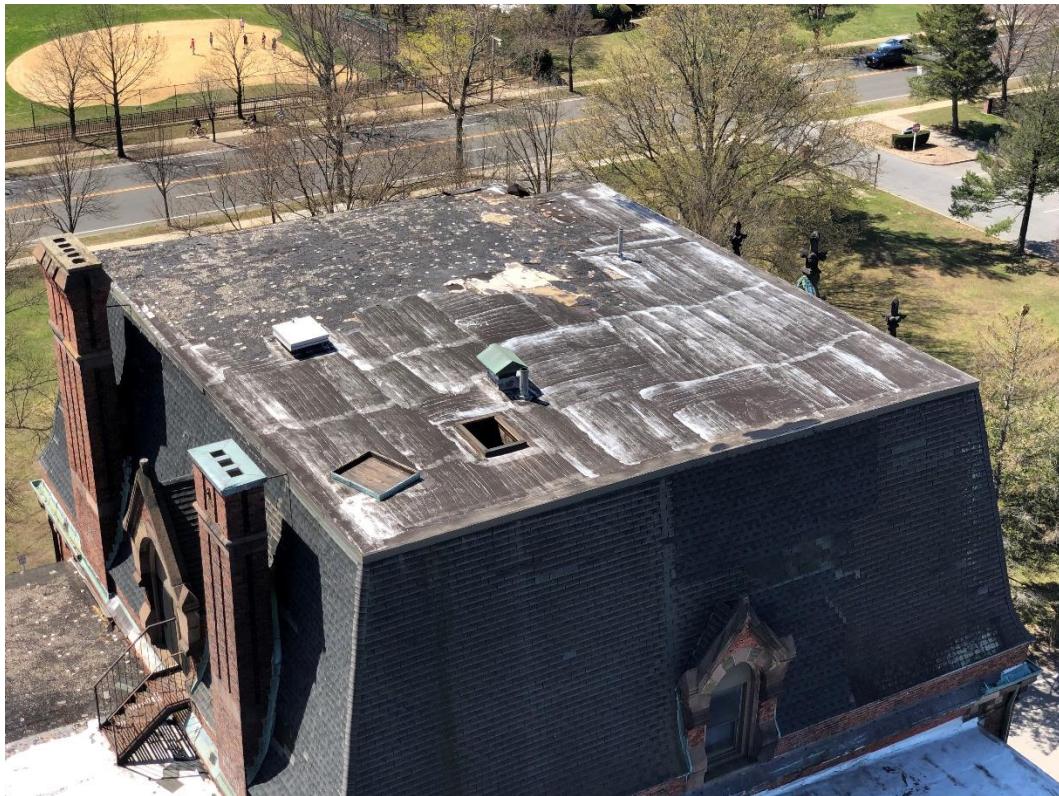
**Roof 4**

Existing roof conditions

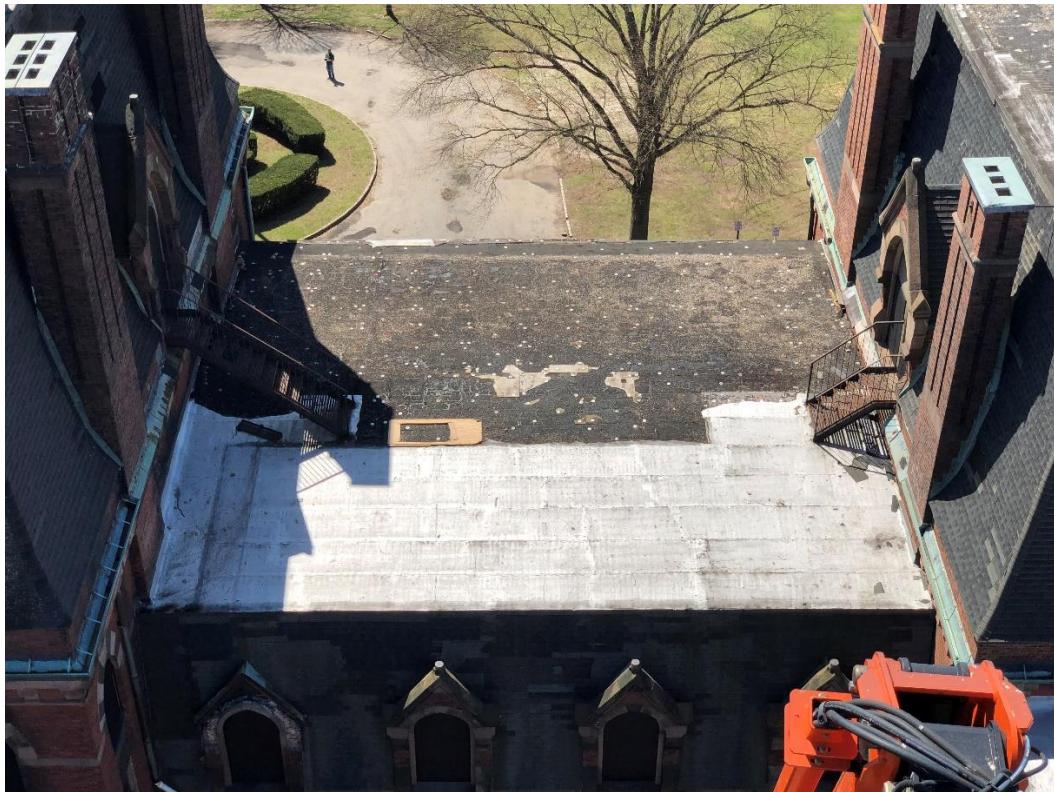
## Roof 5

Existing roof conditions

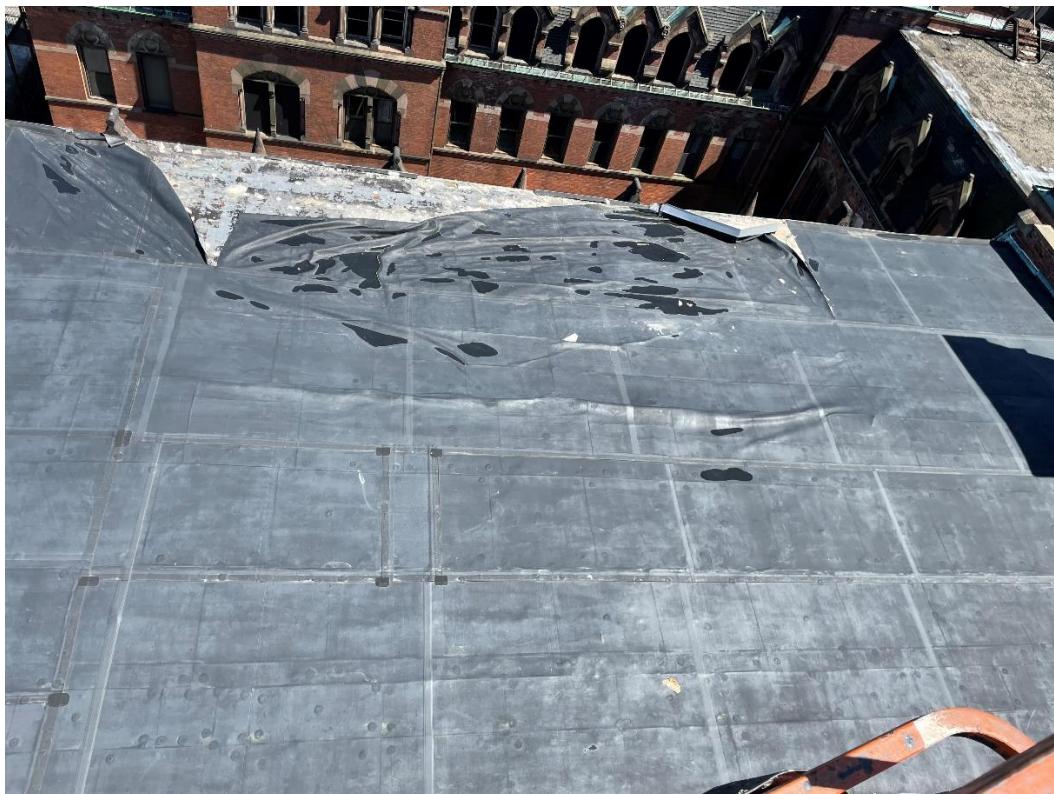
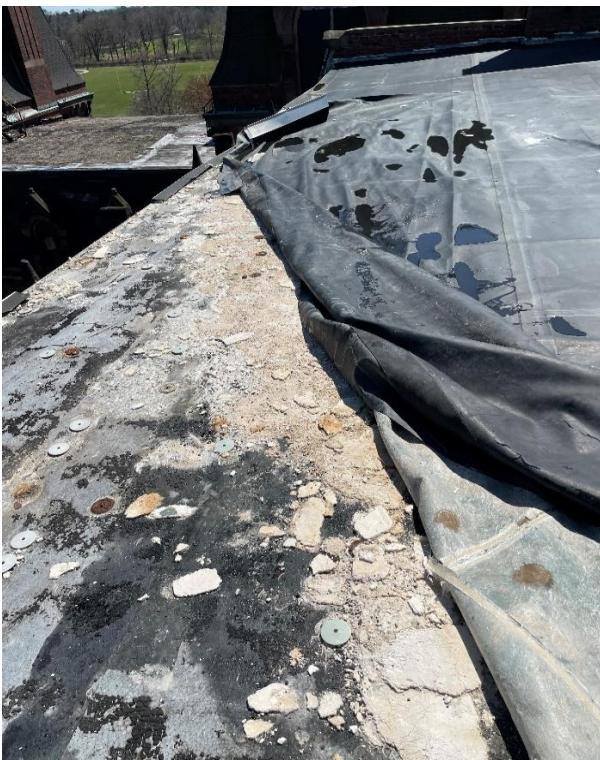
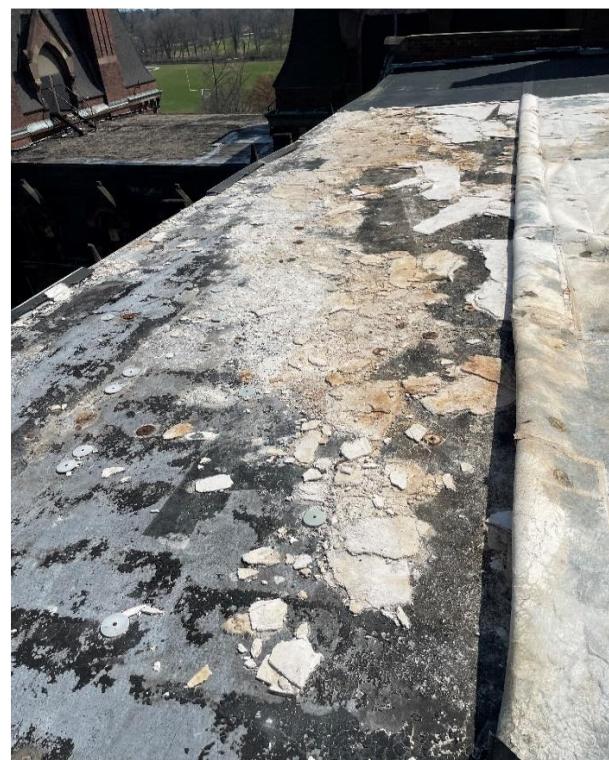
**Roof 6**

Existing EPDM roof conditions

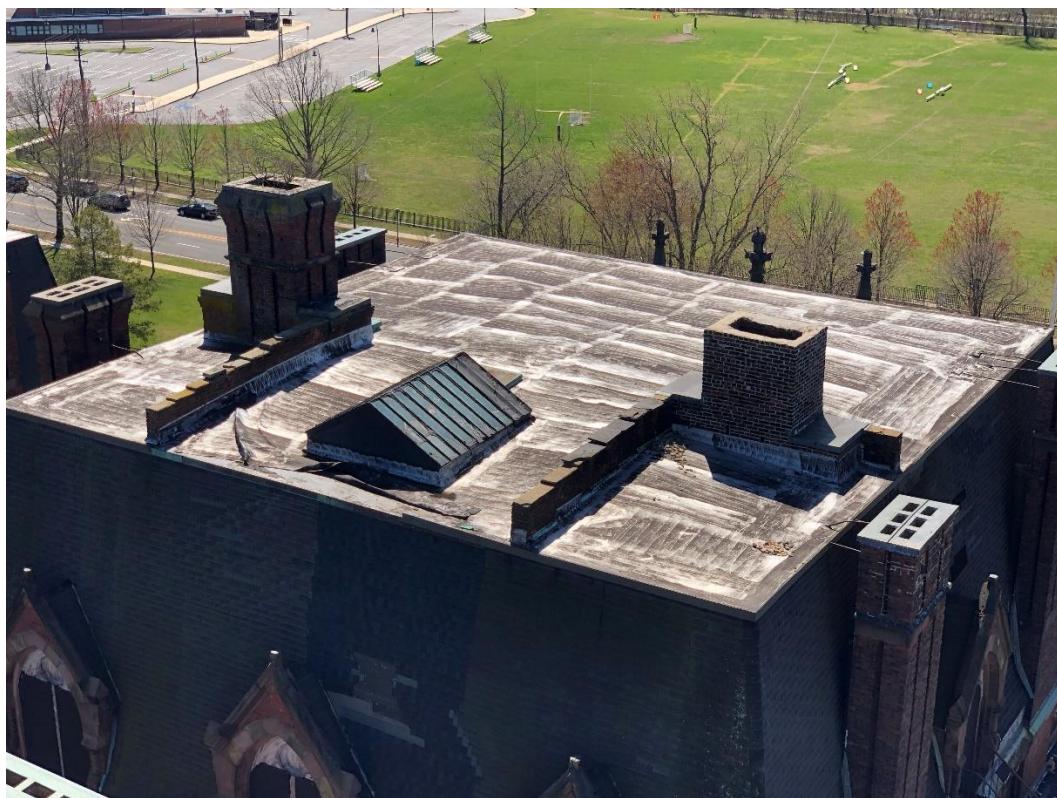
**Roof 8**

Existing roof conditions

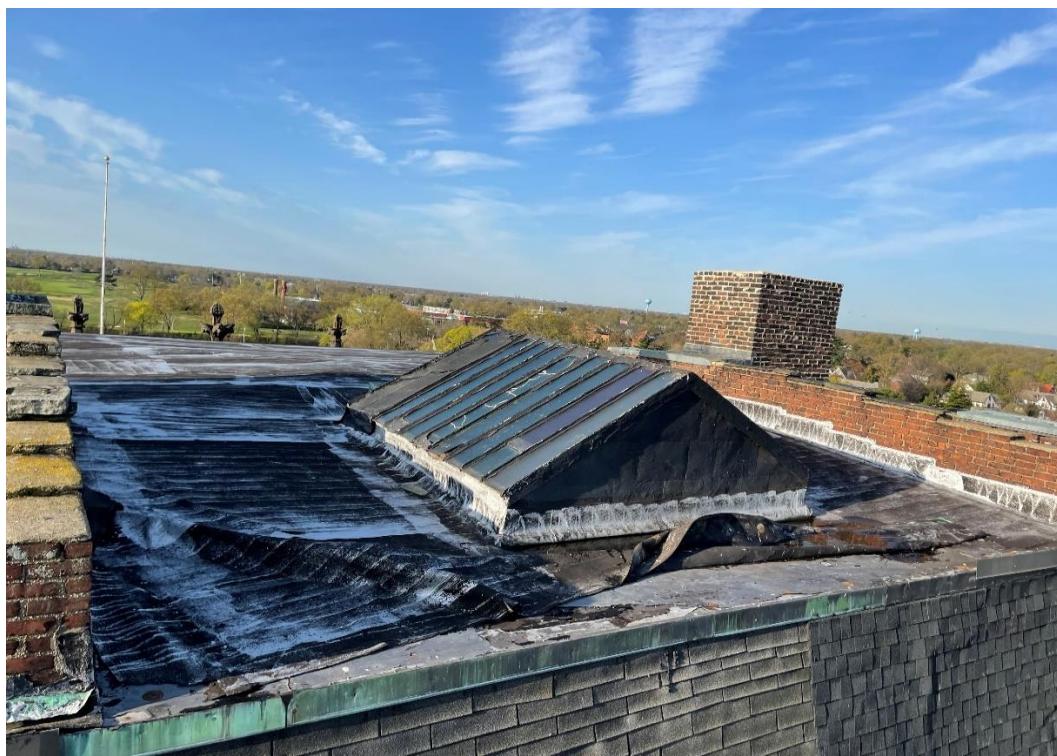
Existing roof conditions, (crack skylight lites)

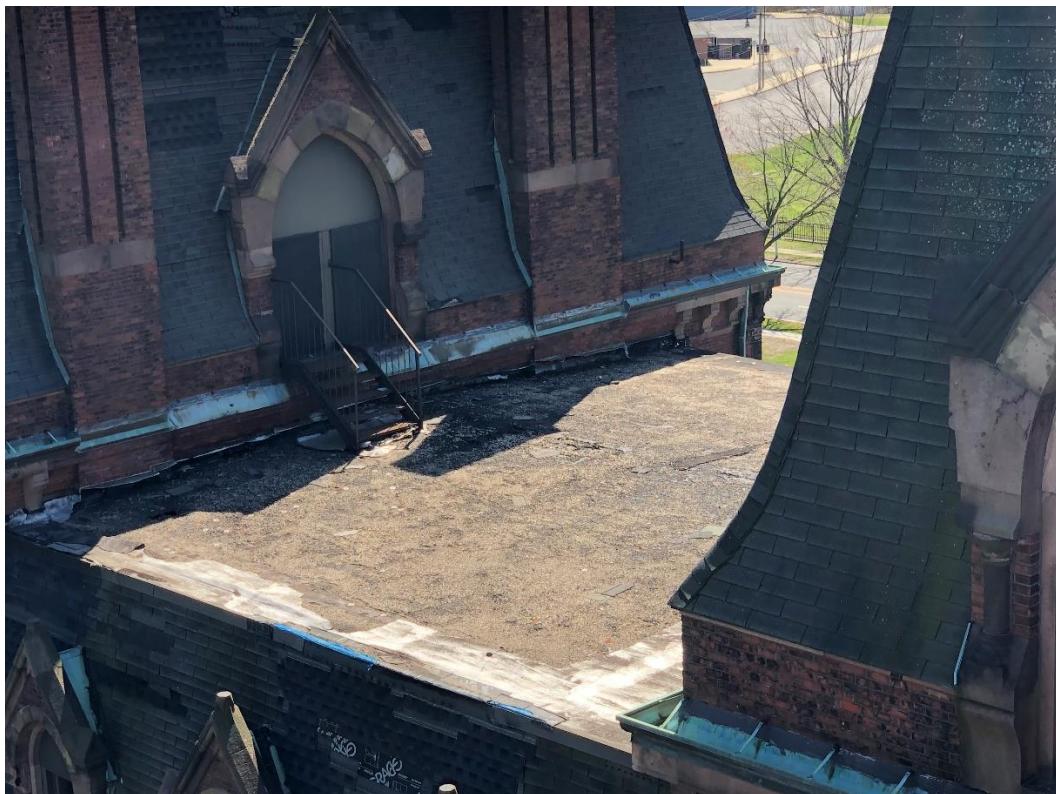
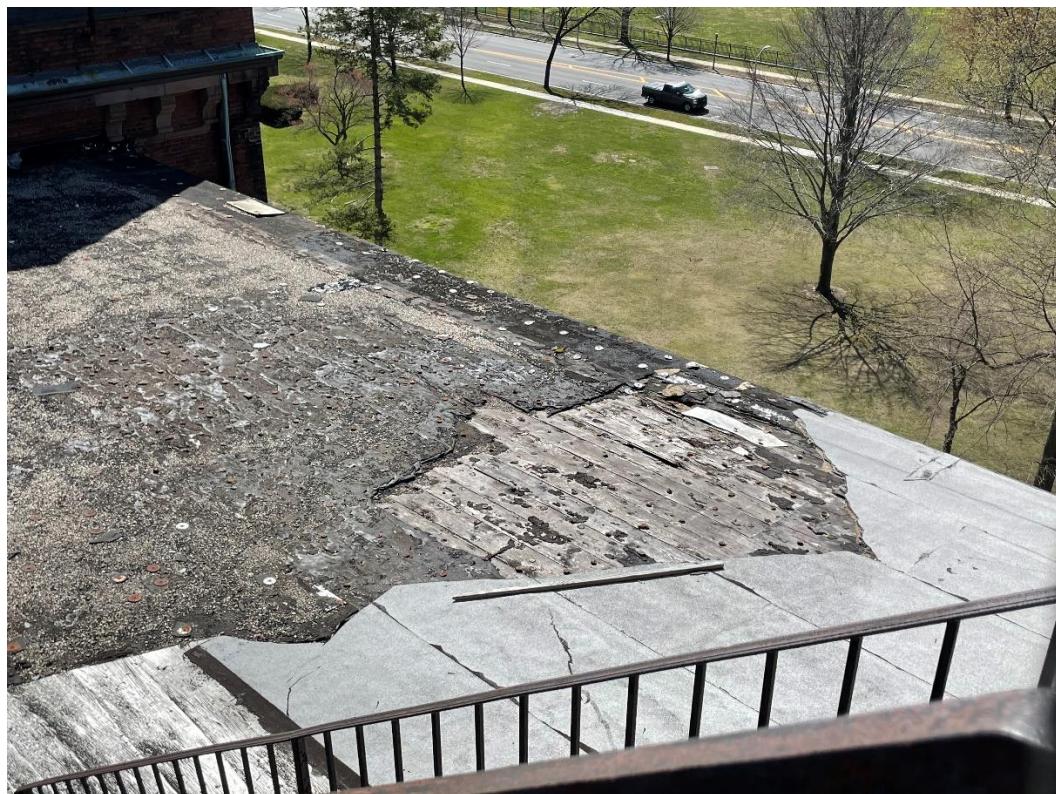
**Roof 9**

Existing roof conditions

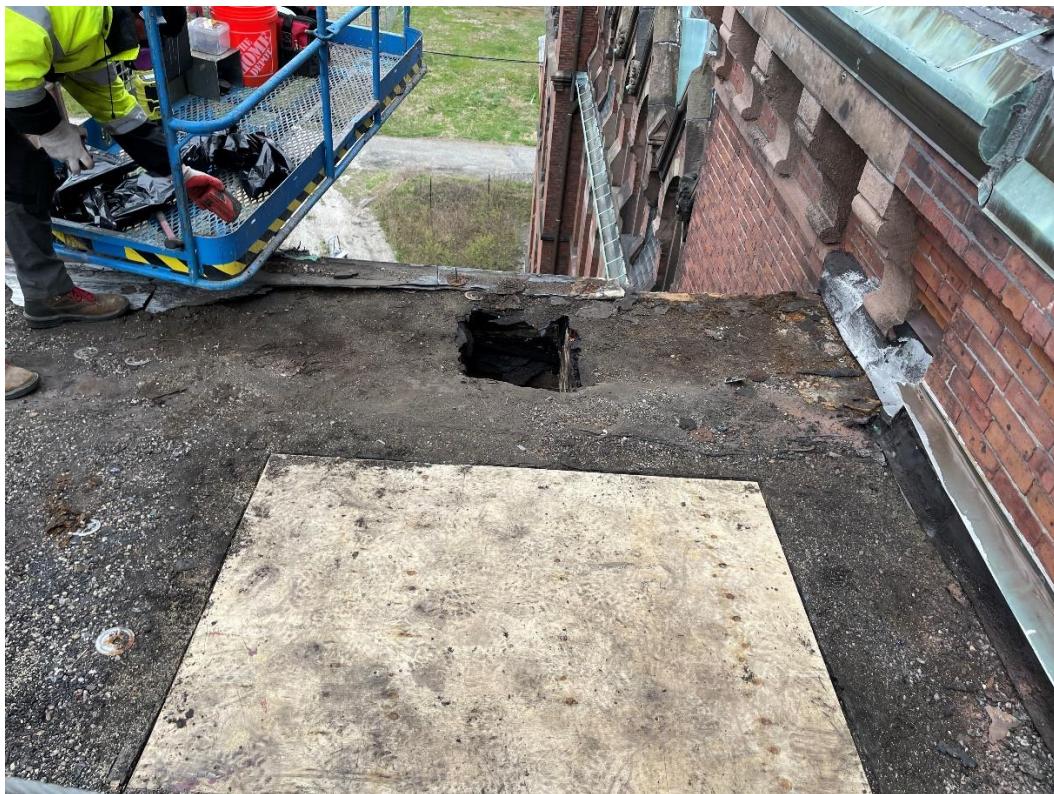
**Roof 9**

Existing roof opening

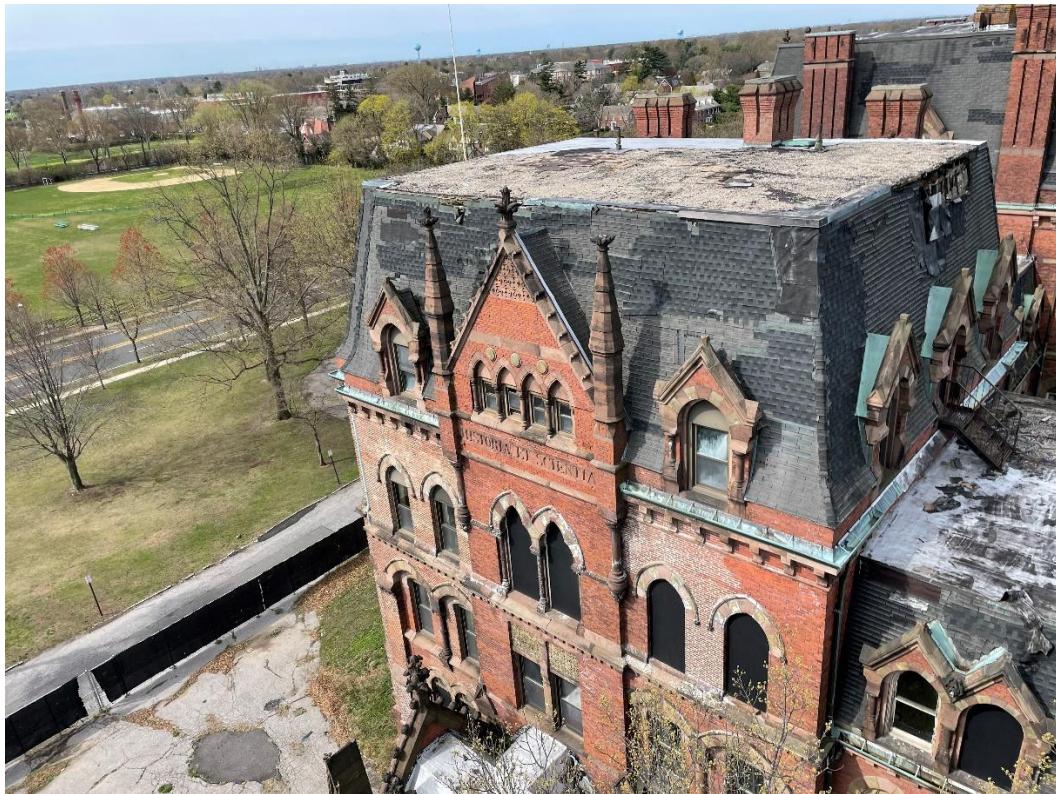
## Roof 10

Existing roof conditions

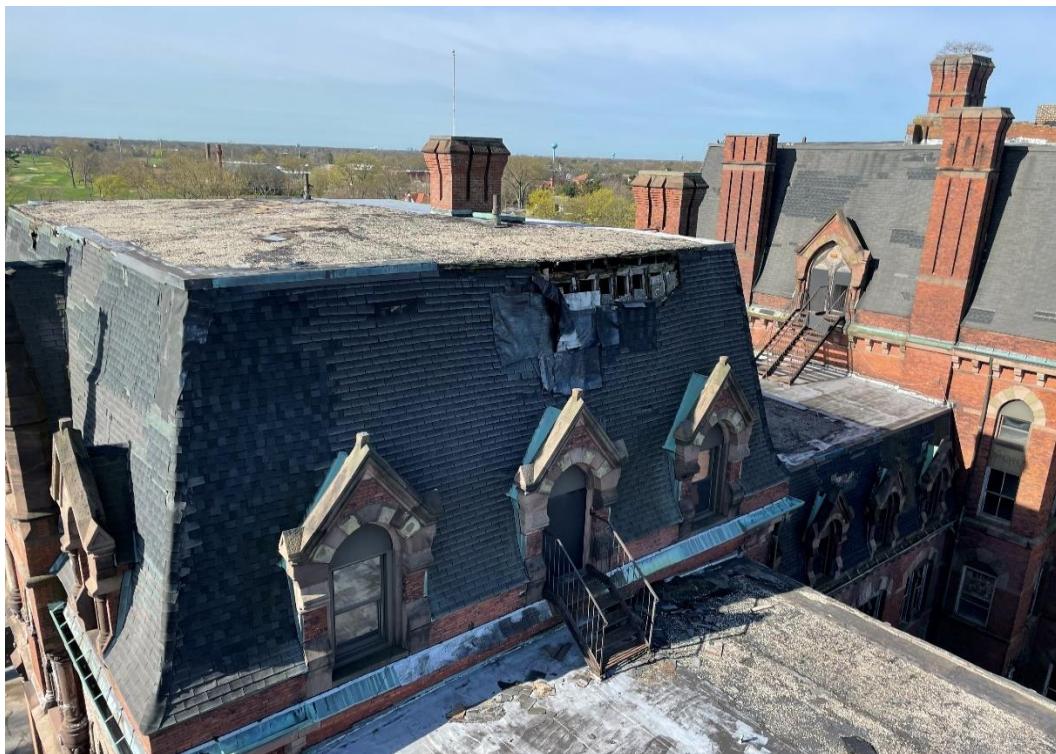
Existing mansard roof conditions, North elevation

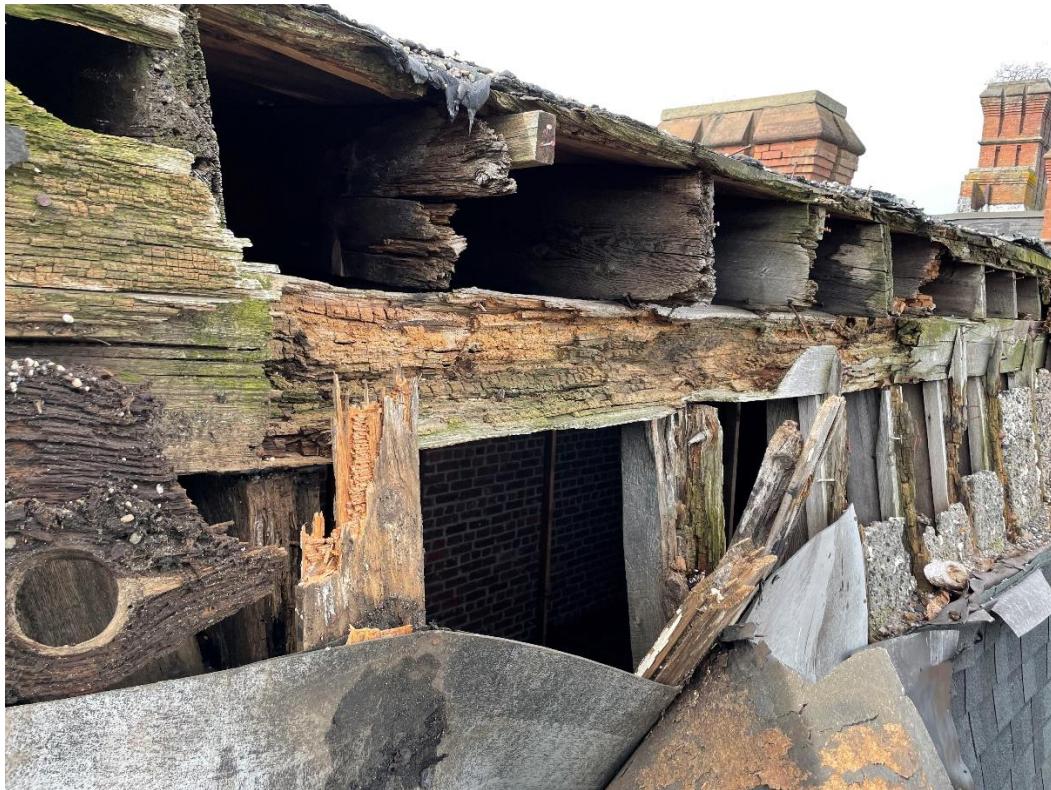
### **Roof 10 North Mansard**

Deteriorated wood structural membrane, (rafters and header beams)

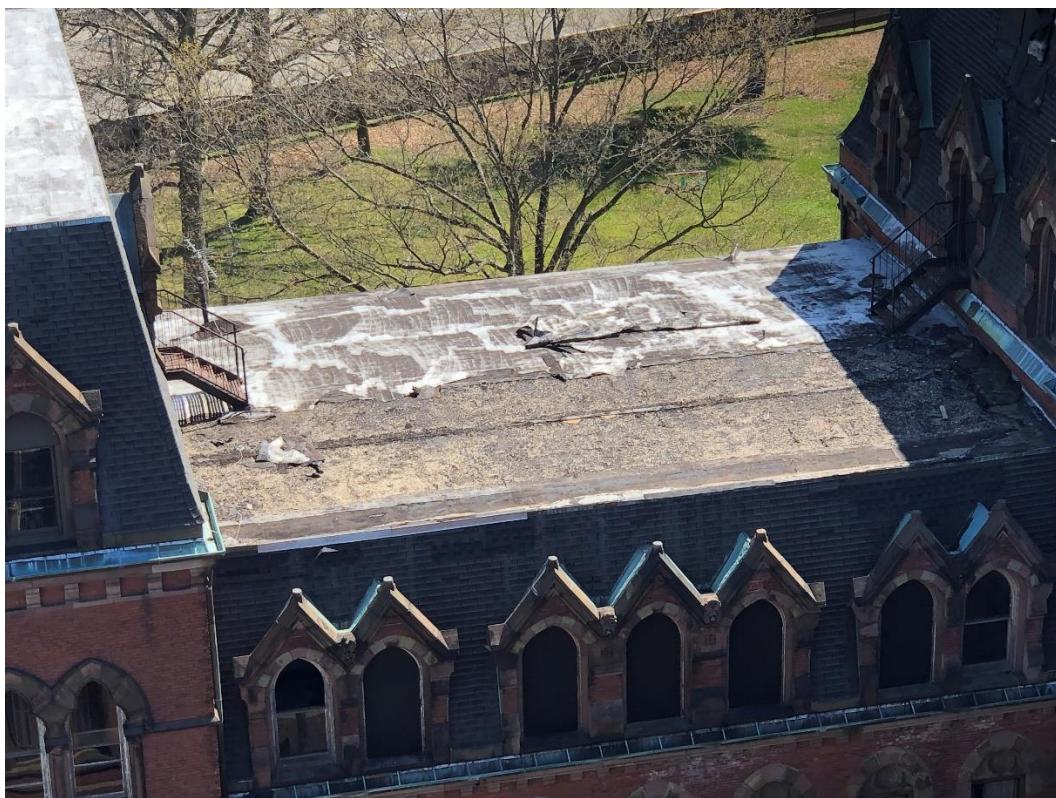
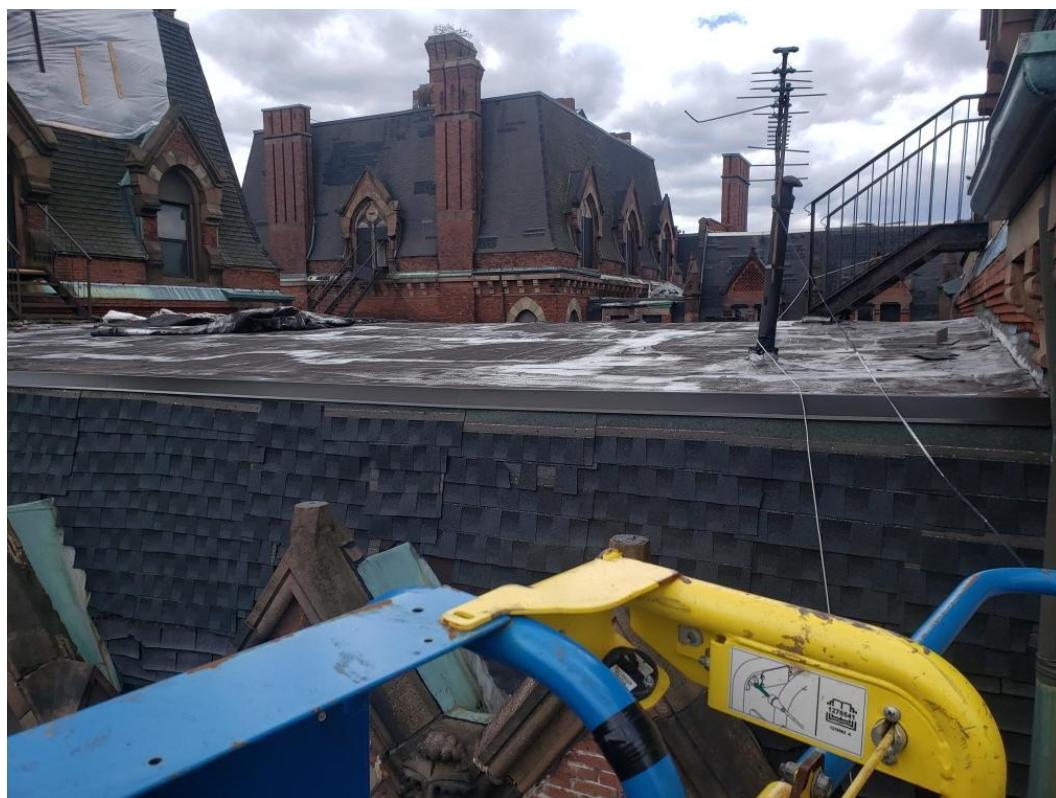
**Roof 11**

Existing roof conditions
