APPENDIX M
**Assessment of Repairs, Restoration,
and Mitigation Costs**

ASSESSMENT OF REPAIRS AND RESTORATION

OF ST. PAUL'S SCHOOL, GARDEN CITY, NEW YORK

Date: January 21, 2011

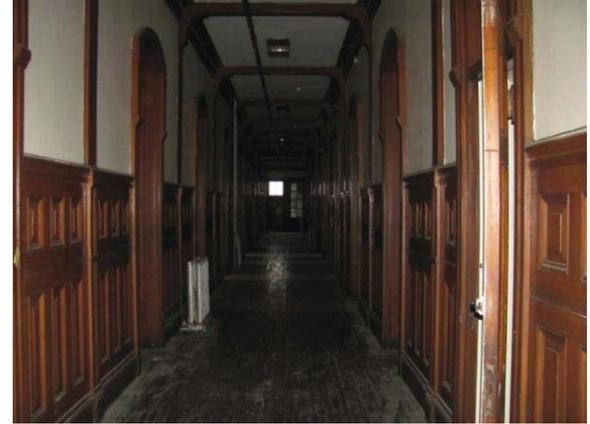
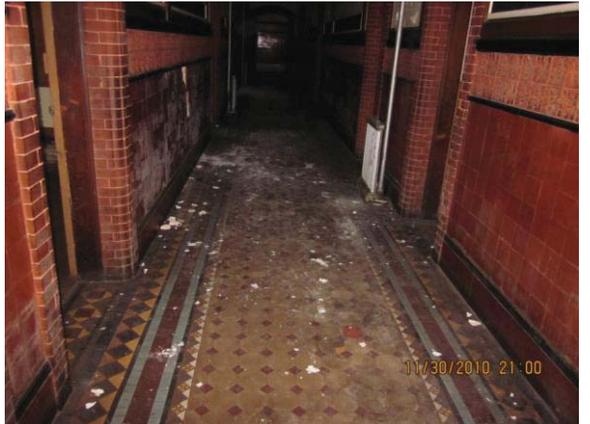
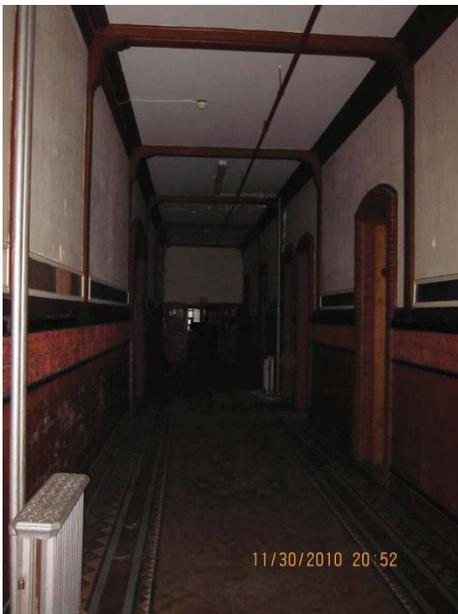
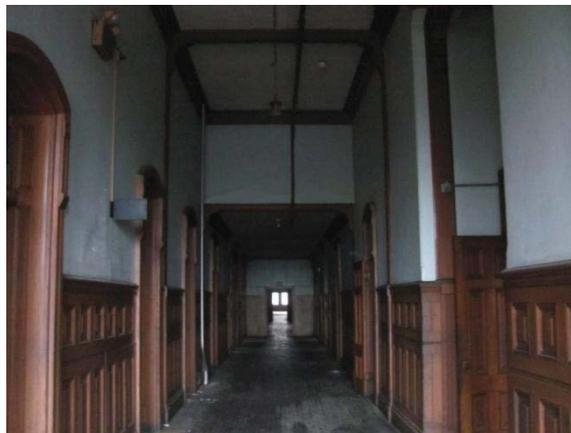
Typical Corridors. Corridor walls are structural and support the floor framing.

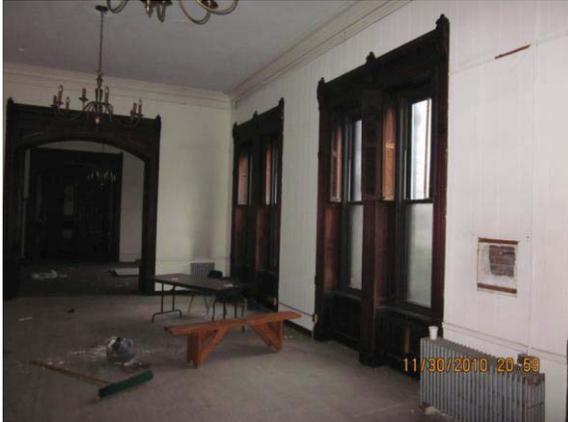
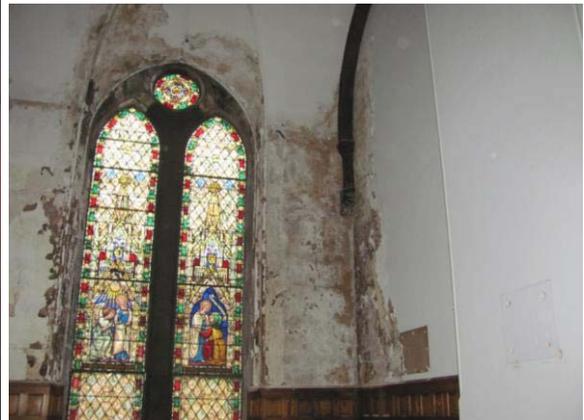
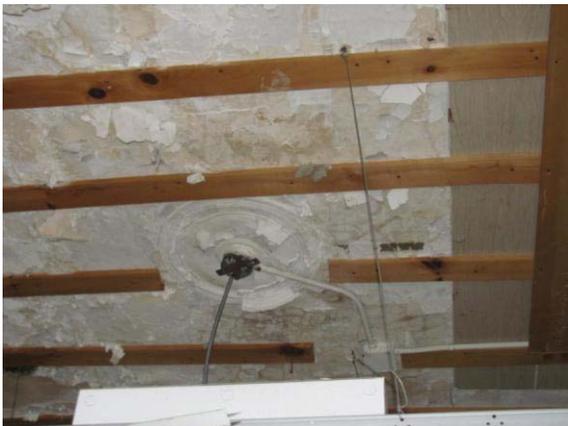
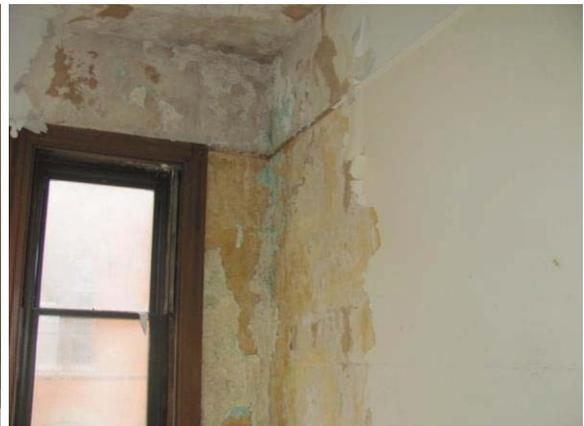
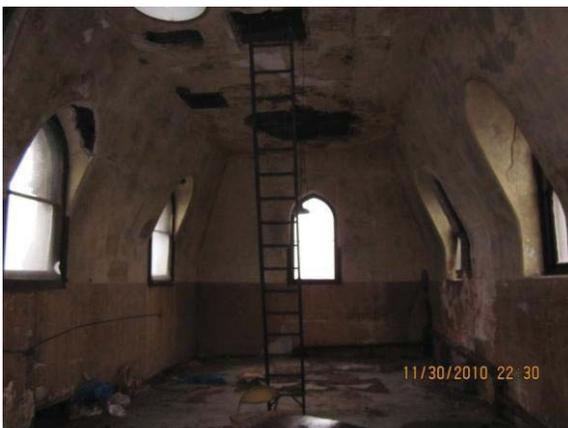
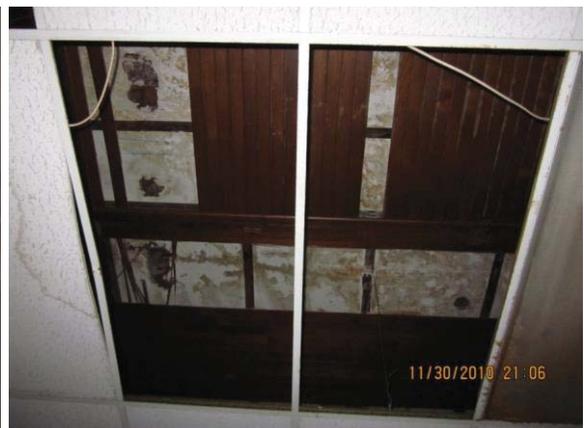
Typical rooms and finishes. Note that the water damage extends to virtually all rooms.

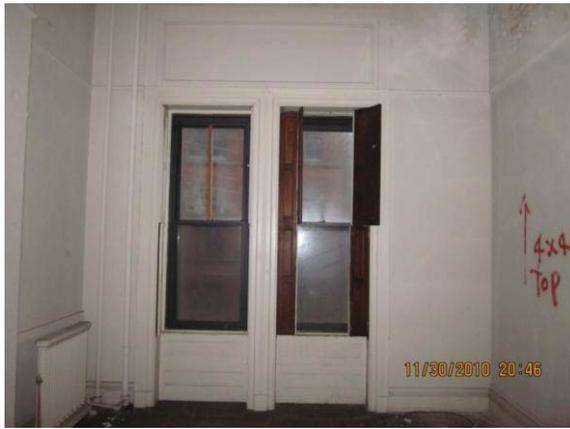
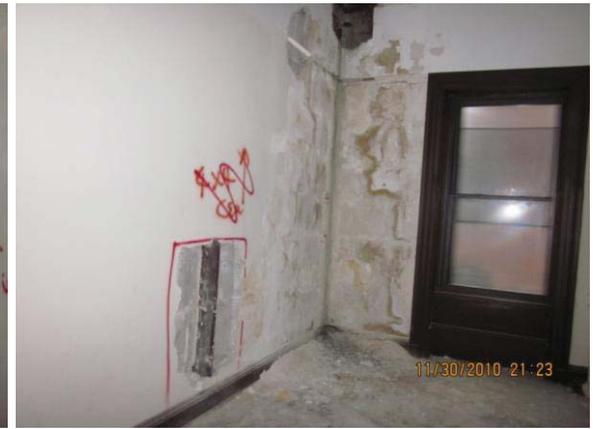
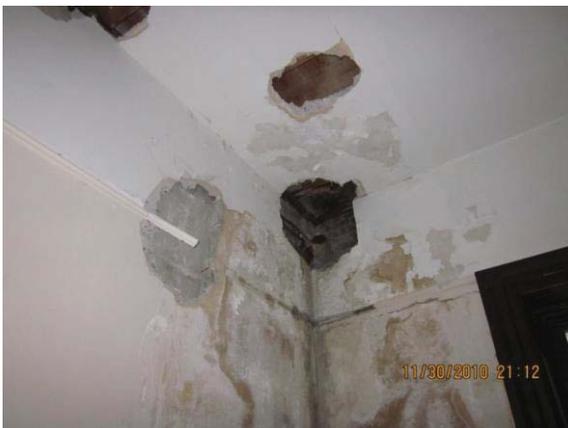
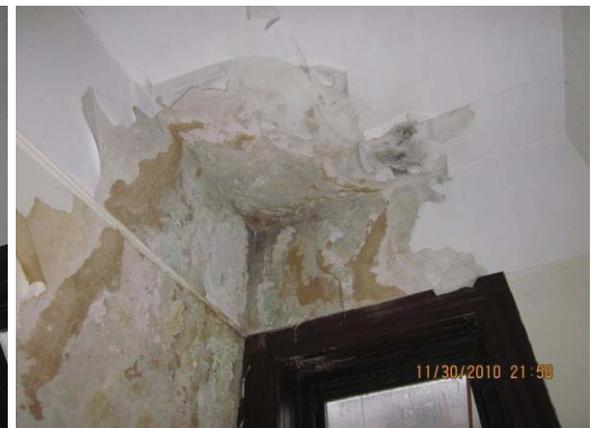
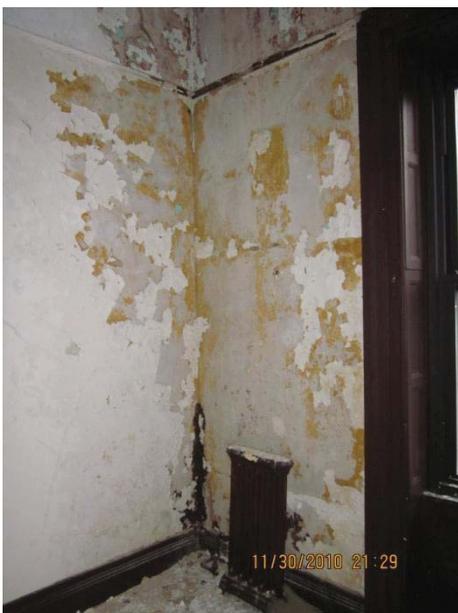
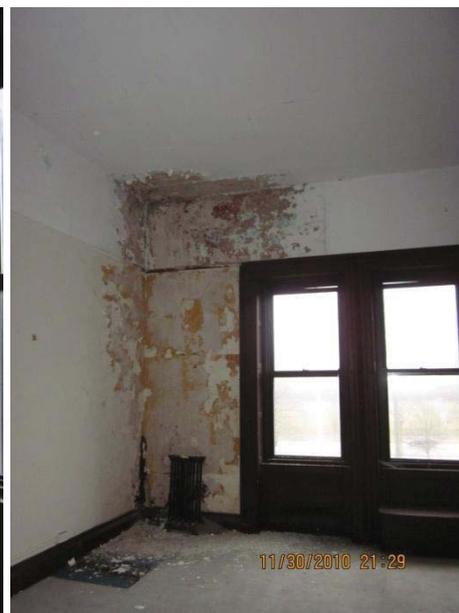
Typical room size and condition of finishes is evident in these photographs.

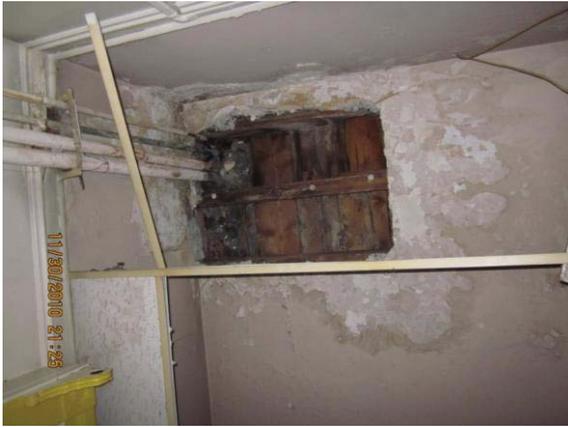
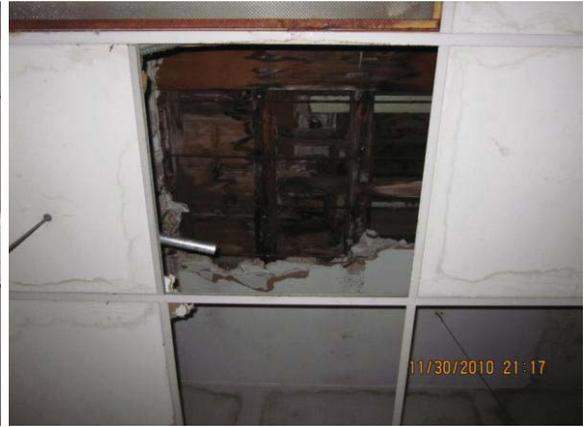
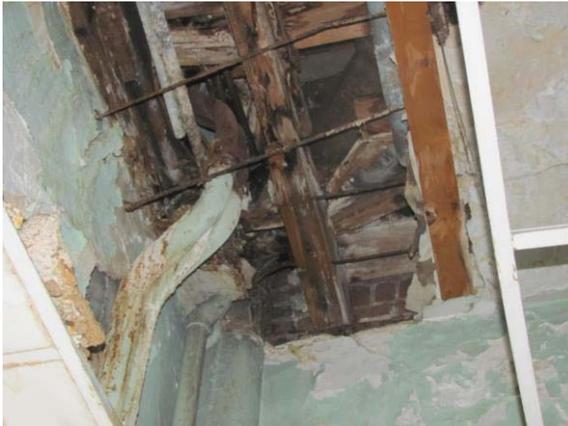
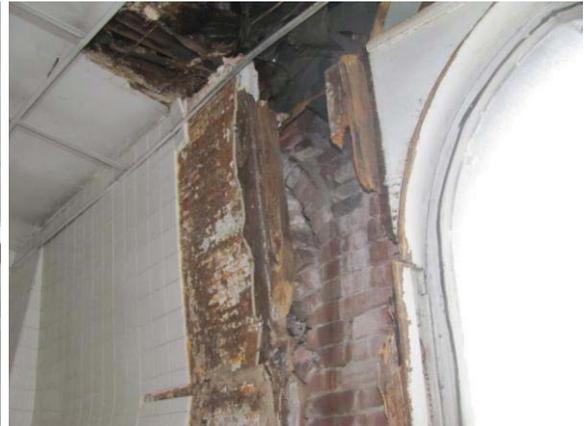
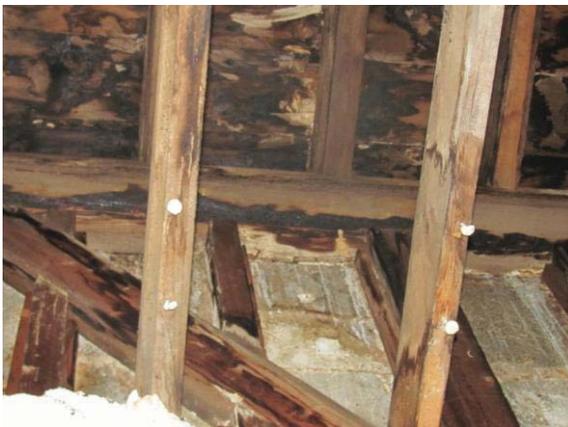
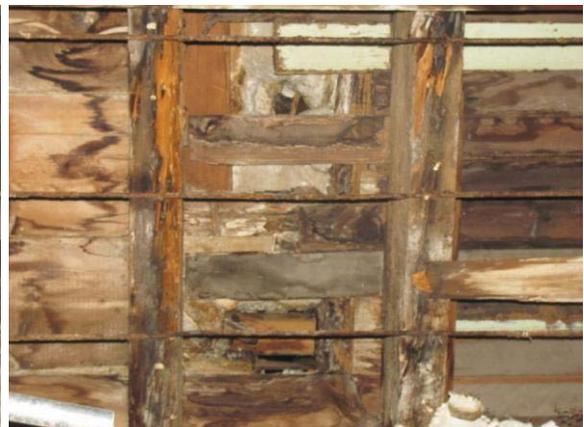
Damage to the wood floor and roof framing is extensive and serious.

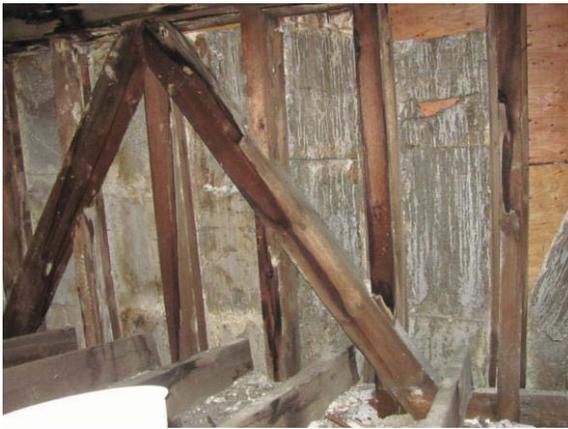
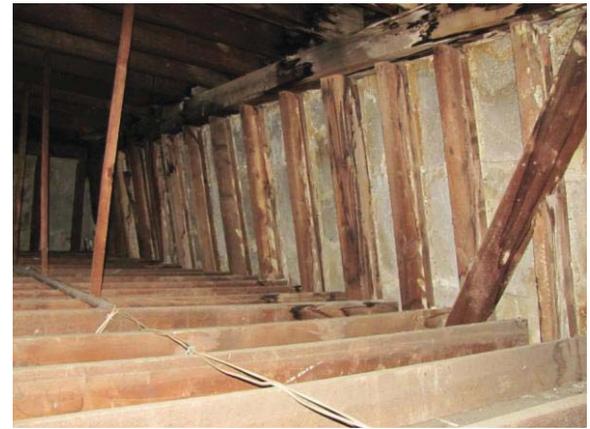
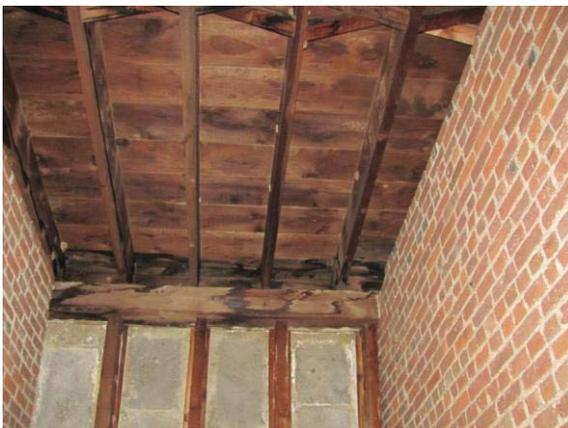
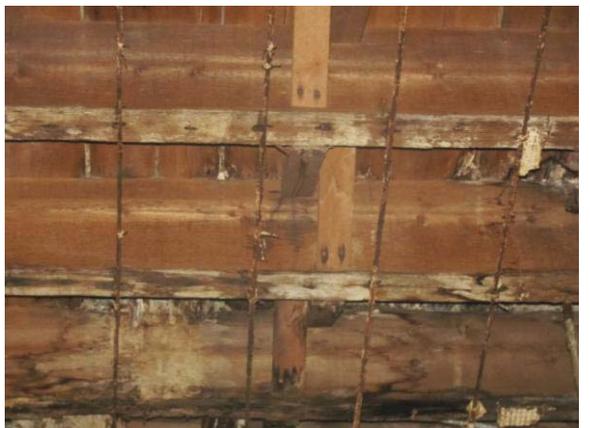
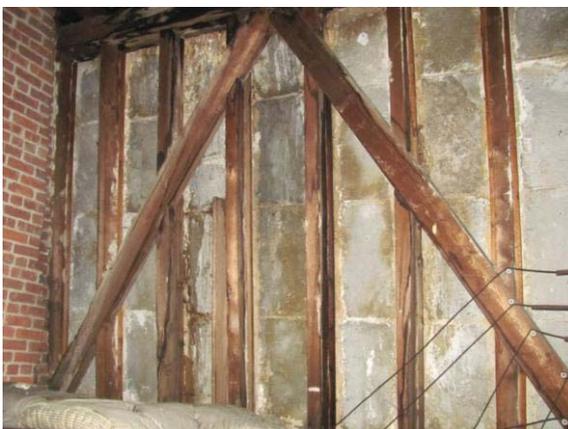
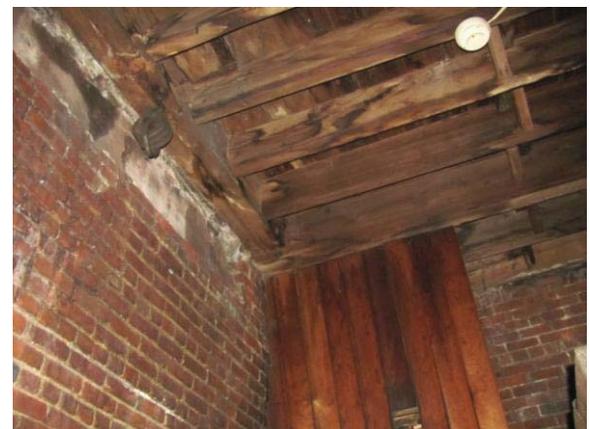
Virtually all of the roof members are deteriorated to some degree and will require extensive restoration or replacement.

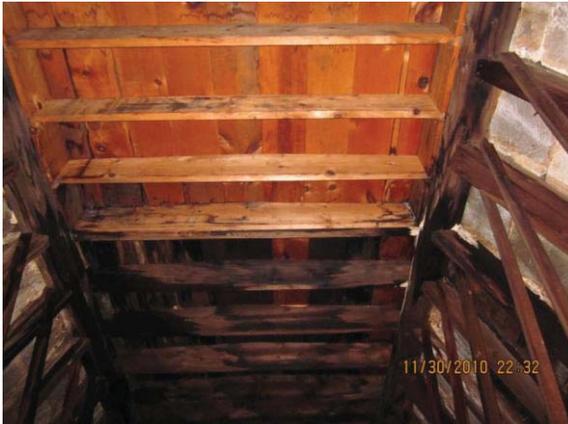
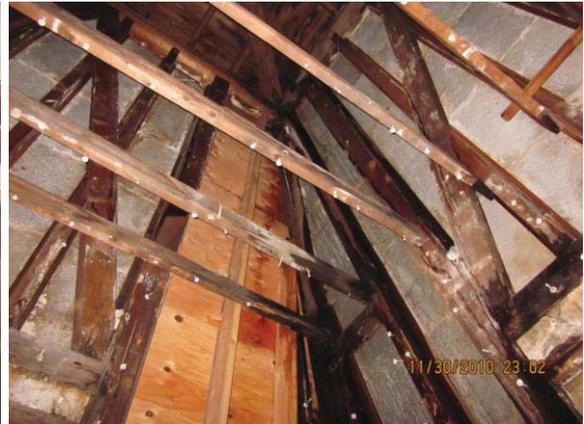
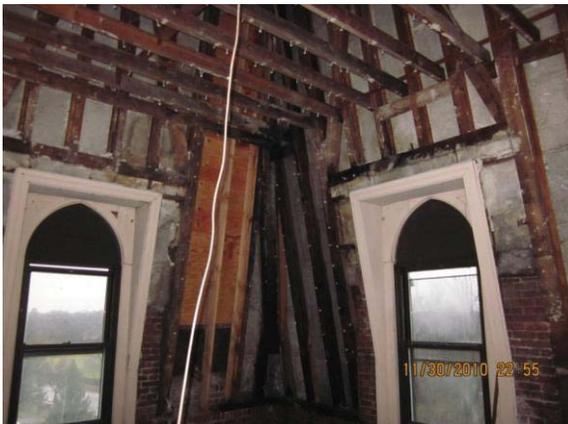
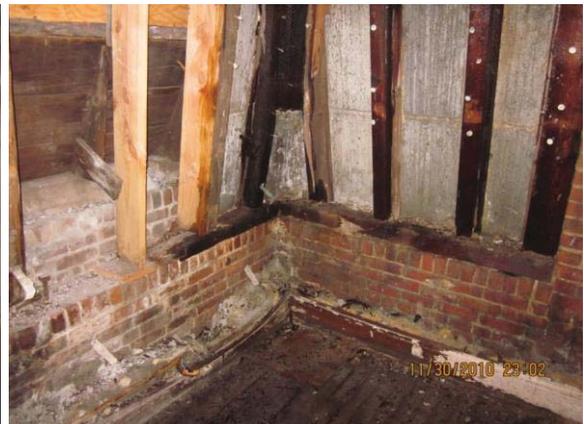
Areas of the roof have been replaced after structural failure. All of the rafters will need to be inspected and repaired.

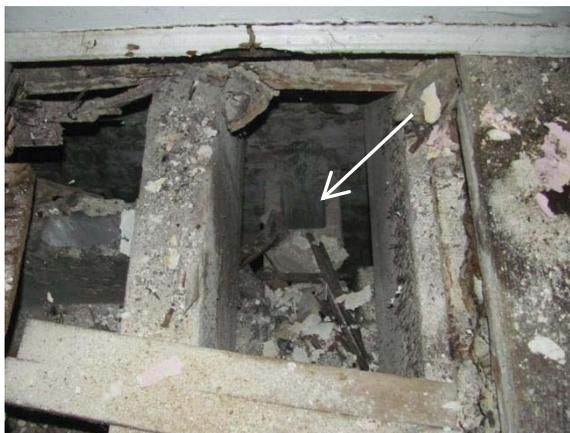
There is no fire-safing around the perimeter of the building. Cavities in the walls and floors extend from the roof to the basement, creating pathways for potential fire and smoke spread

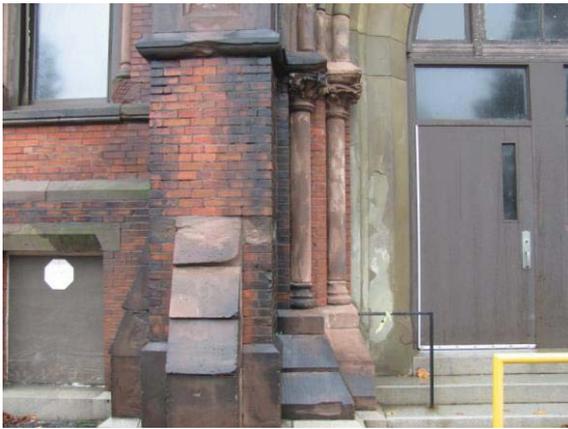
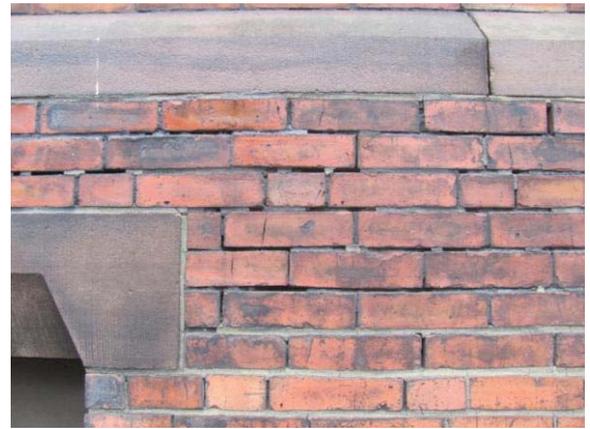
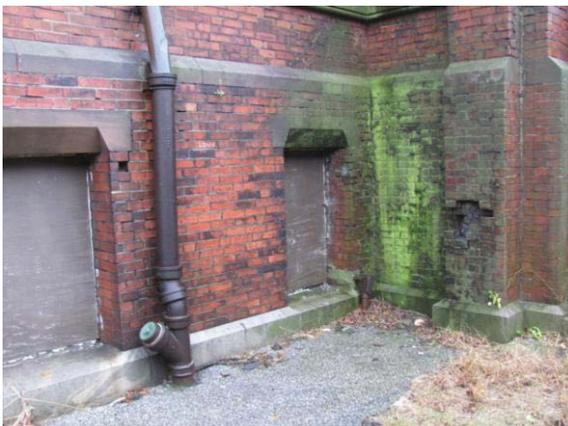
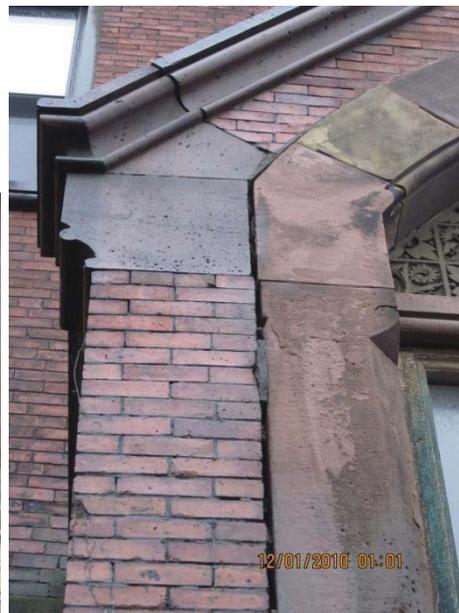
Areas of the brick have been badly damaged by water. In some areas, most of the mortar joints have been washed away and the stone trim is loose.

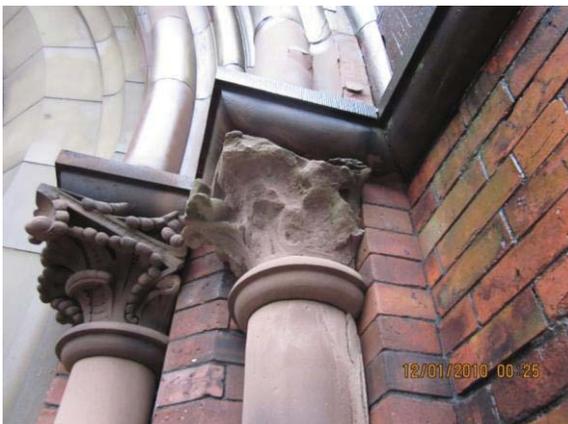
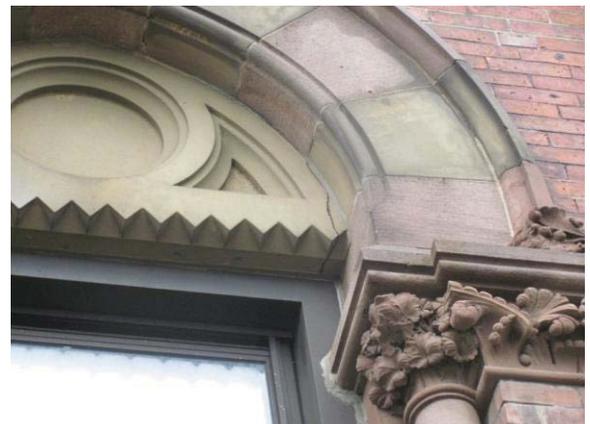
In areas the stone trim is cracking and delaminating

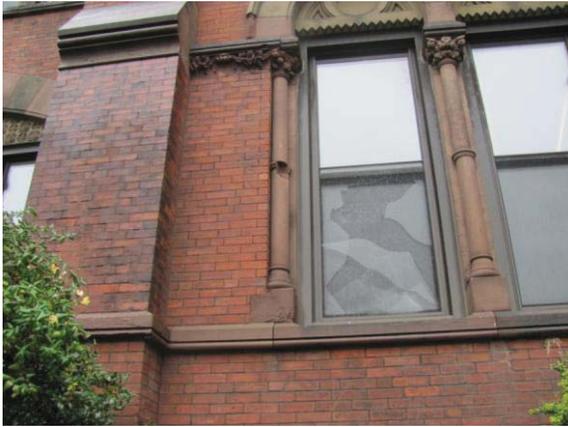
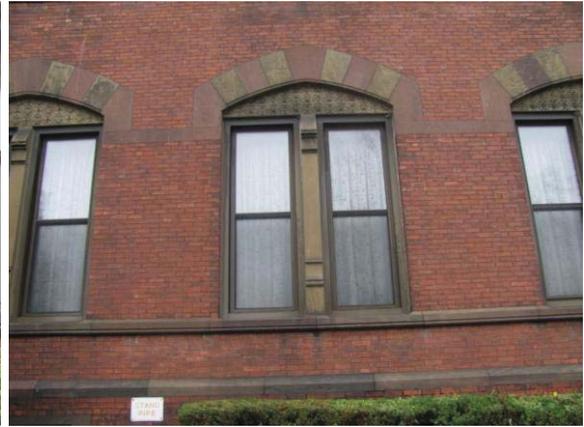
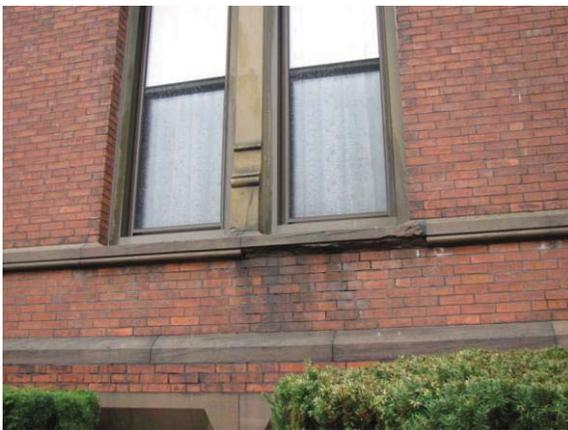
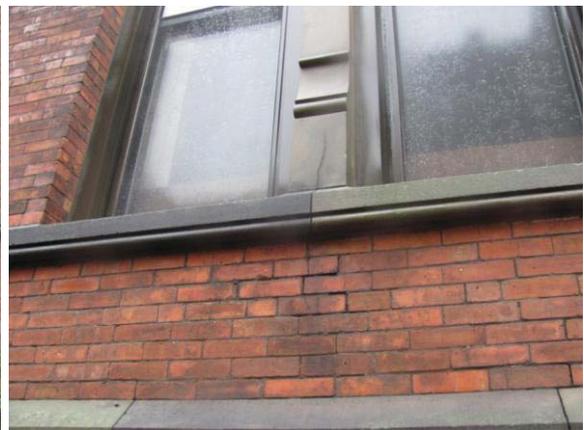
Cracks are developing at most of the stone piers between windows on the ground floor and the stone is deteriorating.

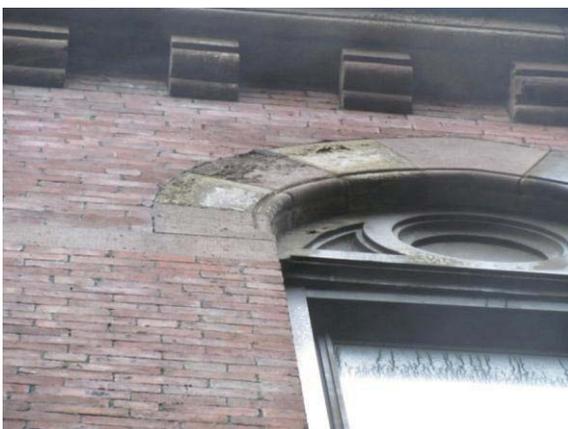
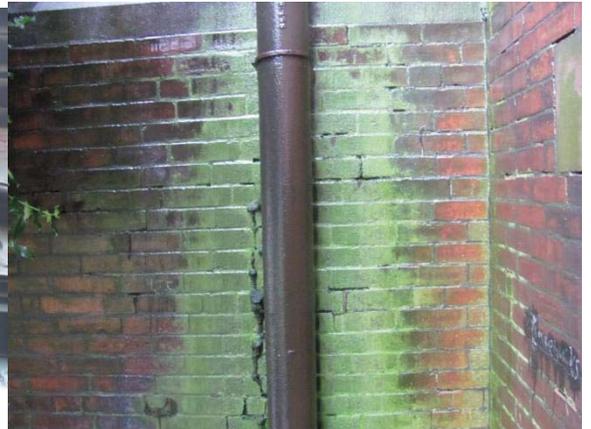
Some of the stone is delaminating, and some of the brick is severely damaged by water.

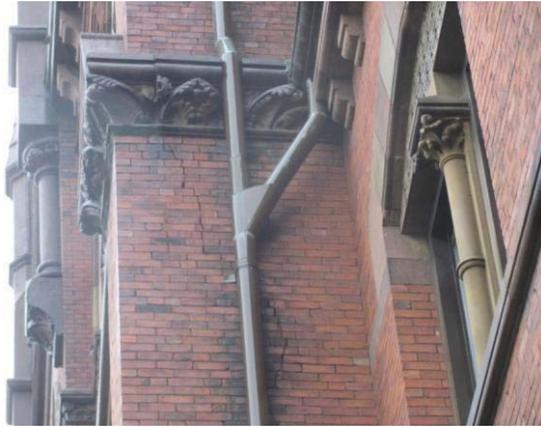
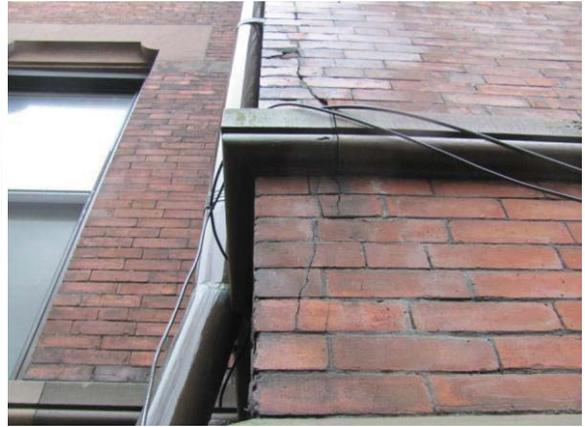
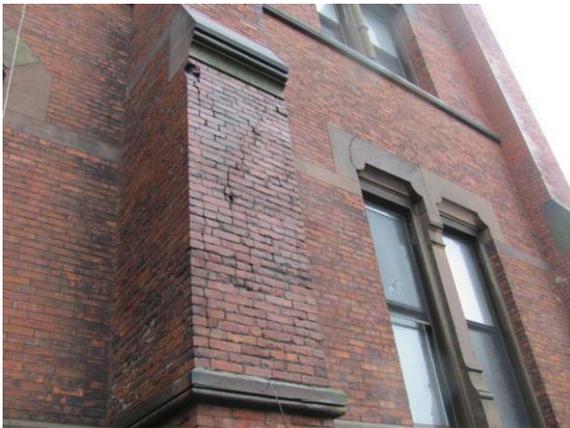
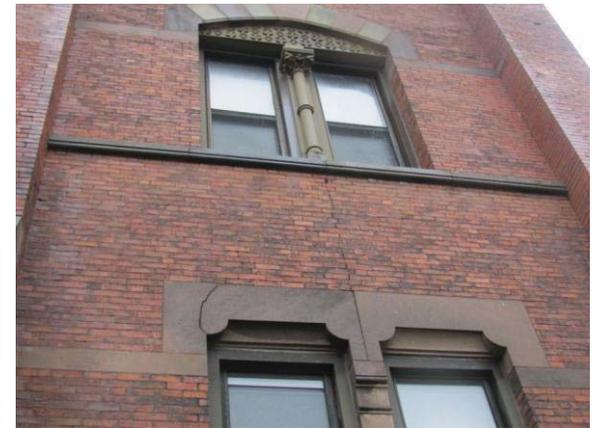
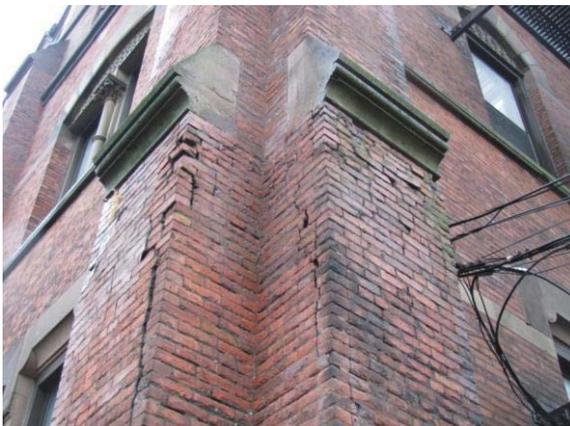
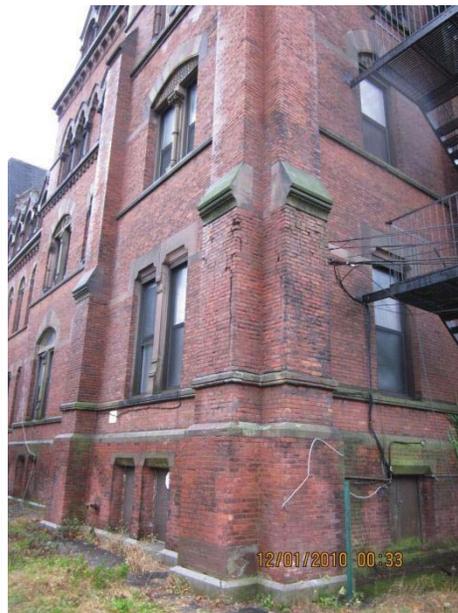
Structural cracks are developing at piers and corners of the building throughout

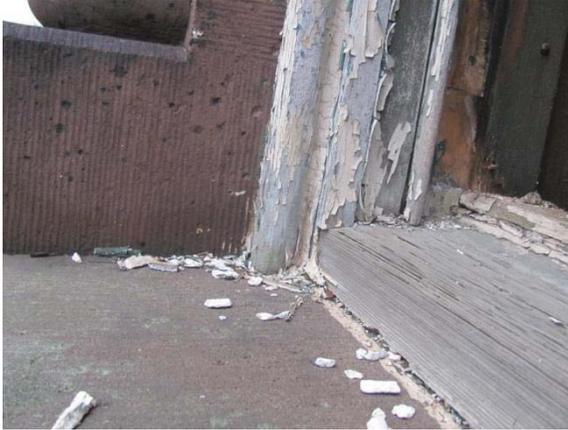
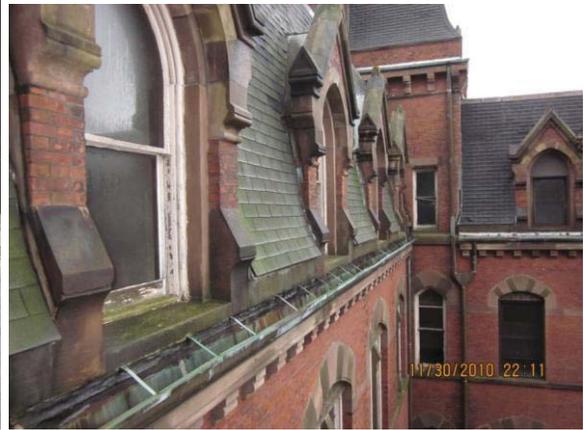
The wood windows are in poor condition. The gutters and downspouts are in need of extensive repair and replacement. The shingle roofs will need to be replaced with slate to restore the building to its original condition.

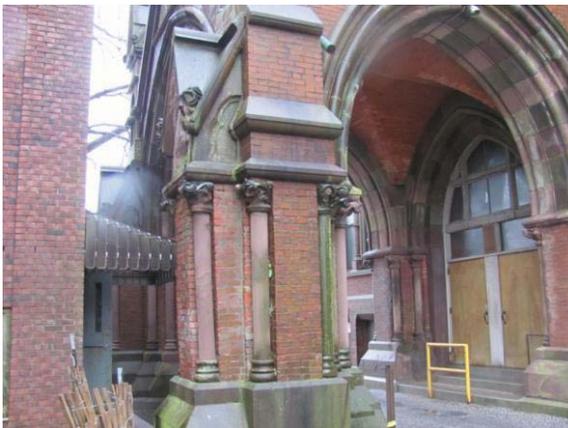
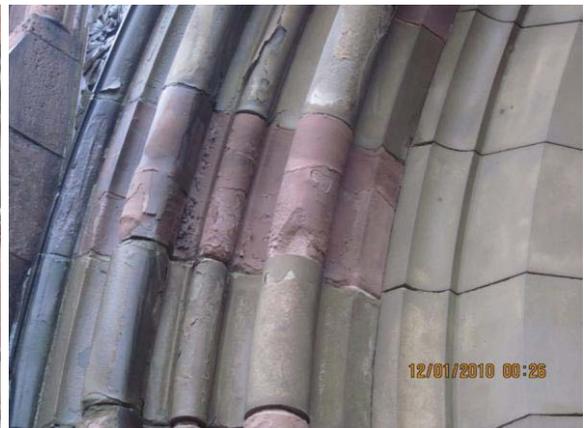
The porte-cochere is in poor condition but could be restored if the community wishes to salvage it as a stand-alone monument.
