Garden City
Fire Department

Firehouse #1, #2 & #3

Existing Conditions
Documentation & Recommendations
DRAFT

February 2, 2018

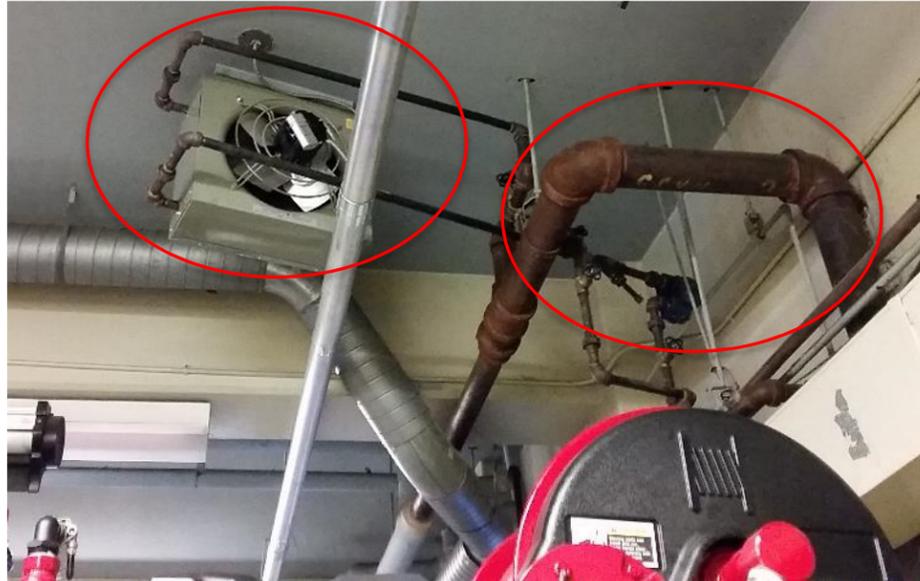
- 1) Observed deficiency: Steam distribution piping & fittings to four (4) unit heaters are uninsulated.

Recommended fix: All uninsulated piping and fittings should be cleaned, insulated, and provided with a service jacket as per New York State Energy Conservation Code. In addition to resolving code problems, insulated piping will reduce building energy usage and operating costs.

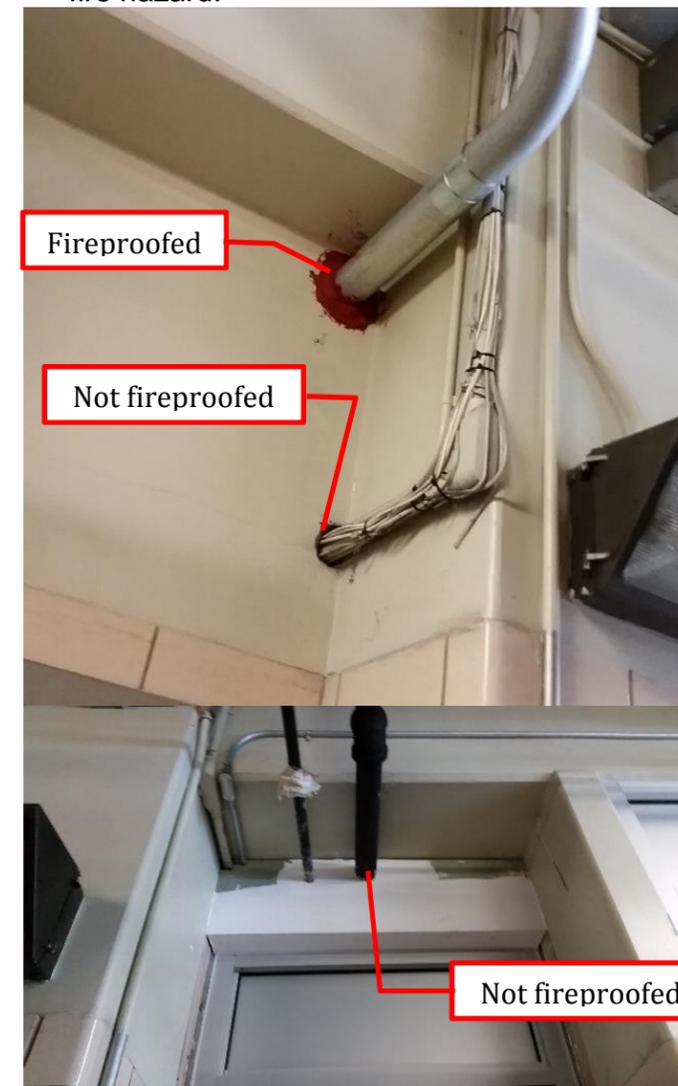
- 7) Observed deficiency: Piping & utility penetrations between apparatus floor & adjacent egress corridor not fireproofed as per New York State Building and Mechanical Code. This is a potential fire hazard.

Recommended fix: Fireproofing should be applied to all penetrations through a fire-rated assembly. 3M Fire Barrier CP 25 caulk (or a UL listed equivalent) may be utilized and applied as per its UL listing.

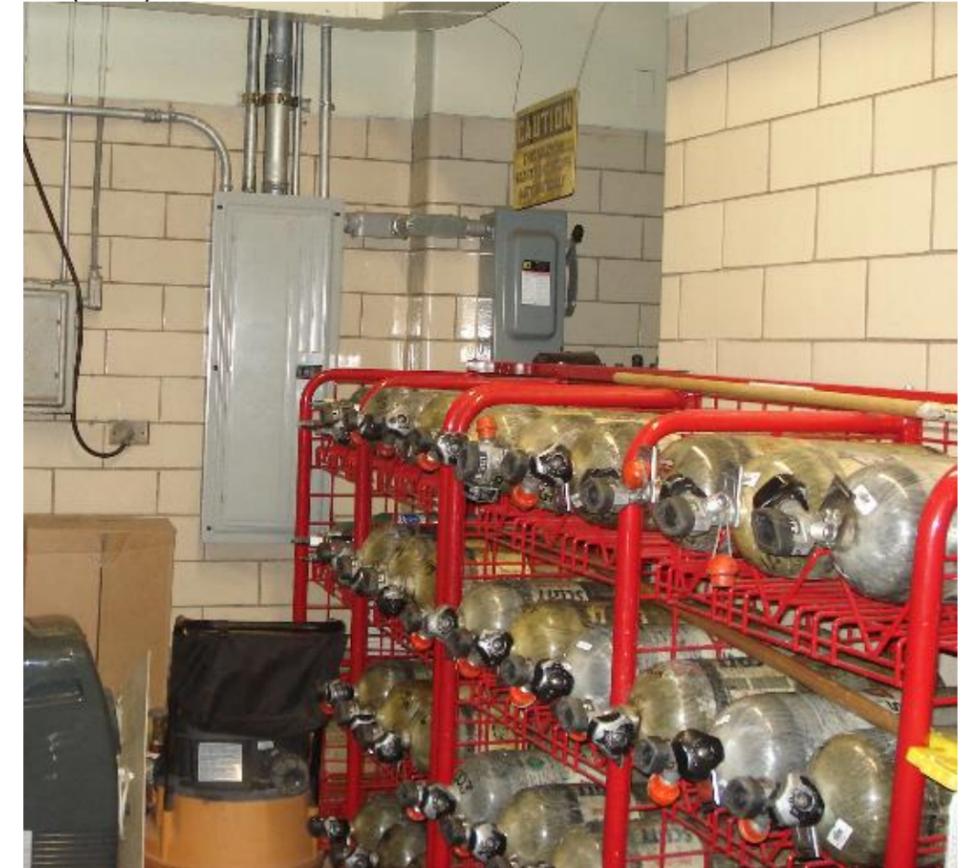
1) Observed Deficiency: Electrical panel & disconnect switch are blocked by oxygen rack & air compressor, 3-foot minimum clearance in front of panel required by National Electric Code (NEC):

Recommended fix: Remove and relocated all items obstructing panel and switch to provide minimum clearance.

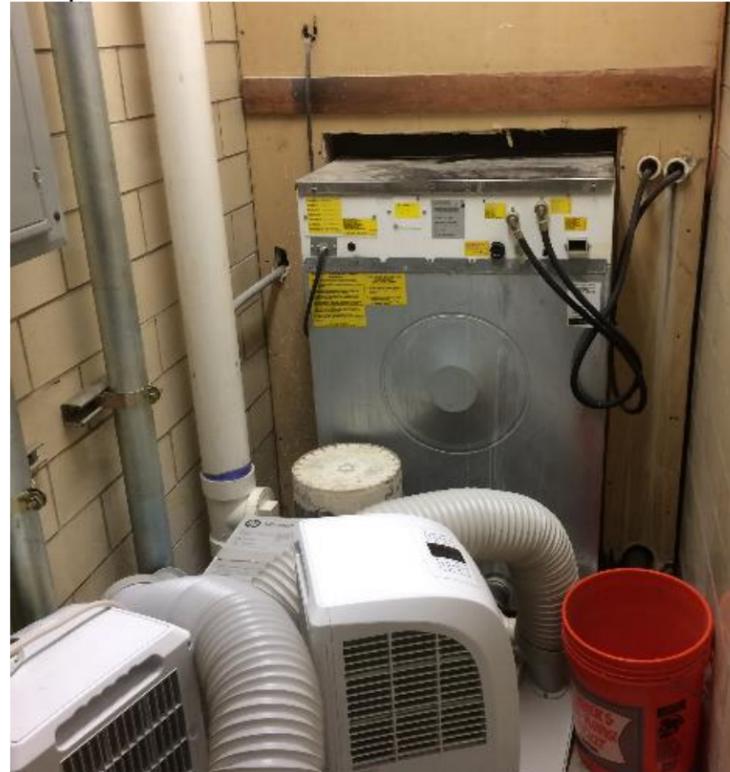
- 1) Observed Deficiency: Washing machine installation not code-compliant.

Recommended Fix: Replace waste connection with standpipe or connect to trench drain; separate or eliminate washing machine intrusion into electrical closet:

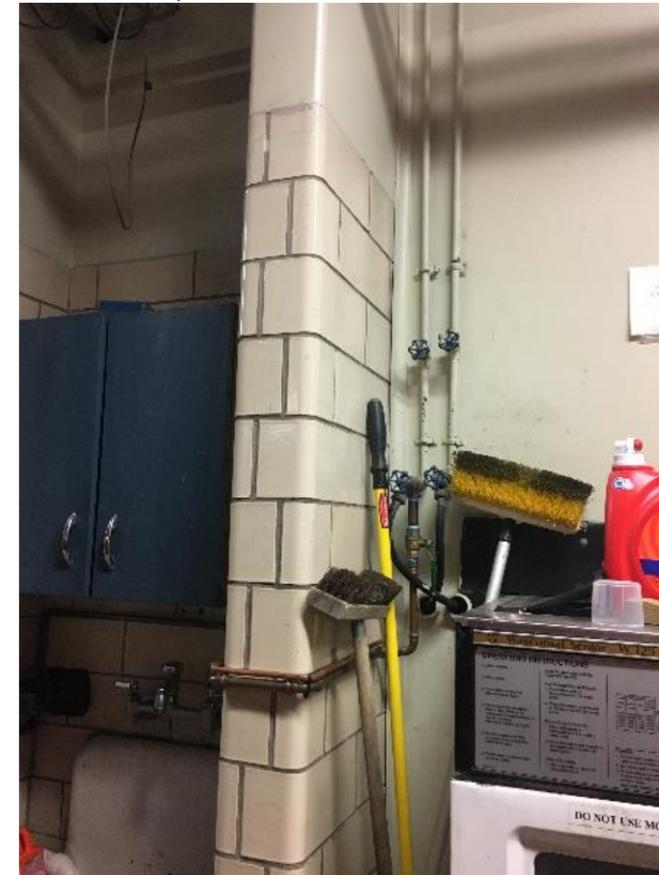
- 3) Observed Deficiency Hot and cold piping in apparatus garage is uninsulated, violates NYS ECC:

Recommended Fix: All water piping should be cleaned and thermally insulated in accordance with Table C403.2.10 of the New York State Energy Conservation Code.

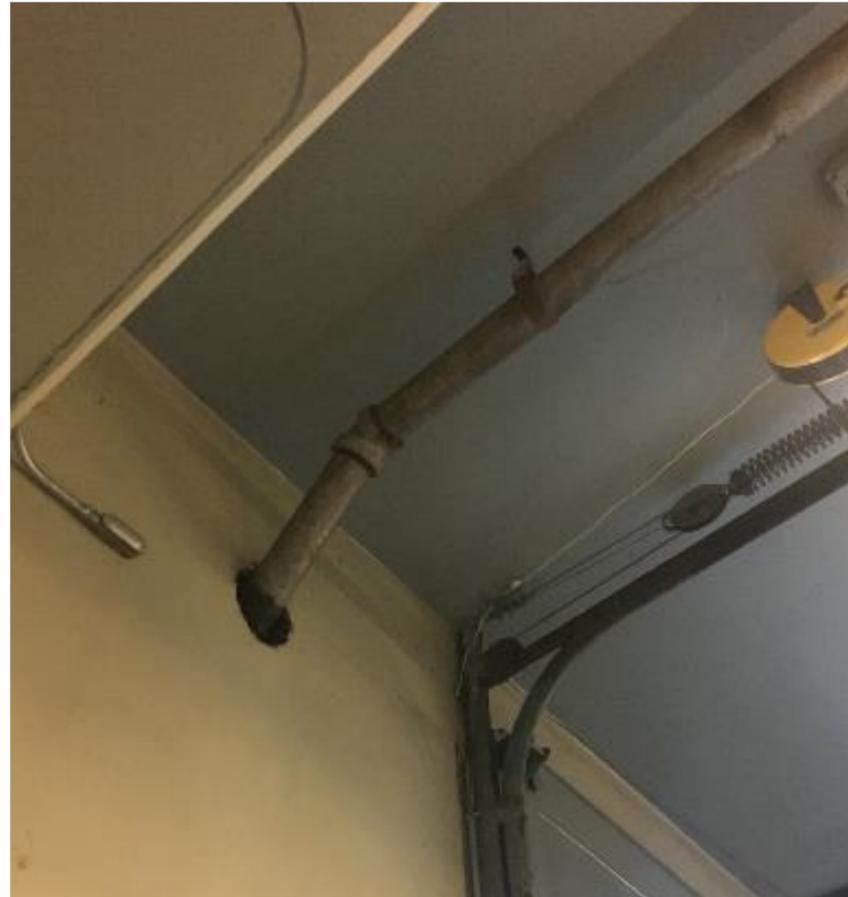
- 4) Observed Deficiency: No fire-stopping around numerous piping penetrations through apparatus garage walls.

Recommended Fix: Fireproofing should be applied to all penetrations through a fire-rated assembly. 3M Fire Barrier CP 25 Caulk (or a UL listed equivalent) may be utilized and applied per its UL listing.

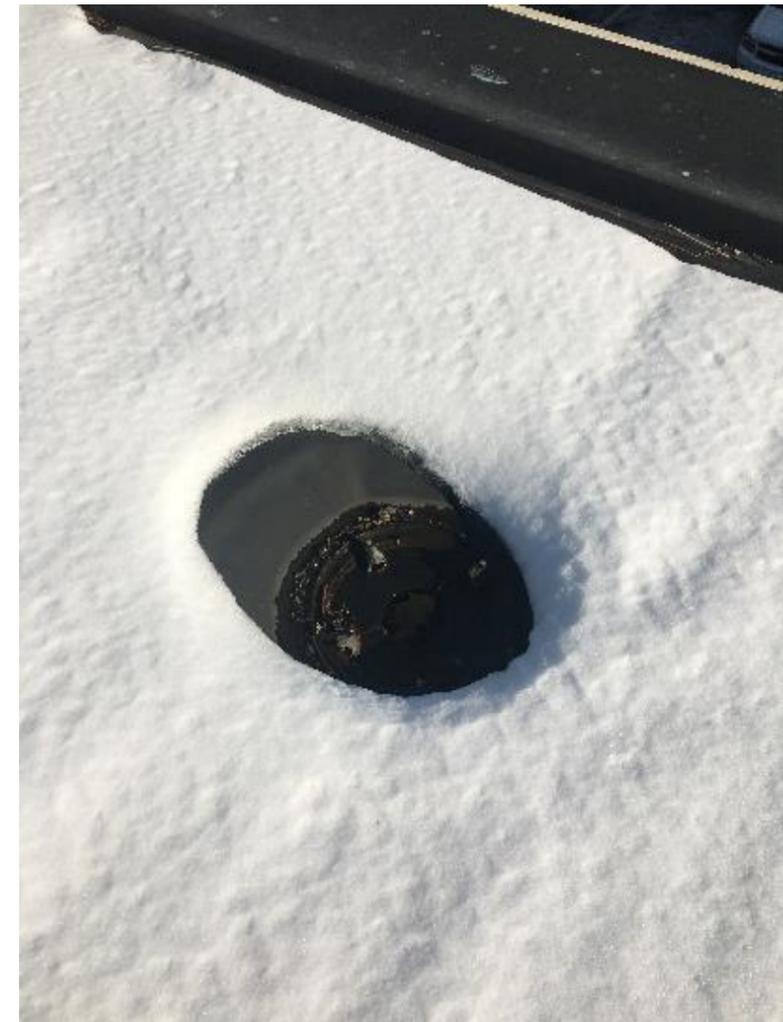
- 7) Observed Deficiency: Beehive cover missing from drain on upper-roof.

Recommended Fix: Replace with cast iron dome.

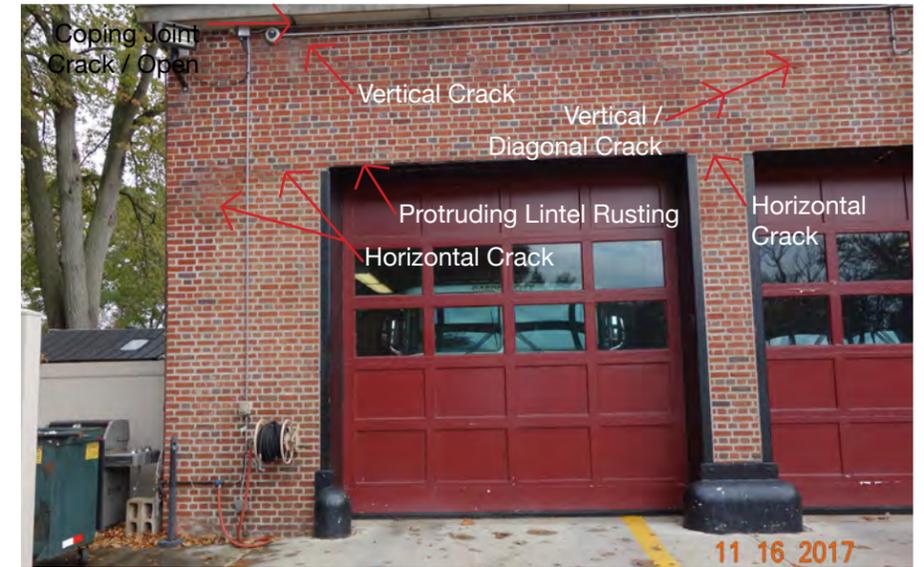
Figure 2.3_8 Front (West) Facade - Horizontal & Vertical Cracks, Lintel Rusting

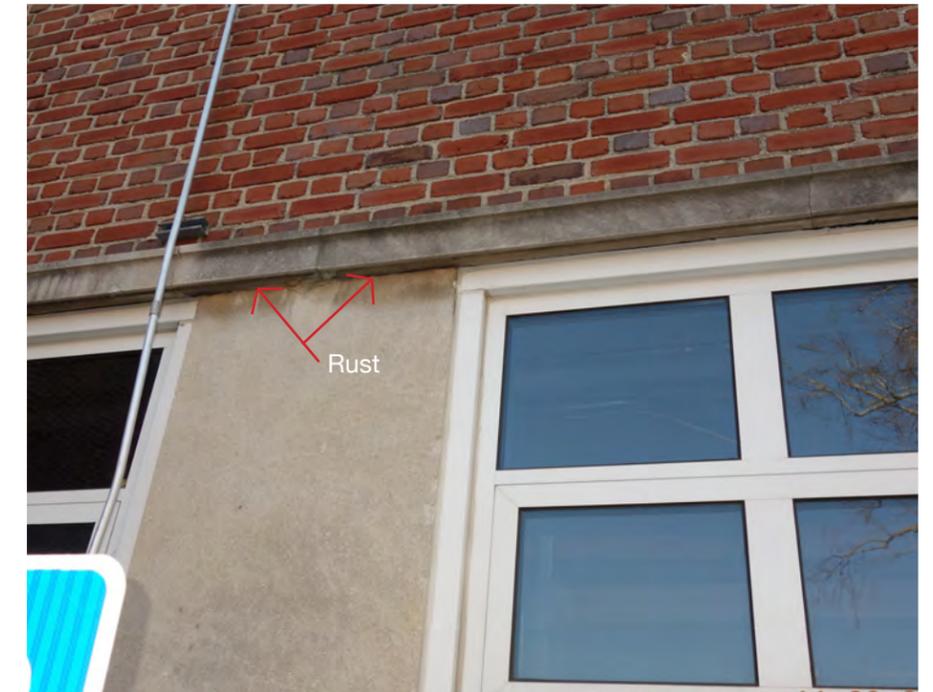
Figure 2.3_24 East Facade - Lintel Rust

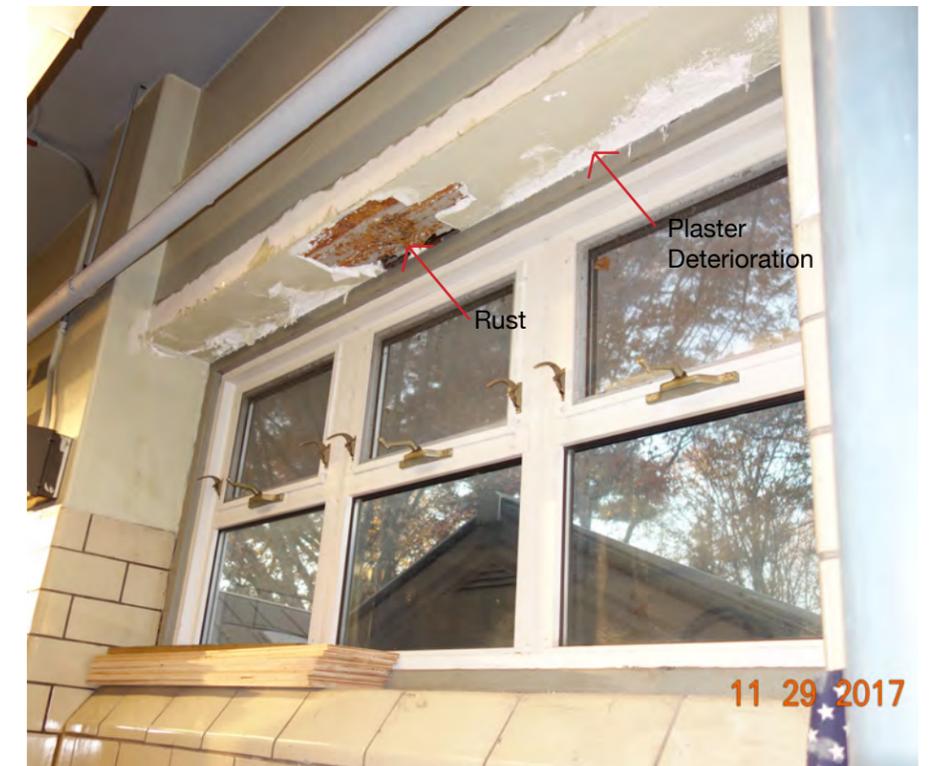
Figure 2.3_25 North Facade - Lintel Rust & Finish Deterioration

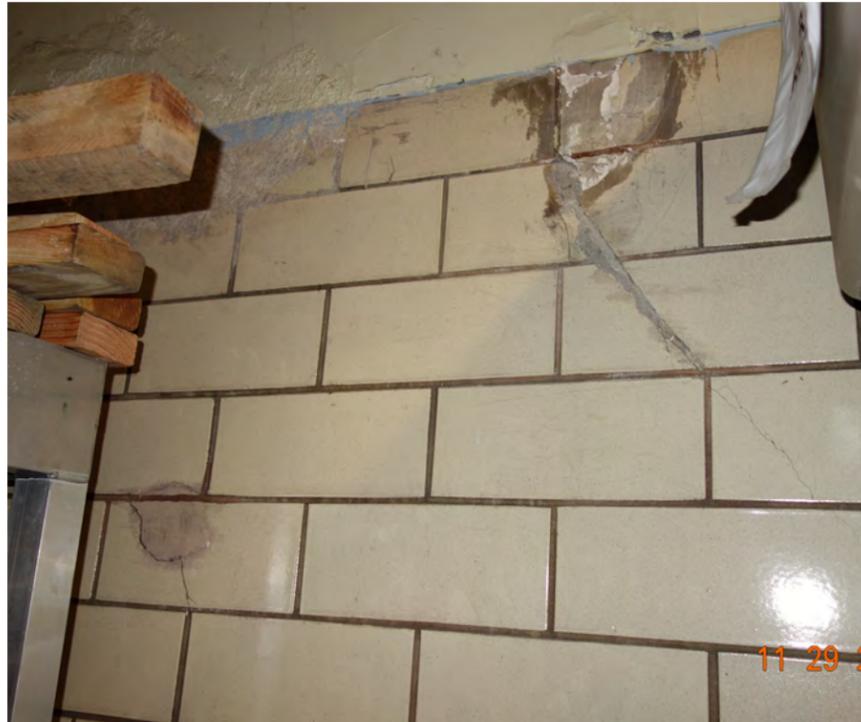
Figure 2.5_1 Apparatus Room - Glaze Wall Tile Cracks

1. Repair glazed wall tile.
2. Repair plaster wall finishes.
3. Repair stucco ceiling.
4. Repair and provide new acoustic ceiling tile.

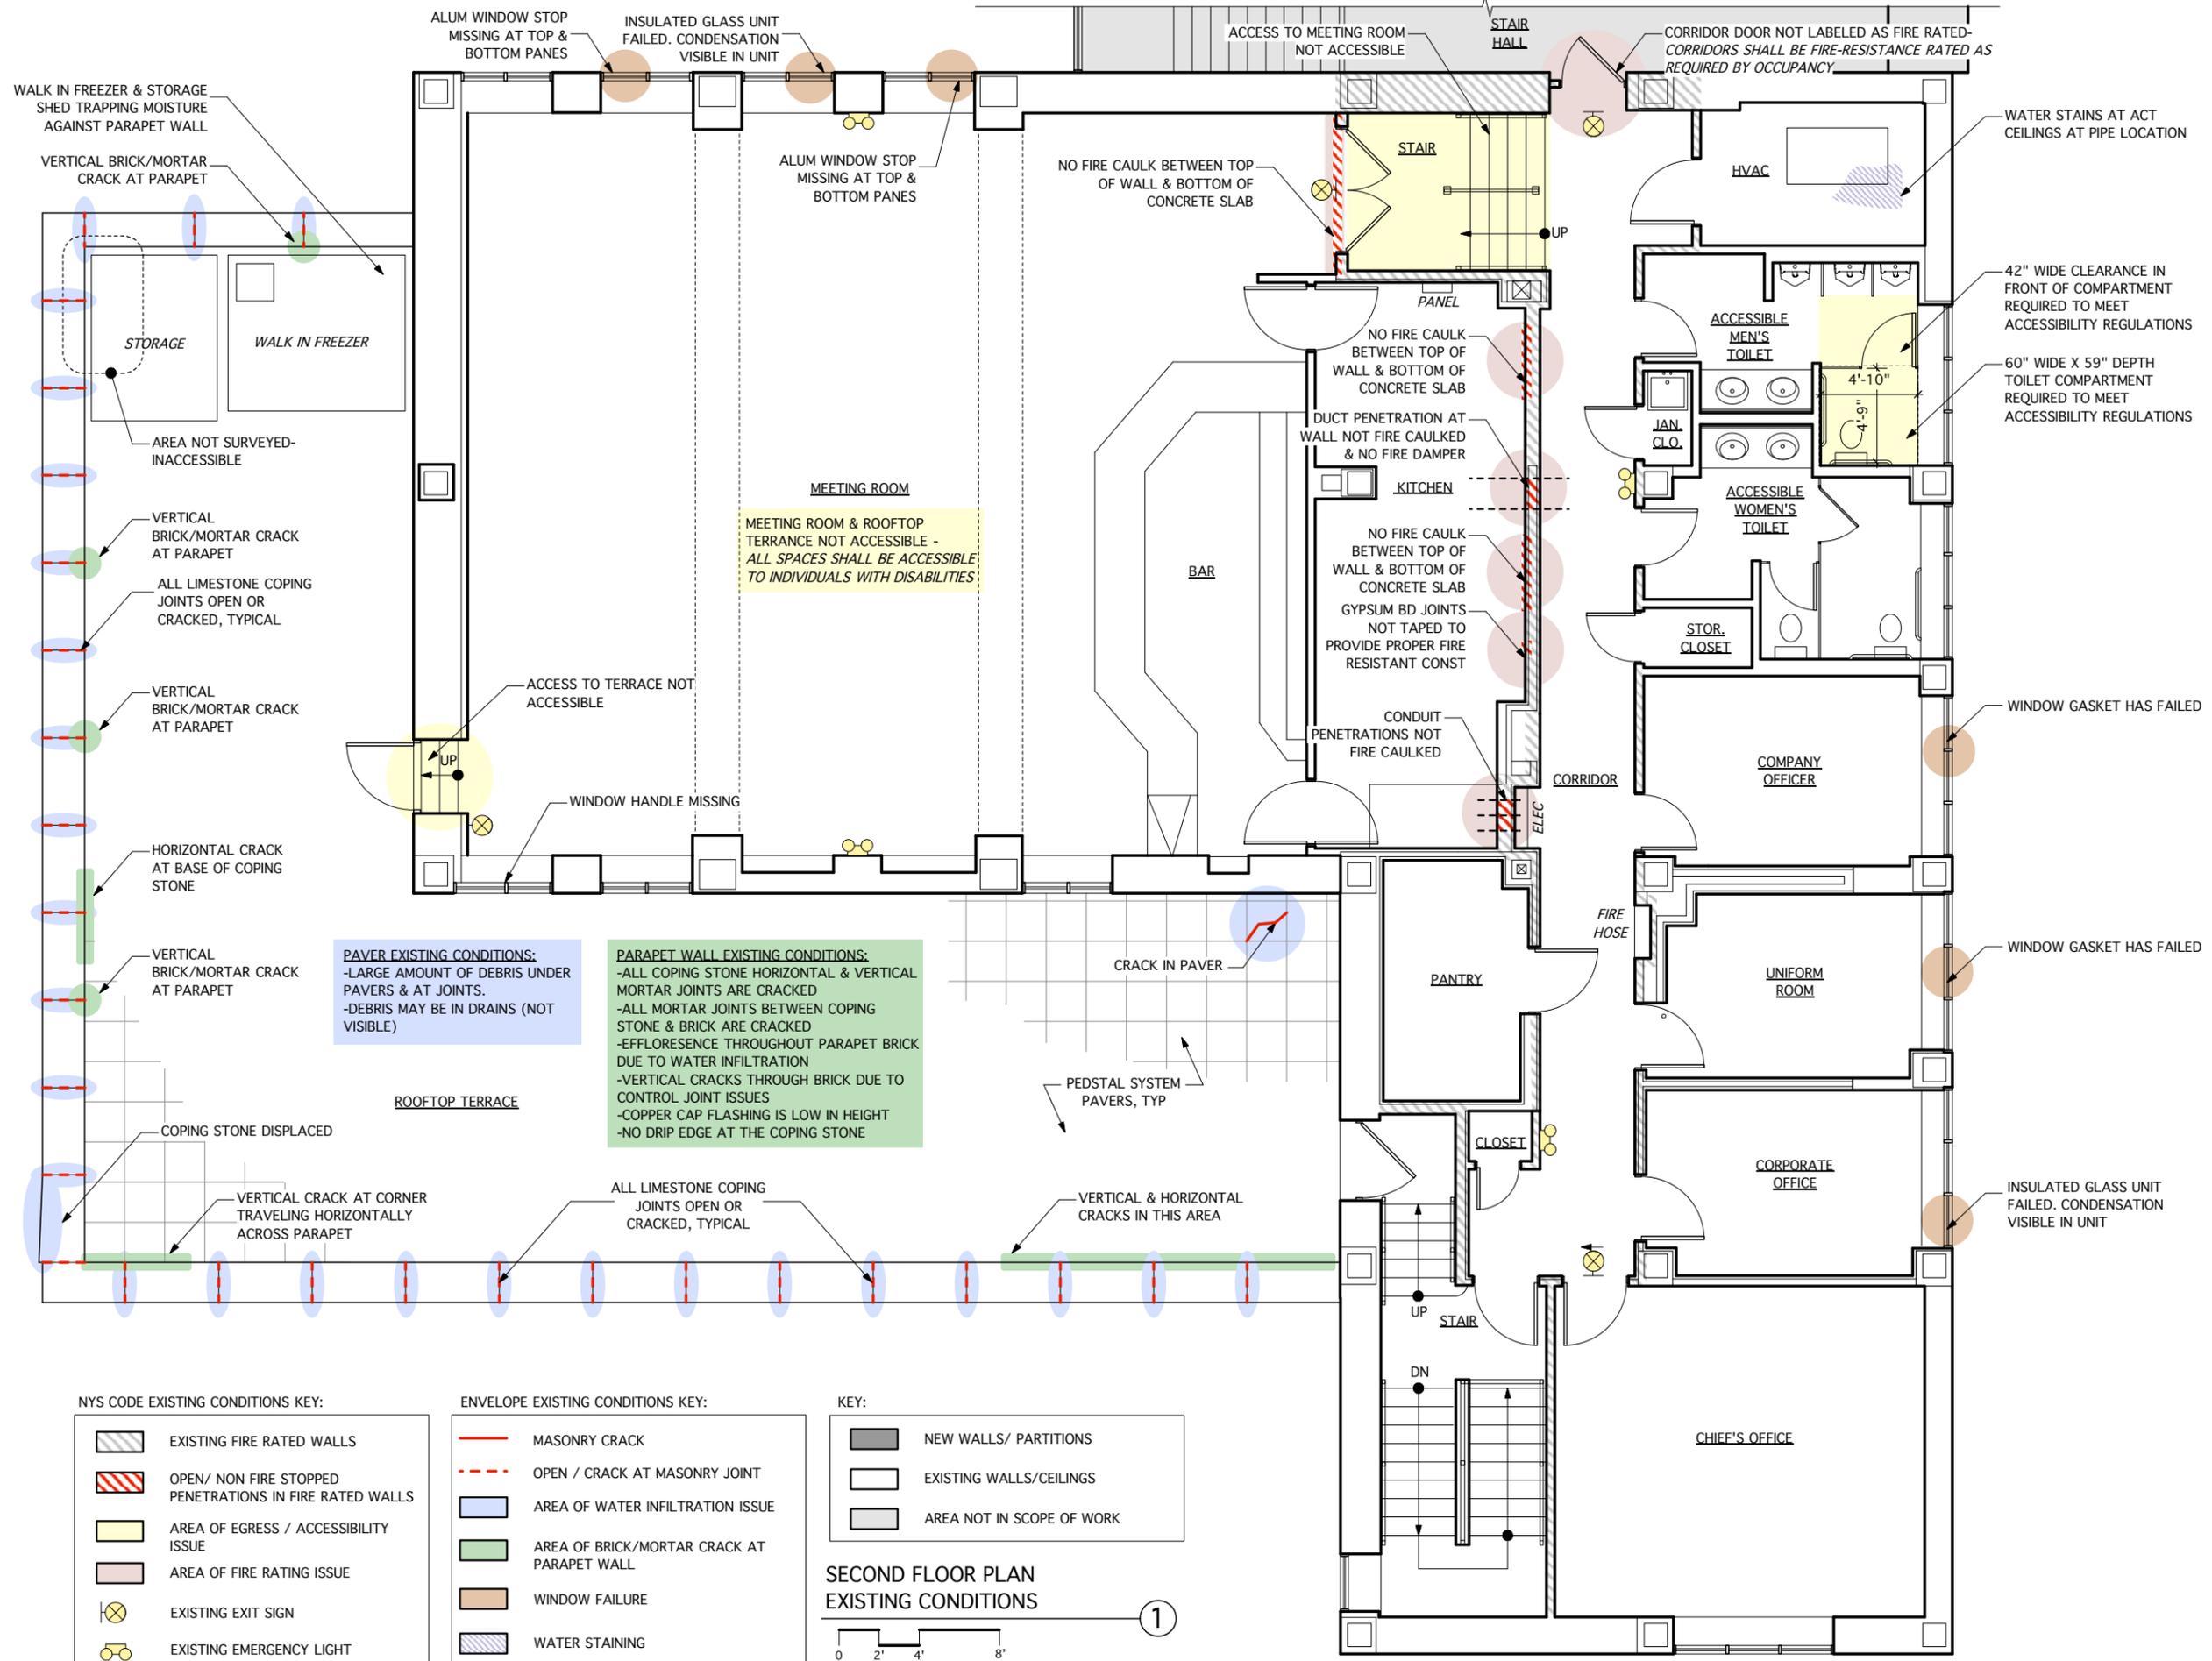
EX-100.00

PAVER EXISTING CONDITIONS:
 -LARGE AMOUNT OF DEBRIS UNDER PAVERS & AT JOINTS.
 -DEBRIS MAY BE IN DRAINS (NOT VISIBLE)

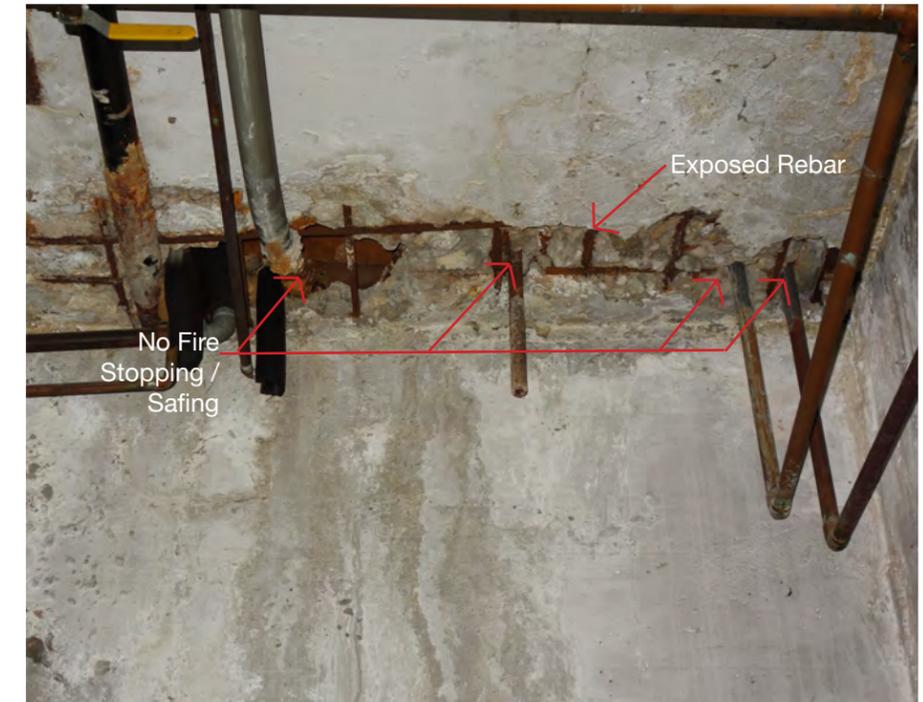
Figure 2.1_3 Basement - Pipe Penetrations & Concrete Deterioration

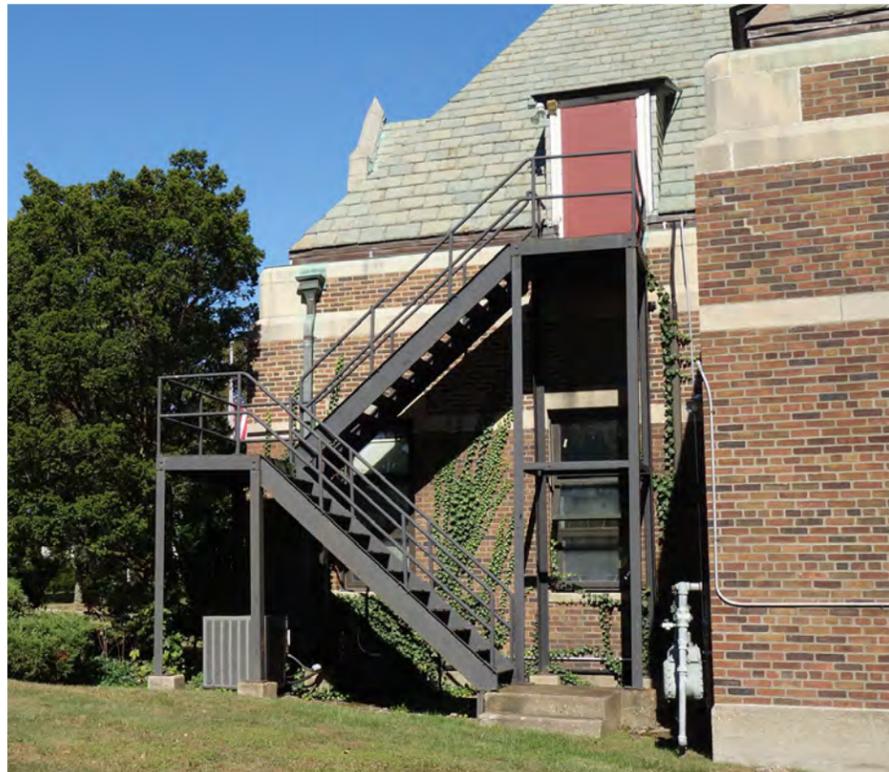
Figure 2.1_4 Exterior Egress Stair - Code Violation

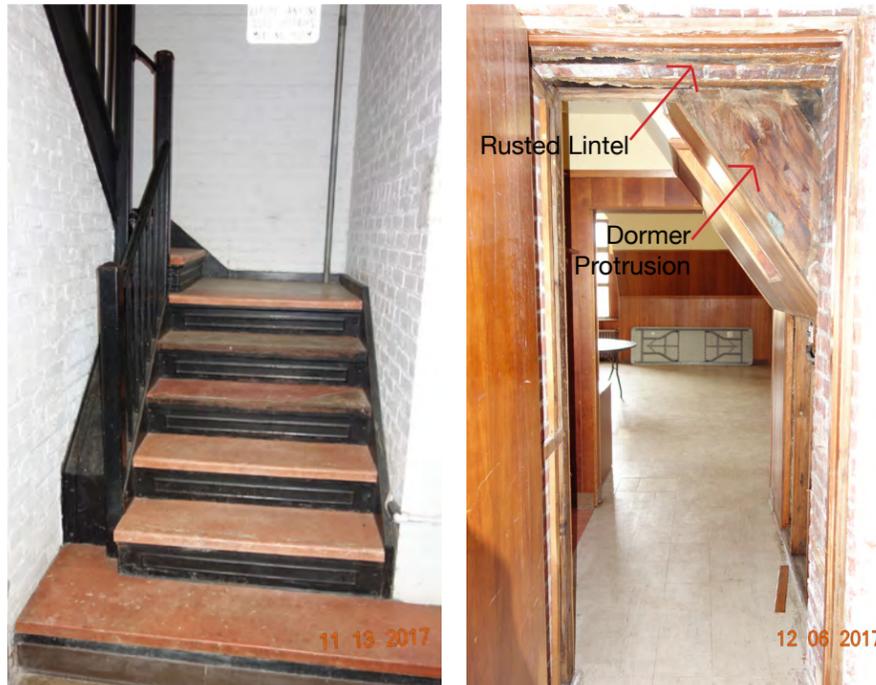
Figure 2.1_5 Tower Egress Stair (left), Meeting Hall Egress Door (right)

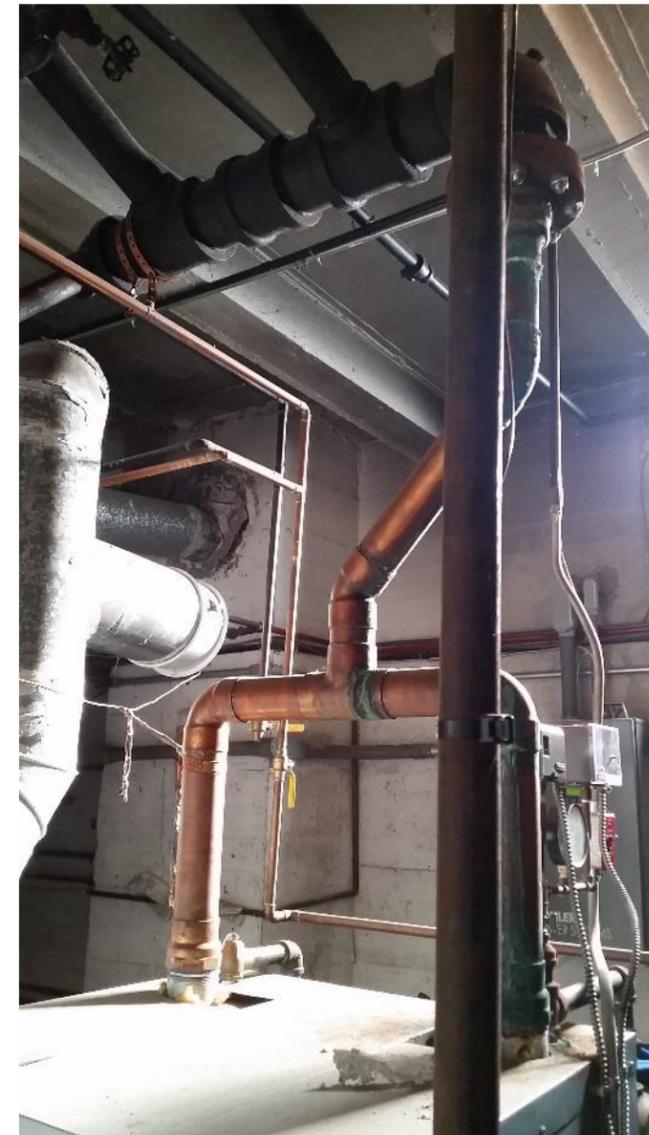
- 2) Observed deficiency: Near-boiler steam & condensate piping and fittings are uninsulated.

Recommended fix: All uninsulated piping and fittings should be cleaned, insulated, and provided with a service jacket as per New York State Energy Conservation Code. In addition to meeting code requirements, insulated piping will reduce building energy usage and operating costs.

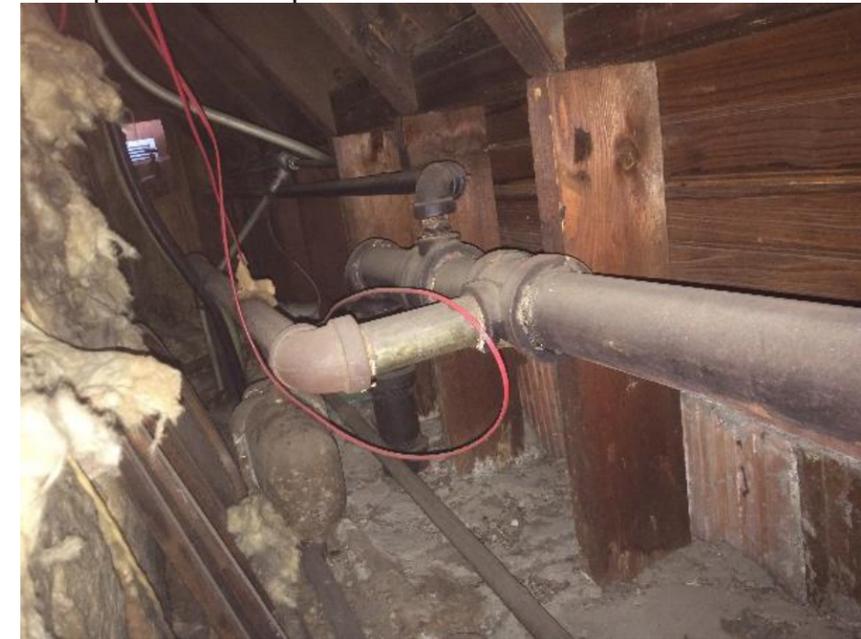
Piping and interior space is therefore exposed to cold air, represents ECC problem for interior room:

Recommended fix: Insulate the entire exterior wall paneling to prevent the interior space from being exposed to cold/hot air.

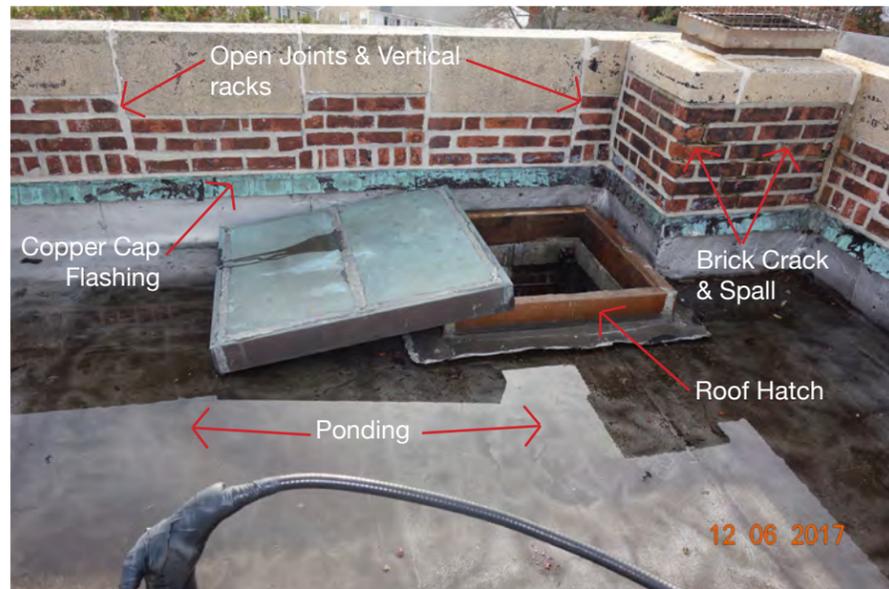
Figure 2.3_1 Roof & Parapet Wall - Copper Cap Flashing, Hatch & Chimney

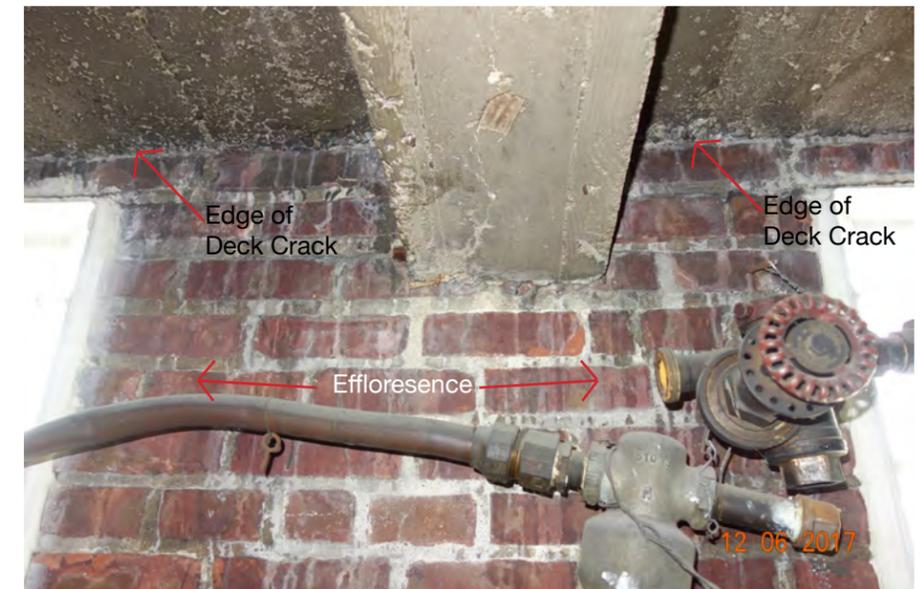
Figure 2.3_3 Underside of Roof Deck - Crack / Gap at Deck Edge

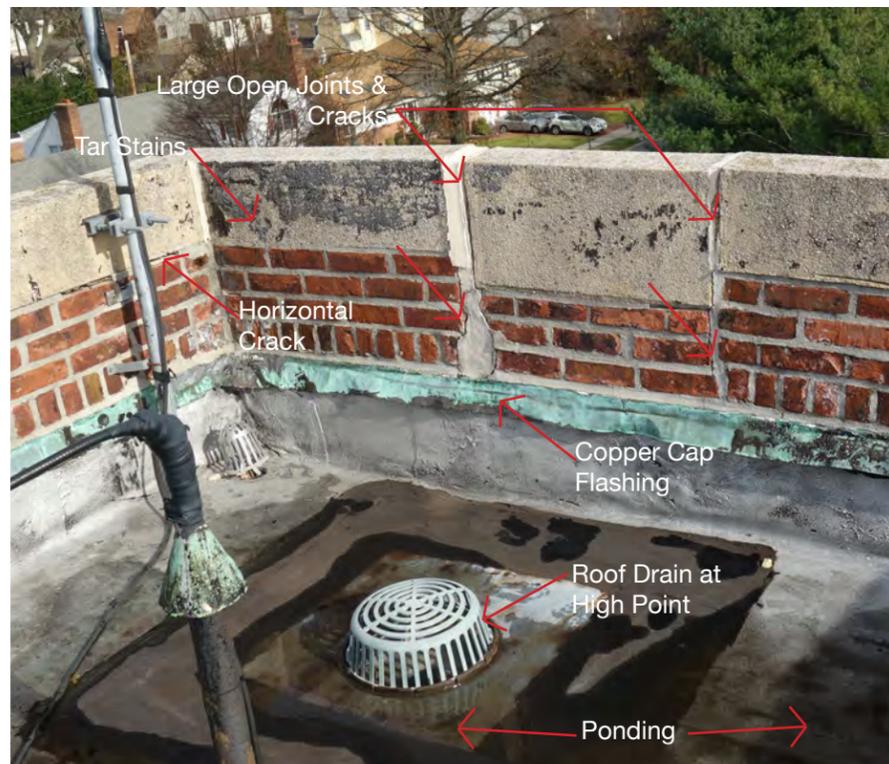
Figure 2.3_2 Roof & Parapet Wall - Coping Stone Cracked & Open Joints

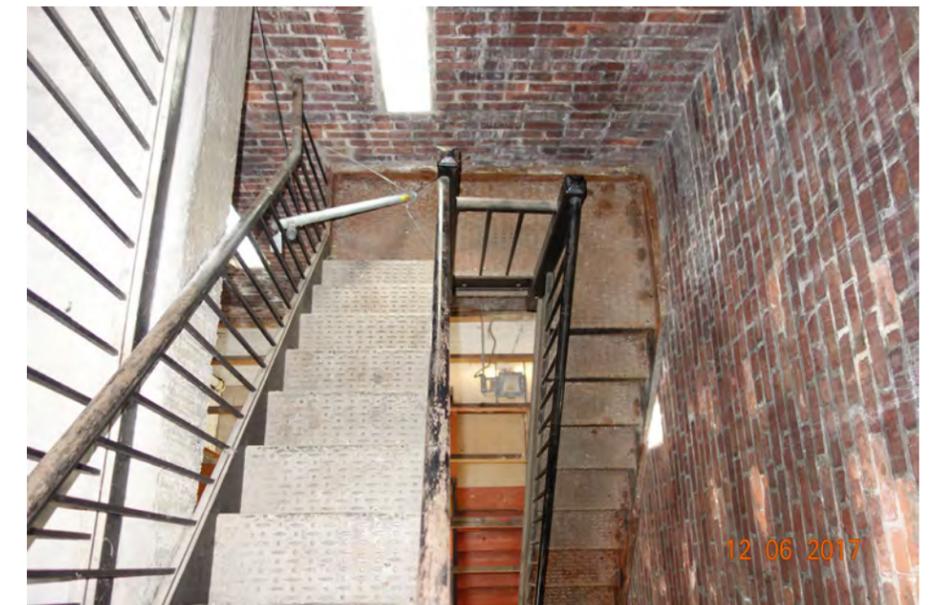
Figure 2.3_8 Rusted Metal Stair

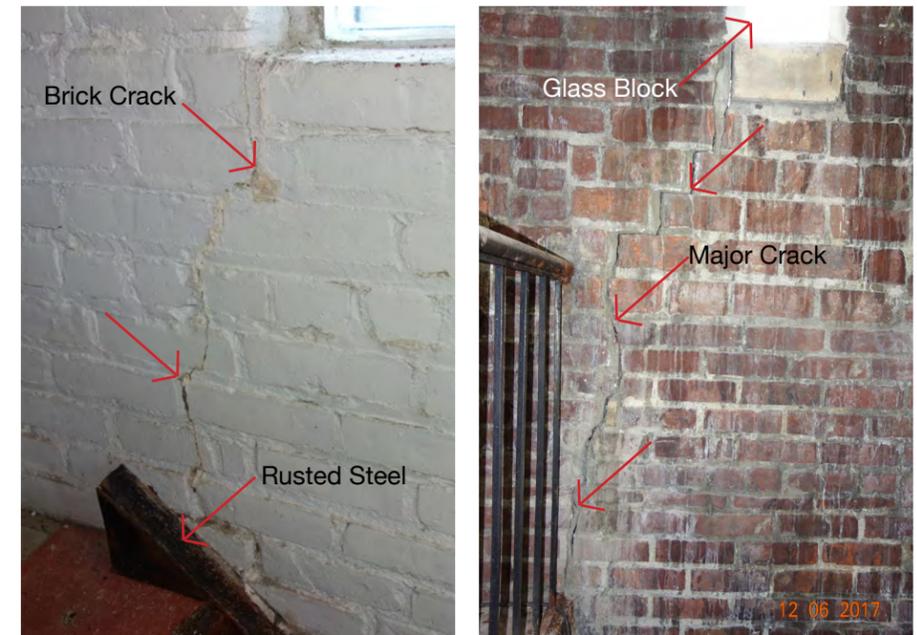
Figure 2.3_10 Major Cracks at Painted Brick (left) and Hose Hoist. Level (right)

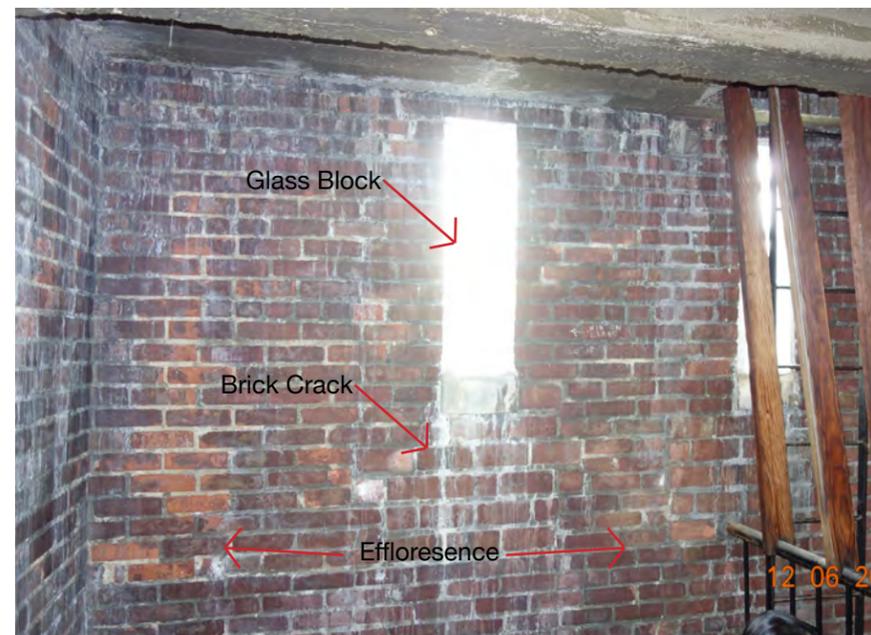
Figure 2.3_9 West Tower Wall - Glass Block, Brick Cracks and Efflorescence

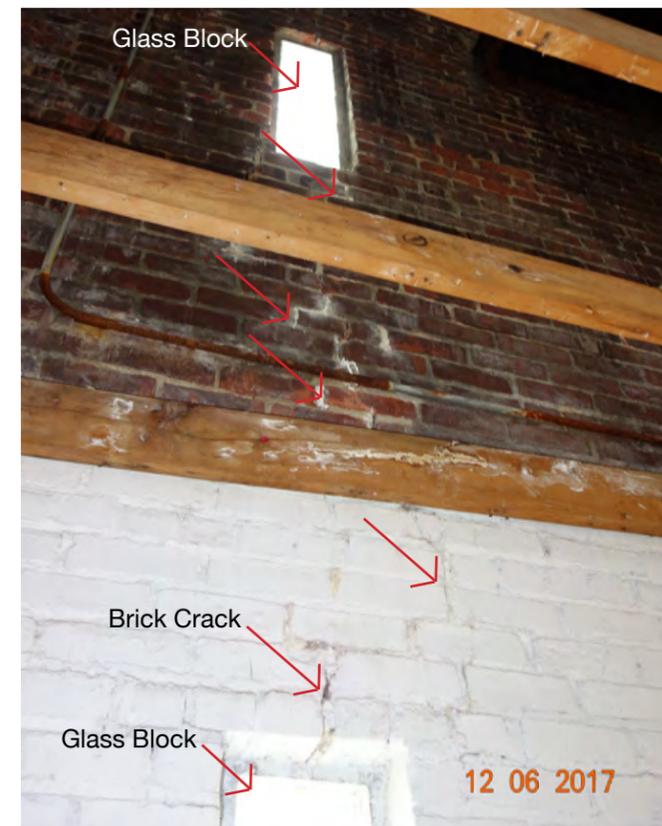
Figure 2.3_11 Window to Window Major Brick Crack

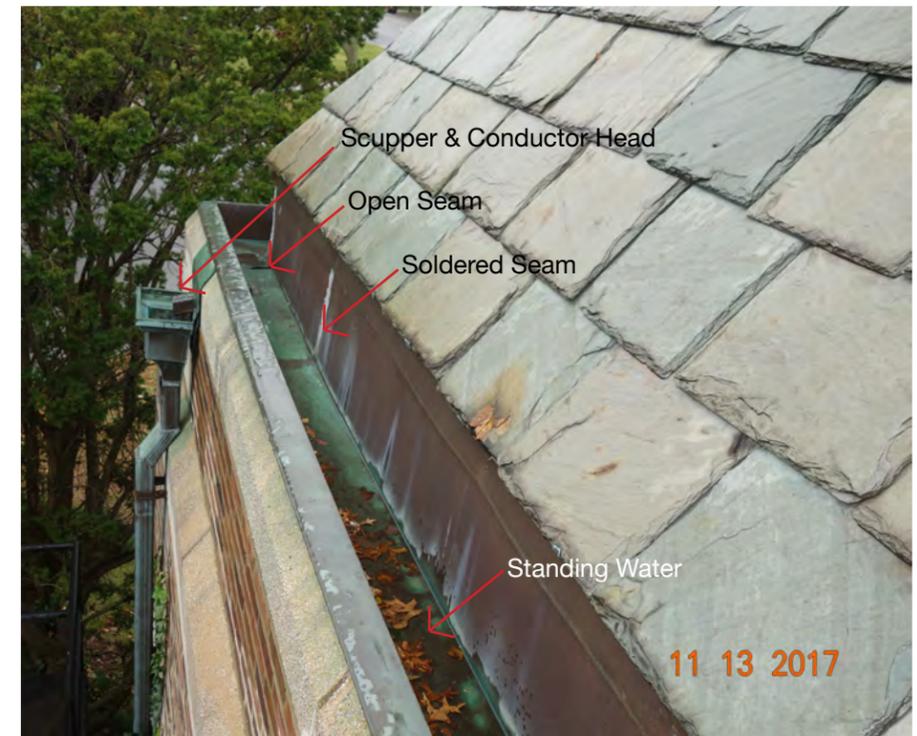
Figure 2.4_2 Copper Liner - Standing Water

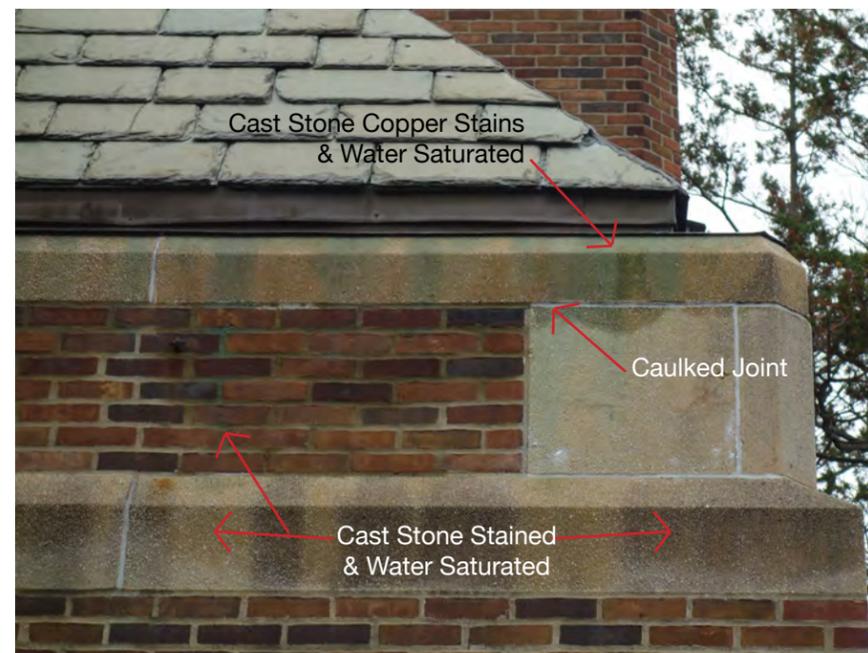
Figure 2.4_1 Cast Stone Gutter - Water Saturated, Copper / Acid Rain Stains

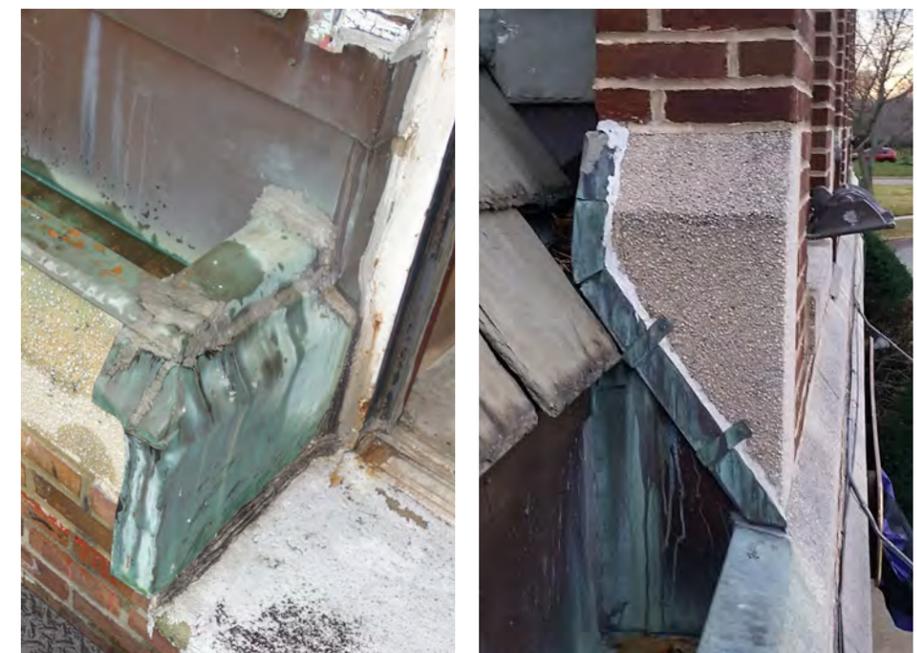
Figure 2.4_3 Copper Liner Poor Workmanship & Detailing

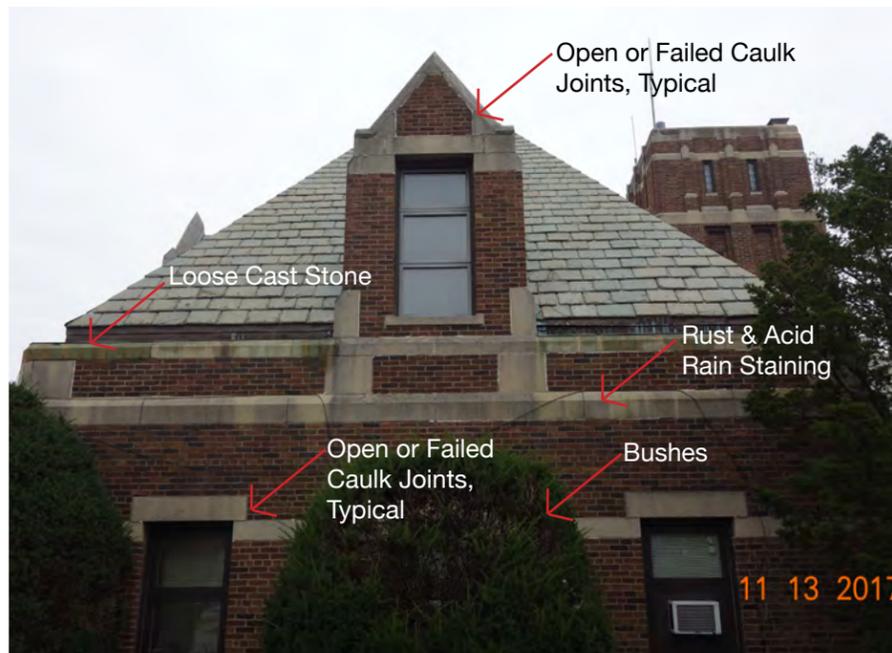
Figure 2.5_2 West Facade - Open or Failed Caulk Joints and Staining

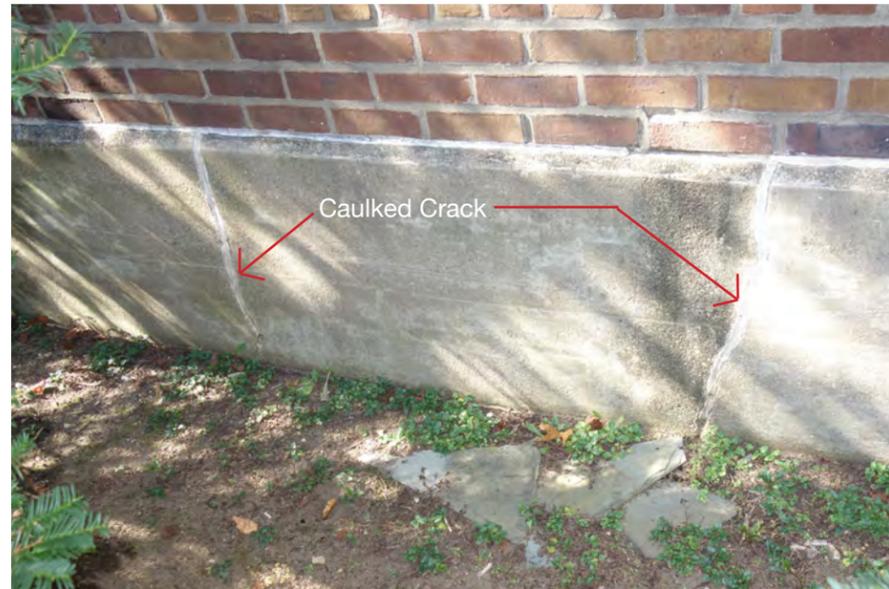
Figure 2.5_3 Concrete Base Caulked Cracks

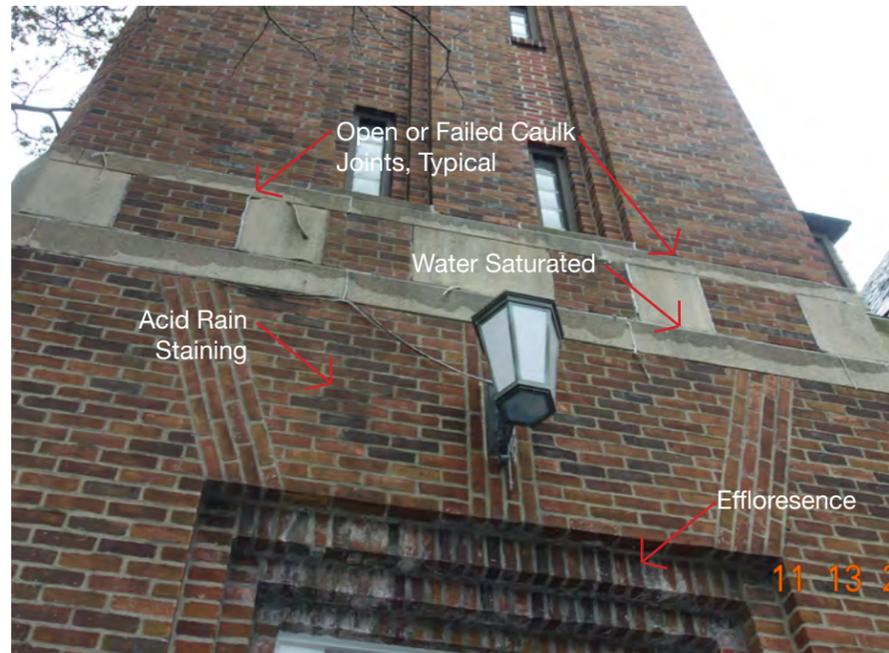
Figure 2.5_4 East Facade - Open or Failed Caulk Joints and Efflorescence
