Garden City
Fire Department

Firehouse #1, #2 & #3

Existing Conditions
Documentation & Recommendations
DRAFT

February 2, 2018

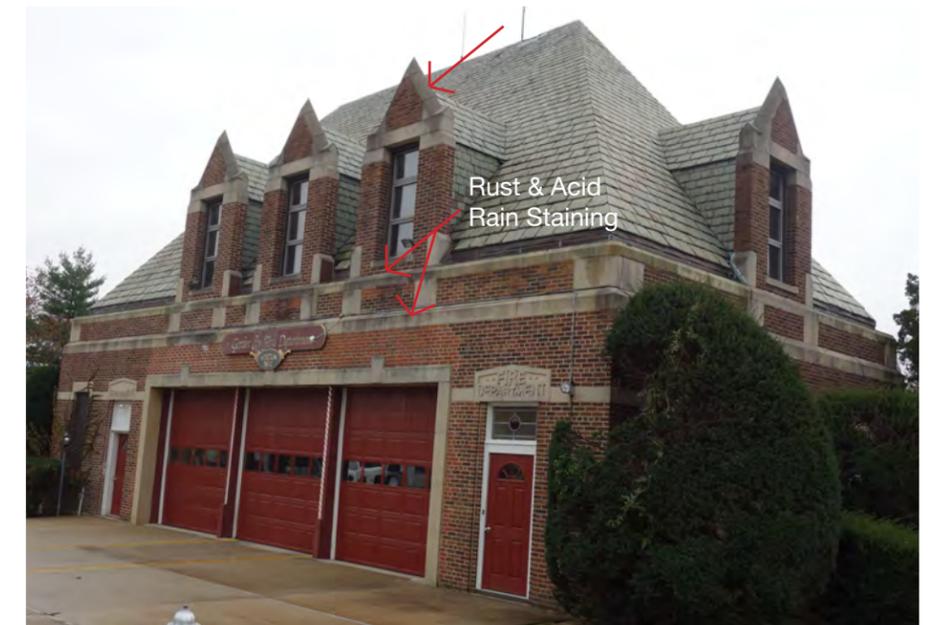
Figure 2.5_5 North Facade - Masonry Staining

1. Repair all brick and concrete base cracks.
2. Re-point all cast stone.
3. Clean Facades of all masonry staining and efflorescence.
4. Provide steel lintel at air conditioner opening, insulate and seal penetration.
5. Remove ivy and repair masonry where required.

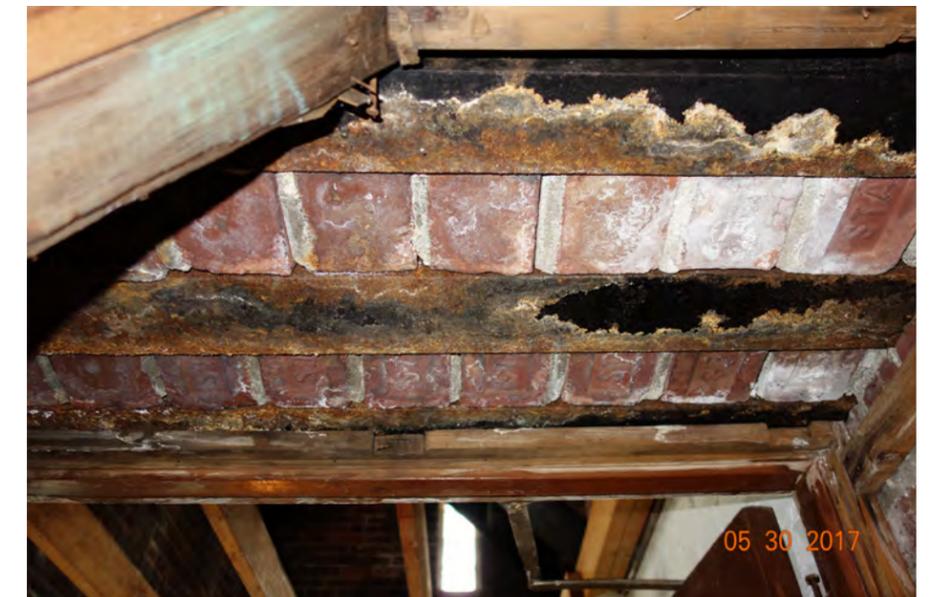
Water infiltration into the wall system has caused the steel lintels to deteriorate and rust. In order to repair and replace the lintels the windows and doors will have to be removed.

Figure 2.5_10 Meeting Hall Door Opening Lintel Rust

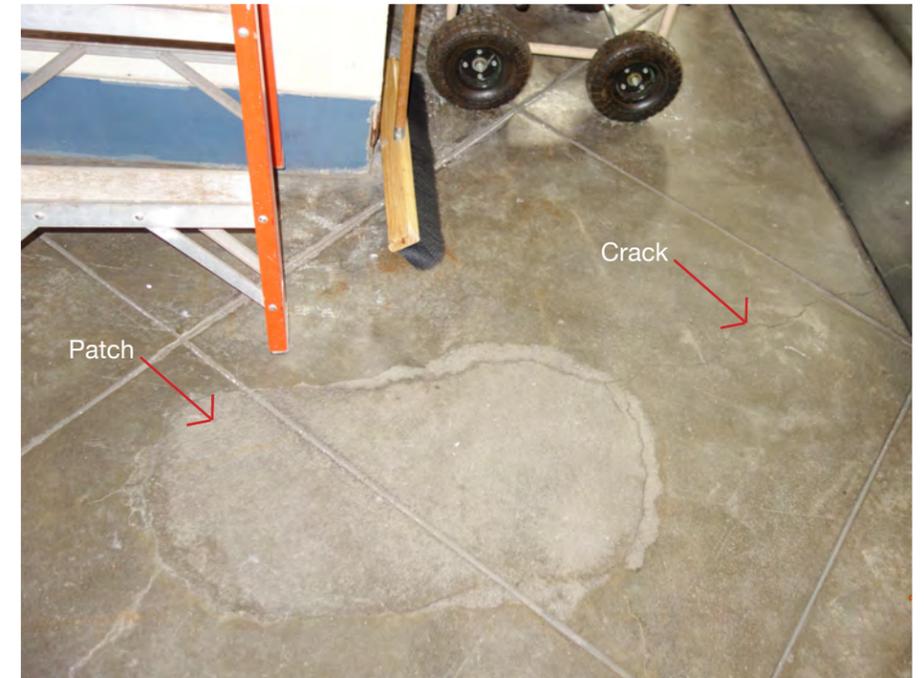
Figure 2.7_1 Concrete Slab Crack & Patch

1. Repair cracks in the concrete slab on grade.
2. Patch plaster ceilings and wall finishes.
3. Clean all efflorescence and staining from Basement wall.
4. Repair brick crack.

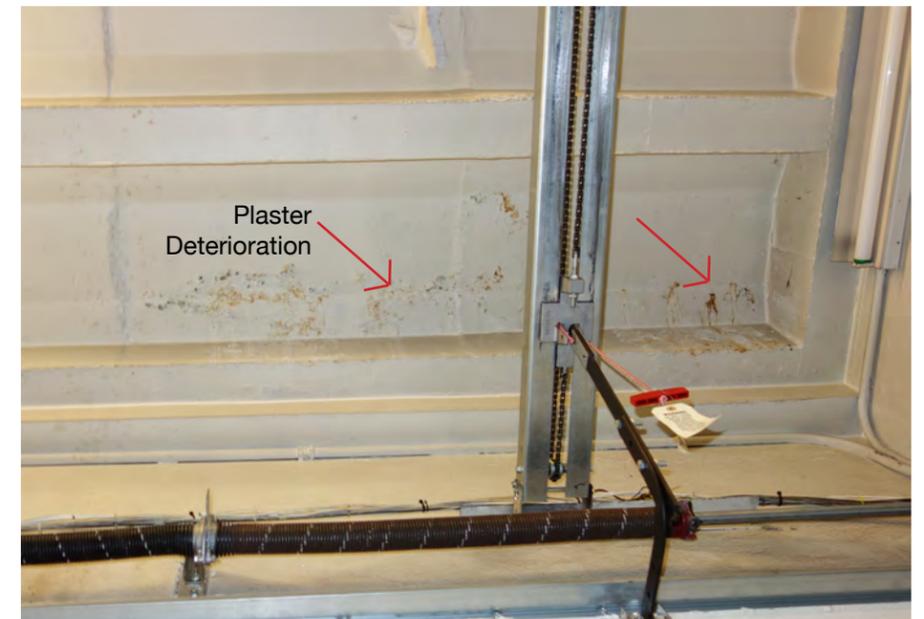
Figure 2.7_2 Plaster Ceiling Deterioration

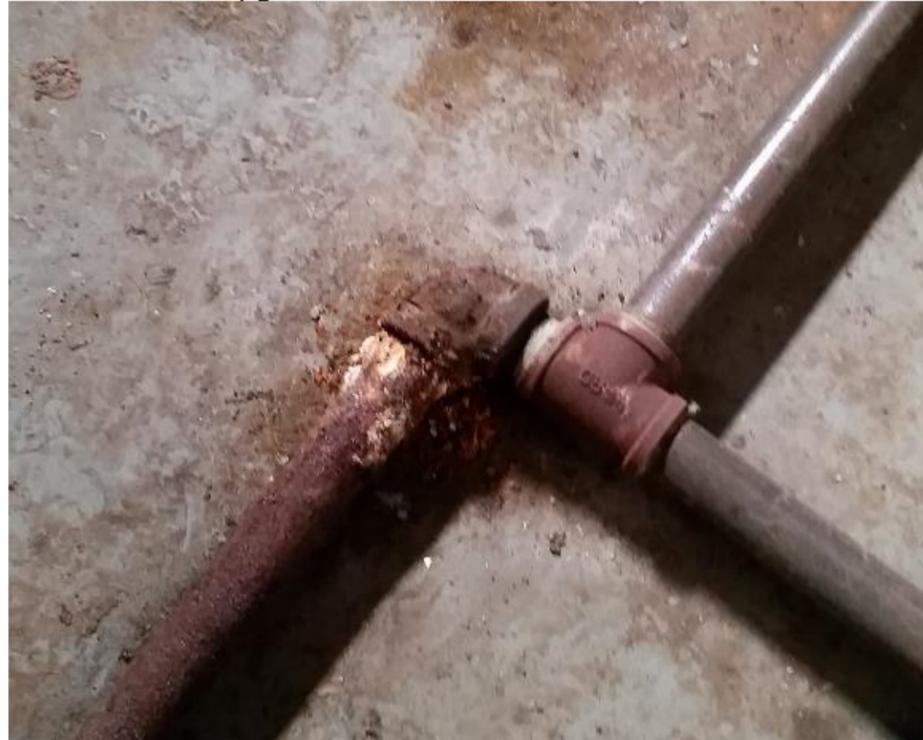
- 1) Boiler steam & condensate piping severely corroded, recommend replacement. New piping must remain on the floor if a steam heating system is to remain. Piping may be rerouted to be less hazardous. Cross-over plates may still be required, refer to Mechanical Upgrades Item 2.

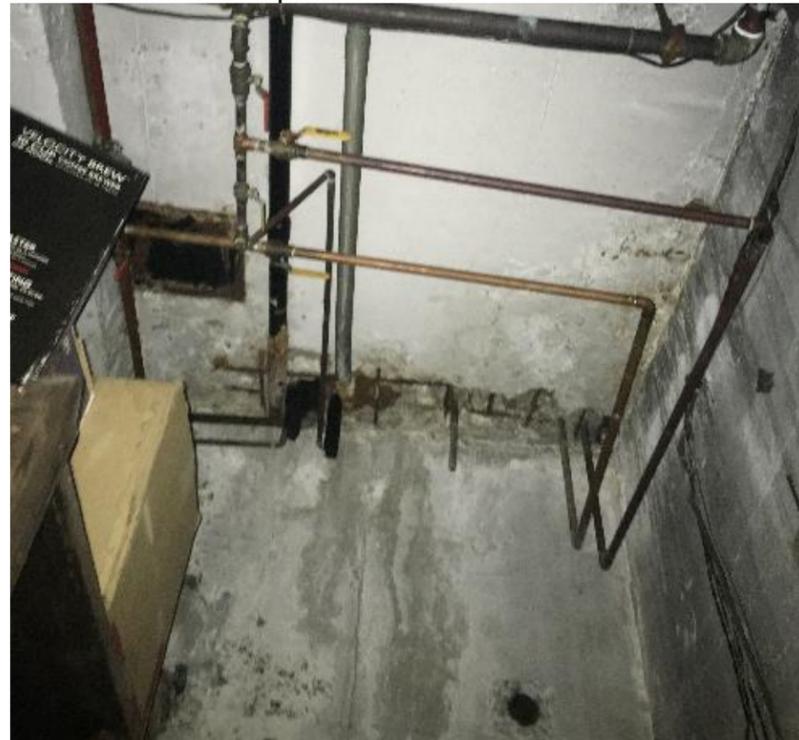
- 1) Various piping branches have been previously abandoned, recommend complete removal of abandoned utilities:

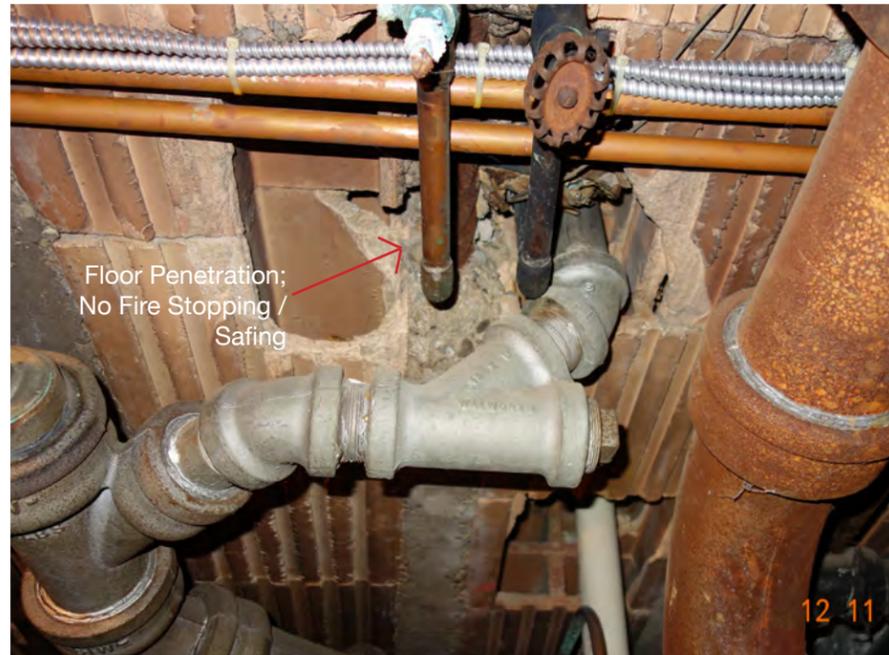
- **Basement pipe penetrations** in multiple locations are not fire stopped / safed at underside of floor assembly. In violation of Code. Portions of the concrete joists and terracotta infill floor assembly are demolished. Portions of the concrete joist have been removed which severely reduce the capacity of the floor structure.
- **Basement ductwork penetrations** in multiple locations are not fire stopped / safed at underside of floor assembly. In violation of Code. A Large portion of the concrete joists and terracotta infill floor assembly are demolished. Portions of the concrete joist have been removed which severely reduce the capacity of the floor structure.

Figure 2.1_1 Basement - Pipe Penetrations Code Violation

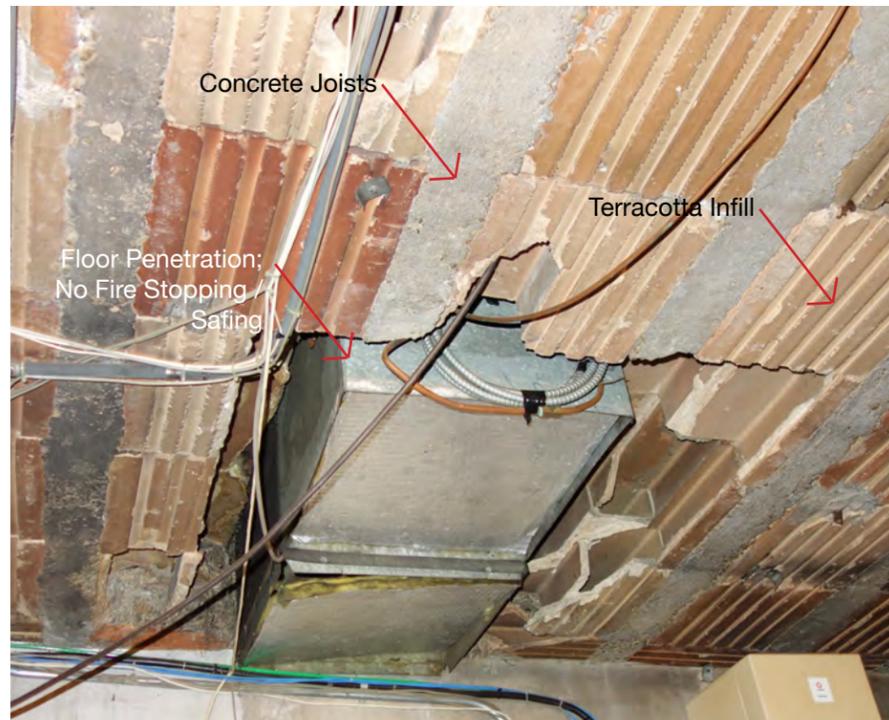
Figure 2.1_2 Basement - Ductwork Penetrations Code Violation

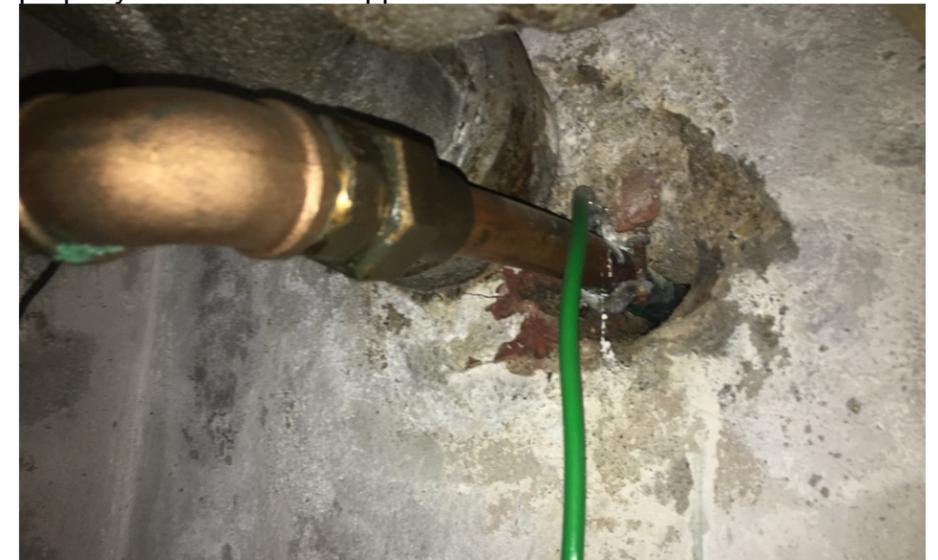
- 2) Observed Deficiency: Piping and other utility penetrations not properly sealed or fire-stopped.

Recommended Fix: Fireproofing should be applied to all penetrations through a fire-rated assembly. 3M Fire Barrier CP 25 Caulk (or a UL listed equivalent) may be utilized and applied per its UL listing.

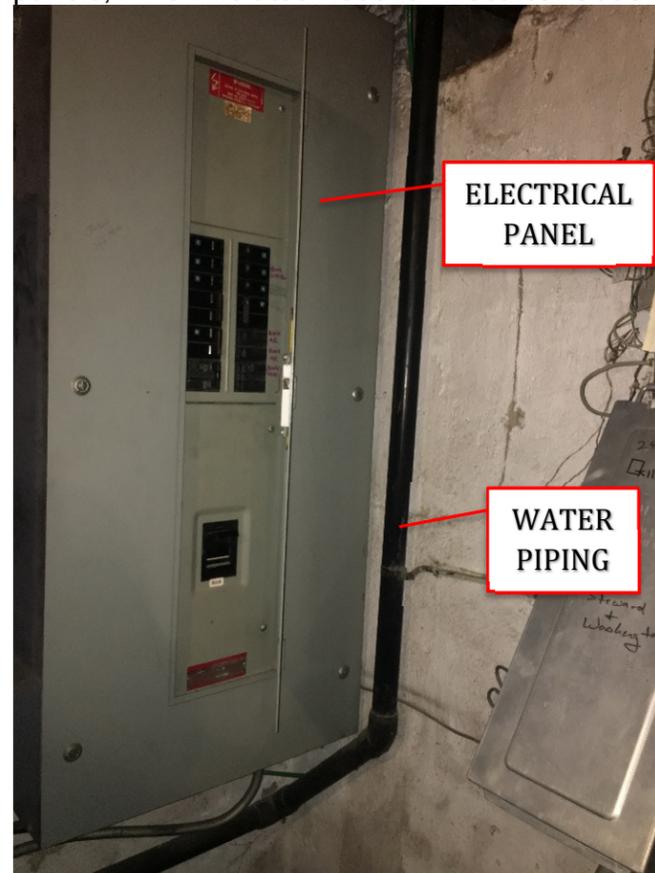
- 3) Observed Deficiency: Cold water piping routed under electrical panels, which violates National Electrical Code (NEC).

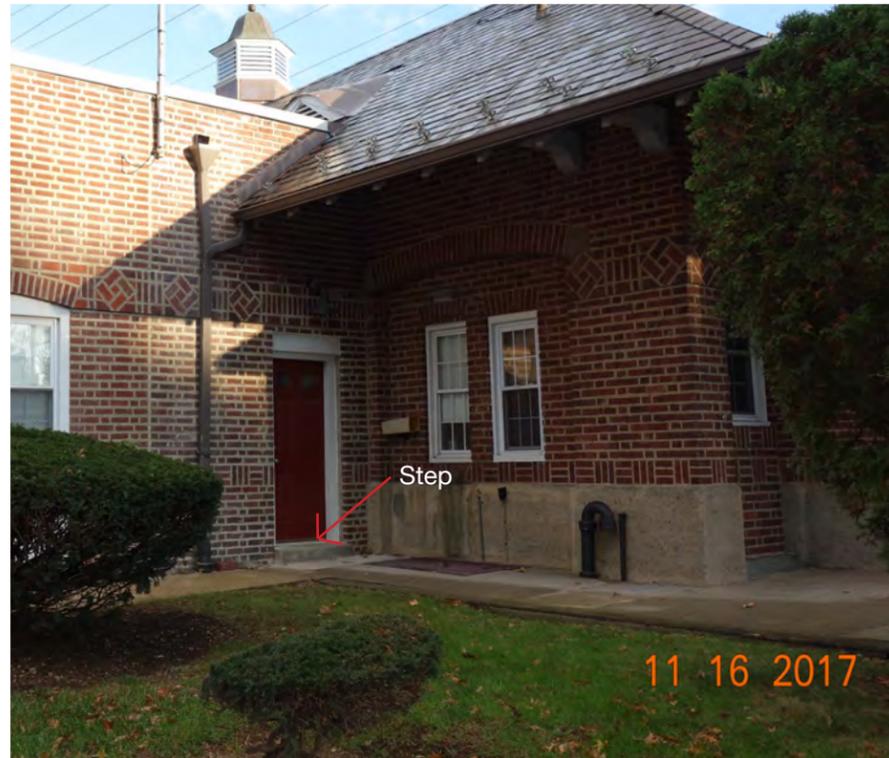
Figure 2.2_1 Exterior Entrance Door - Not Accessible & Code Violation

1. Provide new exterior accessible walkway and landing to the hall door at First Floor elevation.
2. Modify hall door to provide accessible clearances at the exterior entrance hall door.

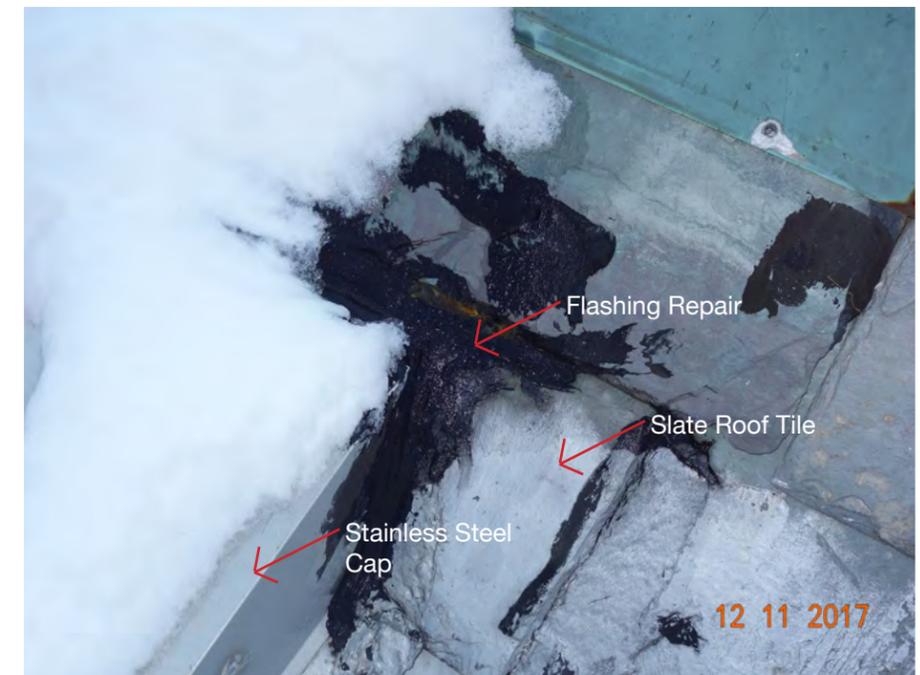
Figure 2.6_4 Stainless Steel Cap & Slate Roof Flashing Connection

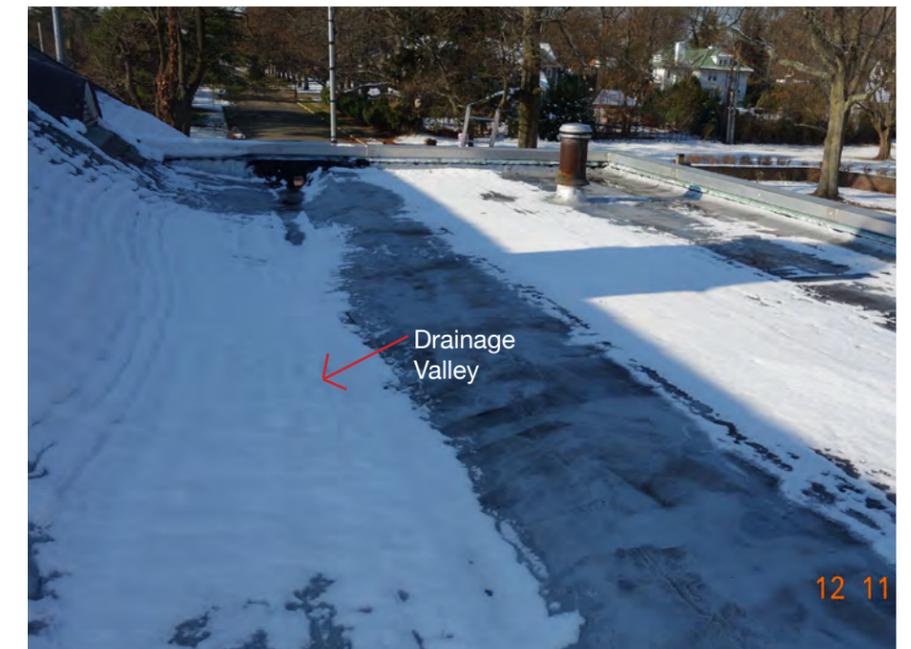
- **Drainage valley** not pitched properly to scuppers. Snow accumulation at valley.
- **Scuppers** are not properly flashed and previous repairs are of poor quality and workmanship. Water ponding and debris at scupper.
- **Conductor heads** and downspouts are in fair condition.

Figure 2.6_7 Flat Roof

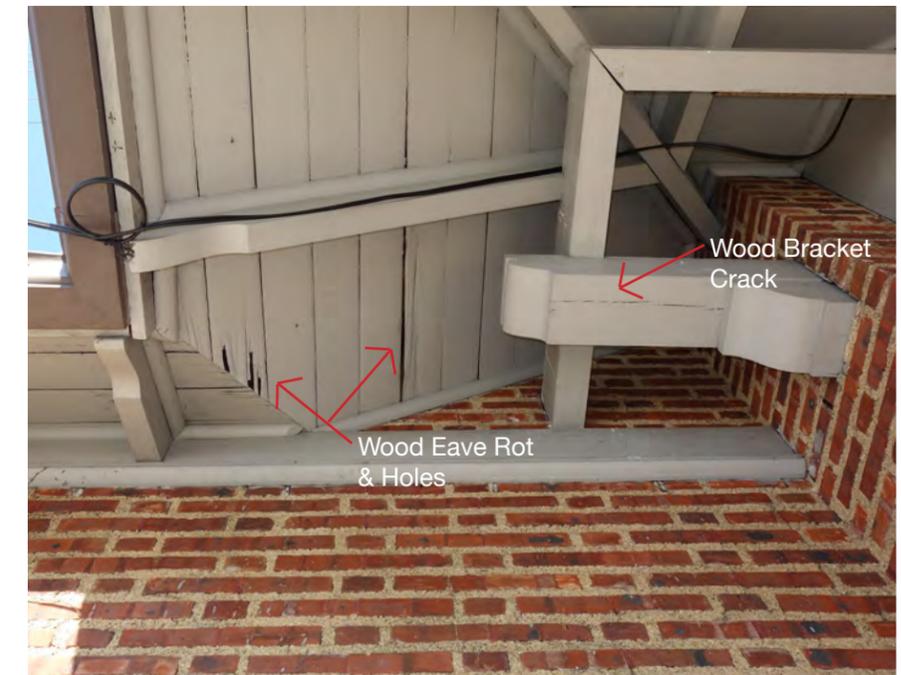
Figure 2.6_10 Wood Eave & Bracket Deterioration

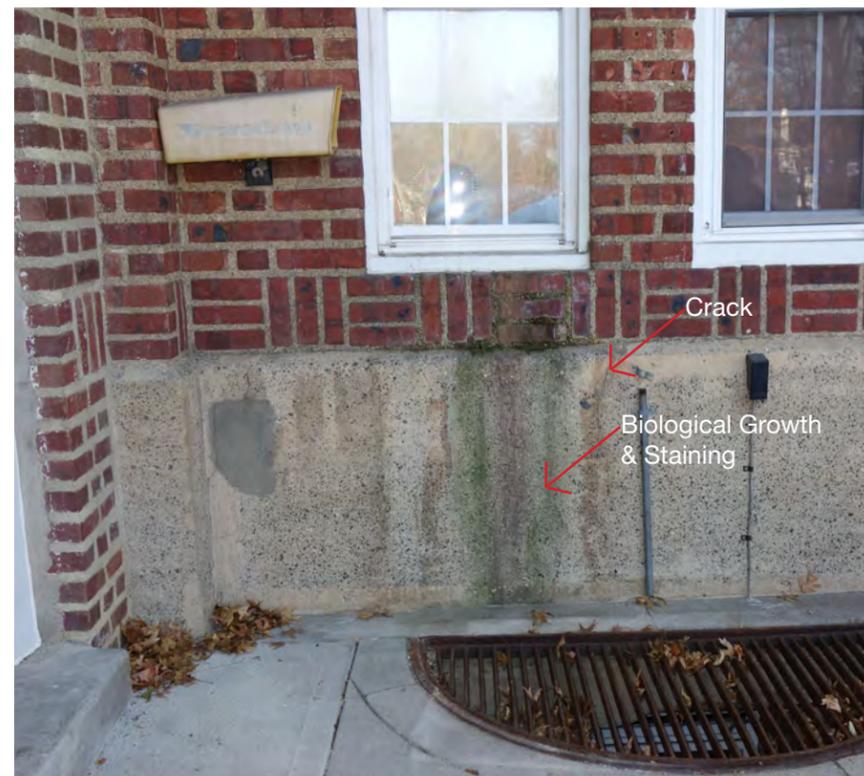
Figure 2.5_3 Concrete Base Crack, Biological Growth & Staining

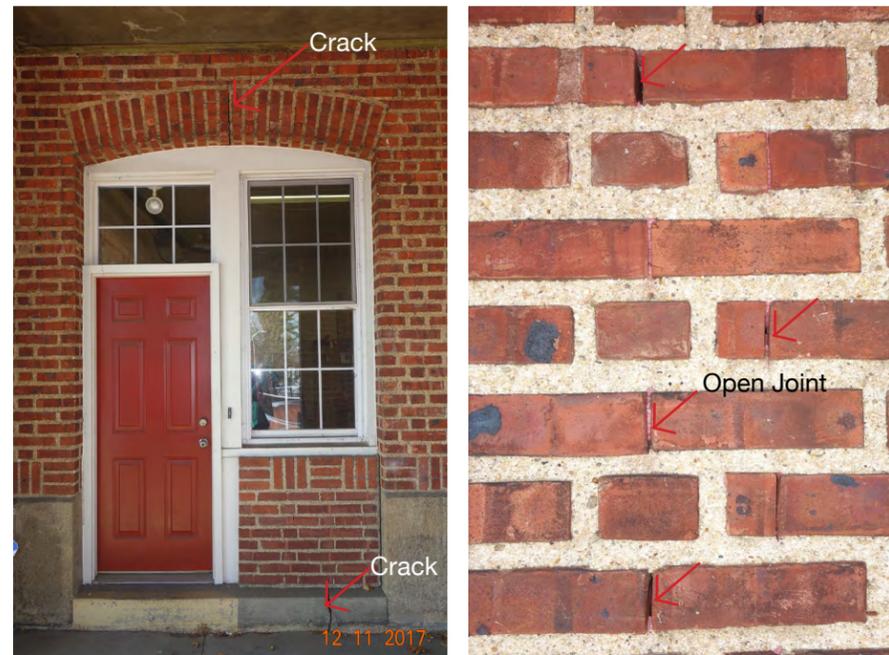
Figure 2.5_7 East Facade - Crack at Arch Head & Step (left), Open Jts (right)

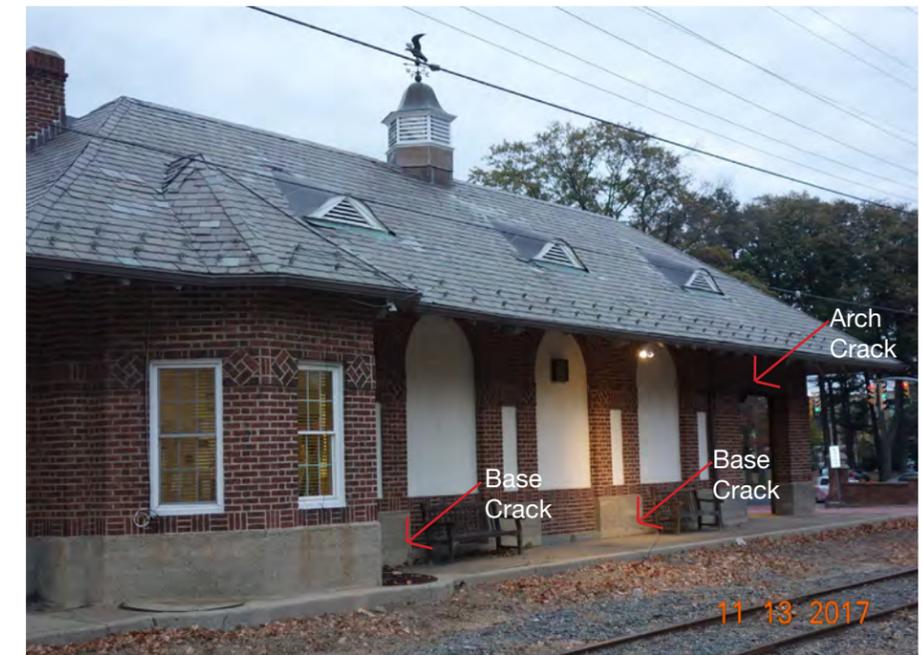
Figure 2.5_8 South Facade - Concrete Base & Brick Arch Cracks

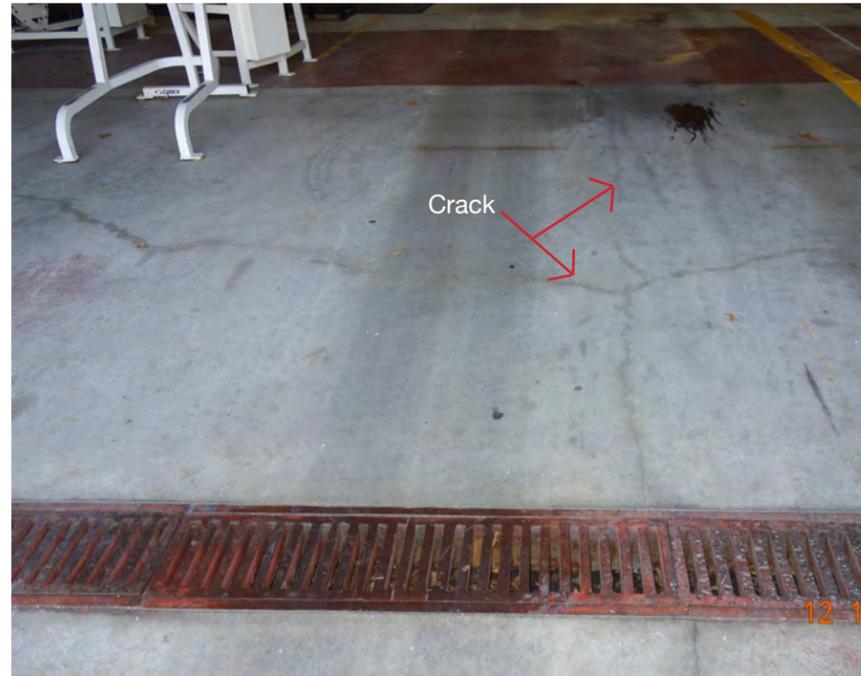
Figure 2.7_1 Concrete Slab Cracks

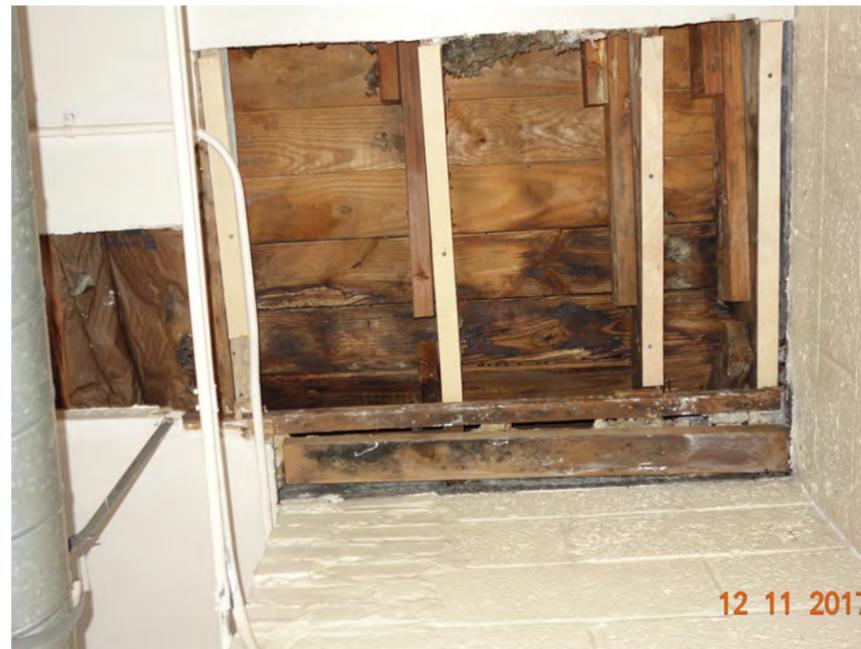
Figure 2.7_2 Plaster Ceiling Deterioration & Wood Deck Staining

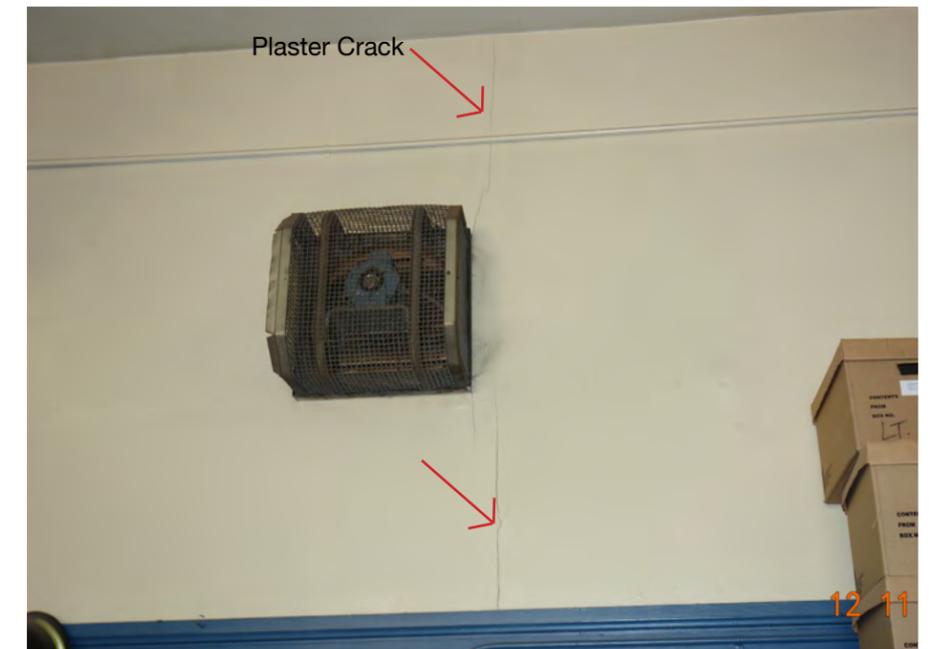
Figure 2.7_3 Plaster Wall Crack
