St. Paul's School
Garden City, NY

Building Envelope and Structural Condition
Assessment Report

July 19, 2019

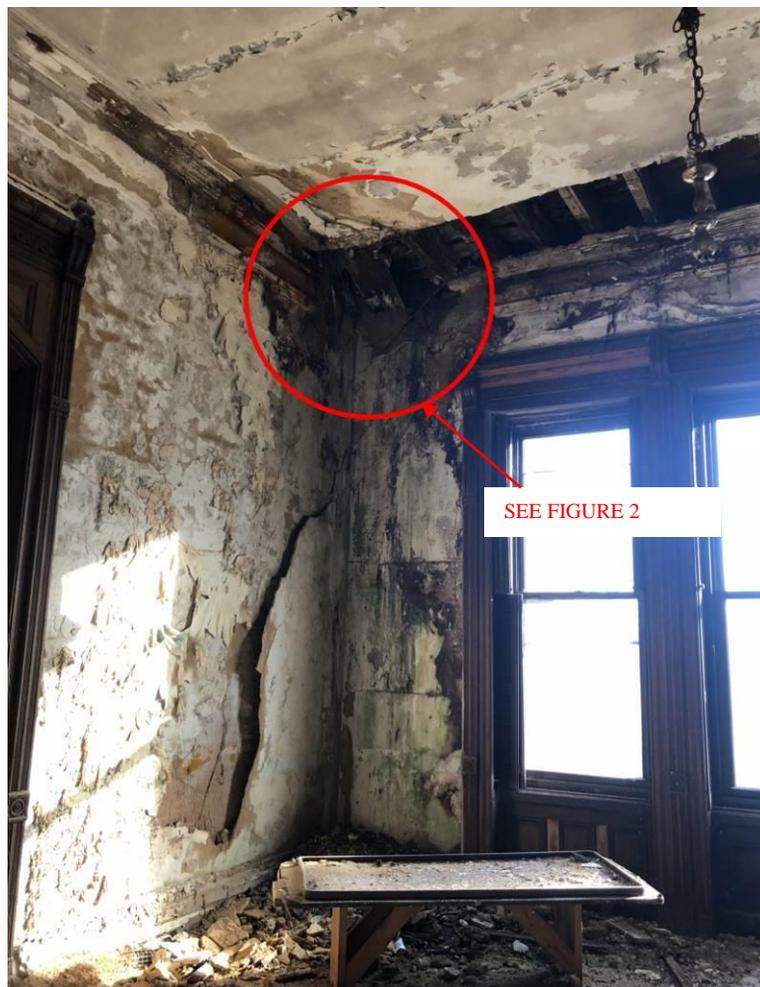
Figure 1: Compromised Floor Joist to Bearing Wall Connection: Front Room, West of Main Entrance

- Immediate shoring of this floor framing for temporary stability.
- Eventual removal of additional ceiling finishes to expose sound joist structure. (Perform required abatements, as necessary, prior to removal of finishes)
- Remove deteriorated joists locally such that new joist can be sistered to remaining joists. Recreate full bearing connection at façade bearing wall.

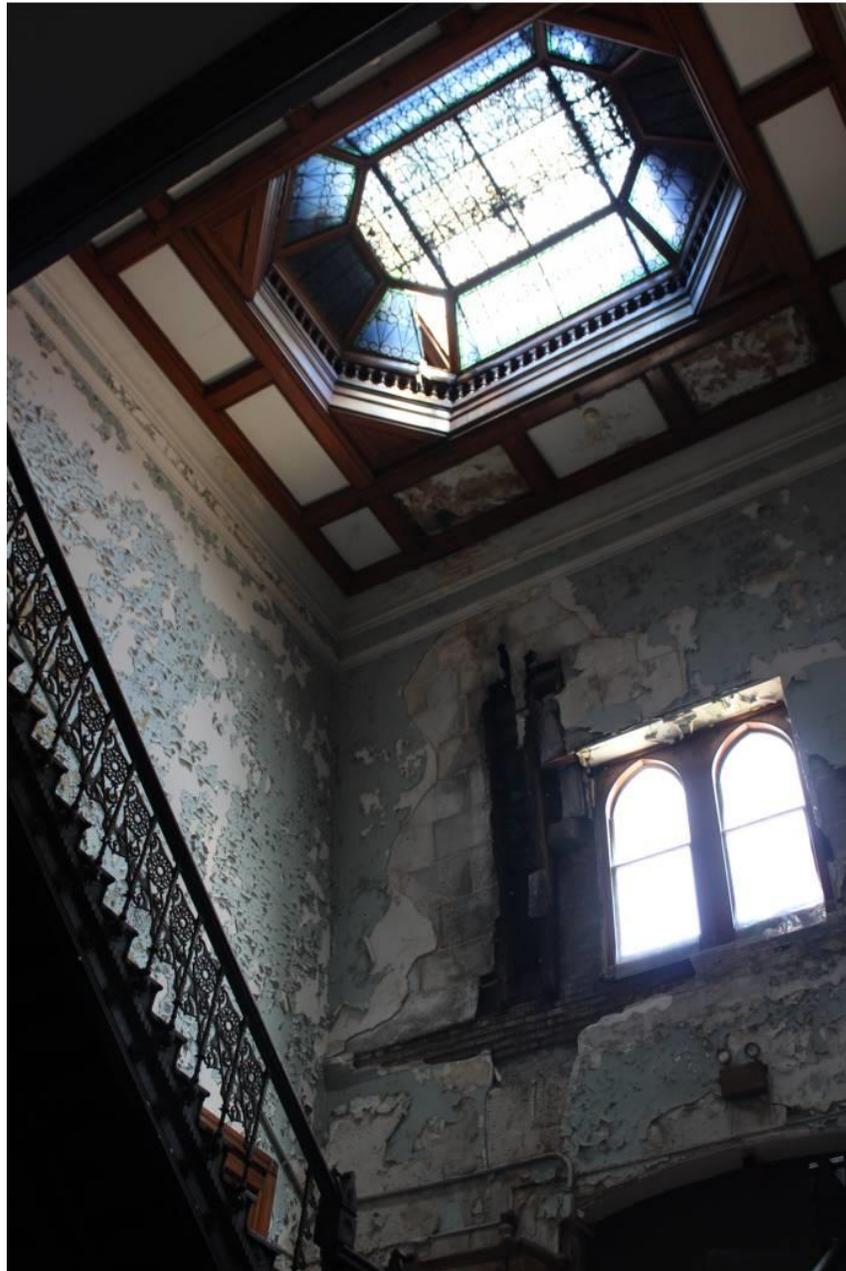
Figure 3: Deteriorated Mansard Roof Framing at Skylight

- Remove accumulated debris from the staircase and hanging skylight framing above.
- Stabilize remaining skylight and window elements, as required, for preservation.
- Remove remaining interior finishes to expose structural wood rafter framing and jamb/sill/lintel conditions around the window such that they can be evaluated and the full repair area defined. (Perform required abatements, as necessary, prior to removal of finishes)
- Replace deteriorated timber elements as required by sistering new joists in kind.
- Restore positive bearing connection between roof structure and bearing wall

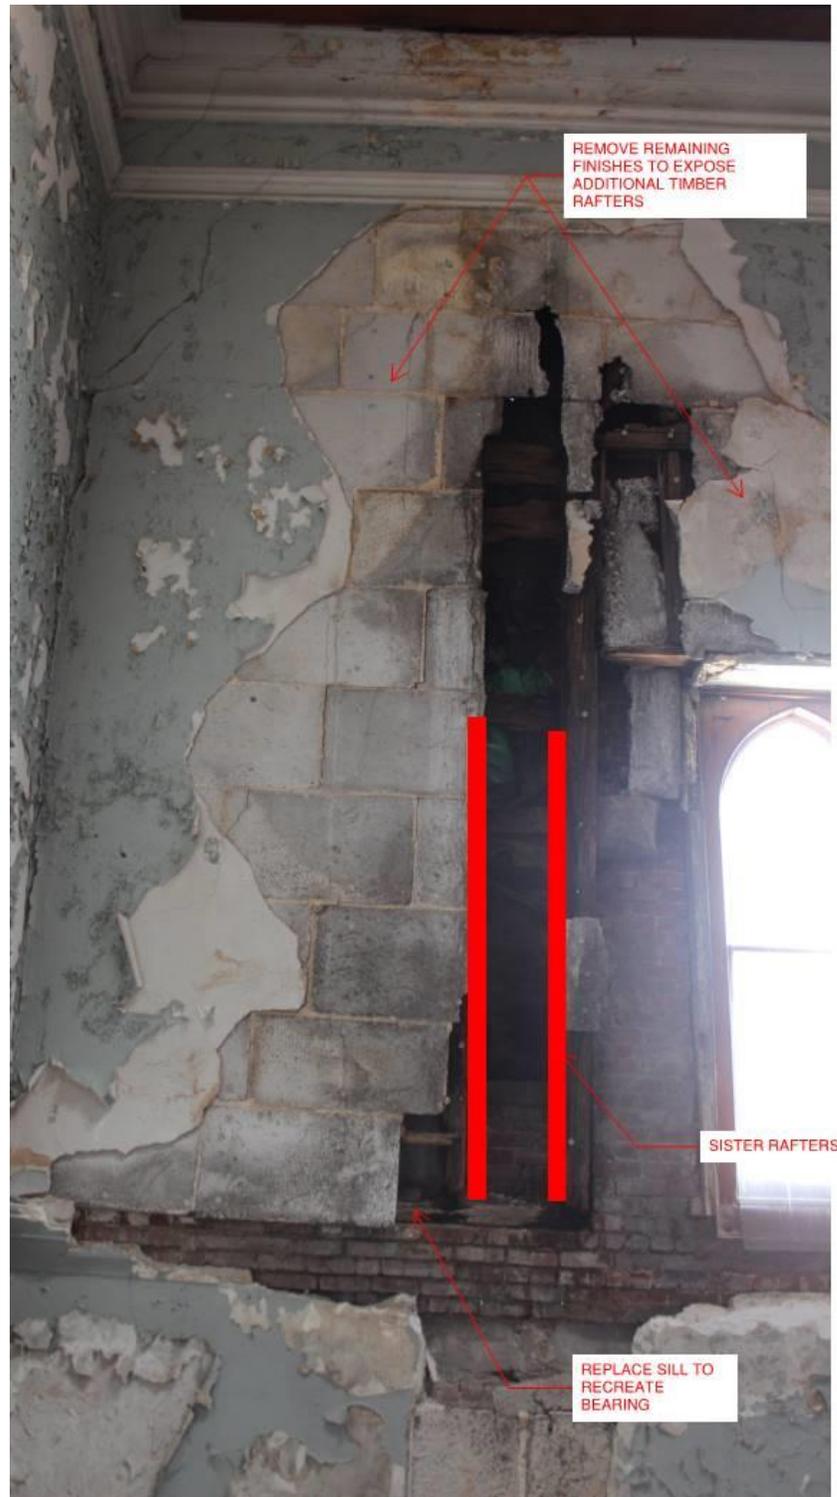
Figure 4: Exposed Roof Structure at Main Hall

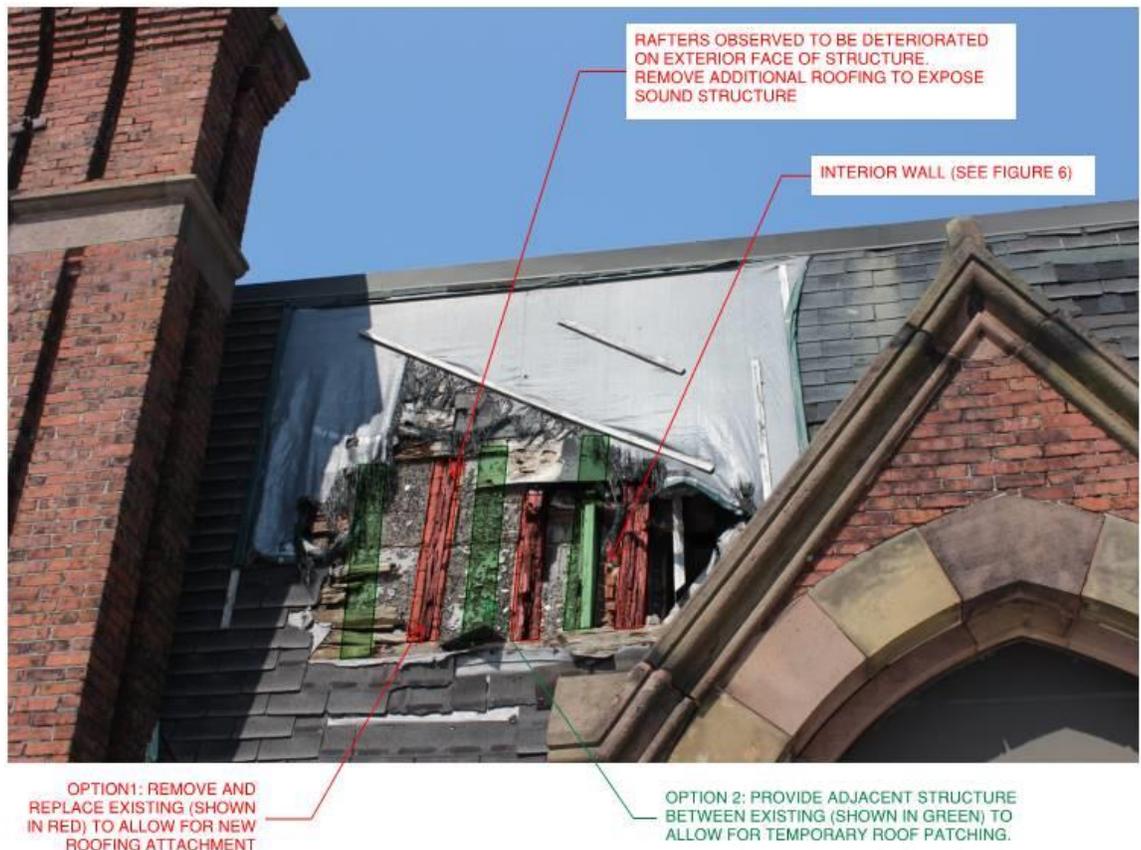
At the east face of the West Wing (see Appendix D for overall location), the condition of the structural wood rafters was observed from both the exterior and interior. From the exterior (Figure 5), the structure is completely deteriorated and does not provide a suitable structural substrate to attach a new roofing patches. The extent of this deterioration is unclear and existing surrounding roofing should be removed in order to uncover undamaged structure.

Figure 5: East Face - West Wing

option will provide both structural stability and a sound surface for roofing installation (see Figure 5).

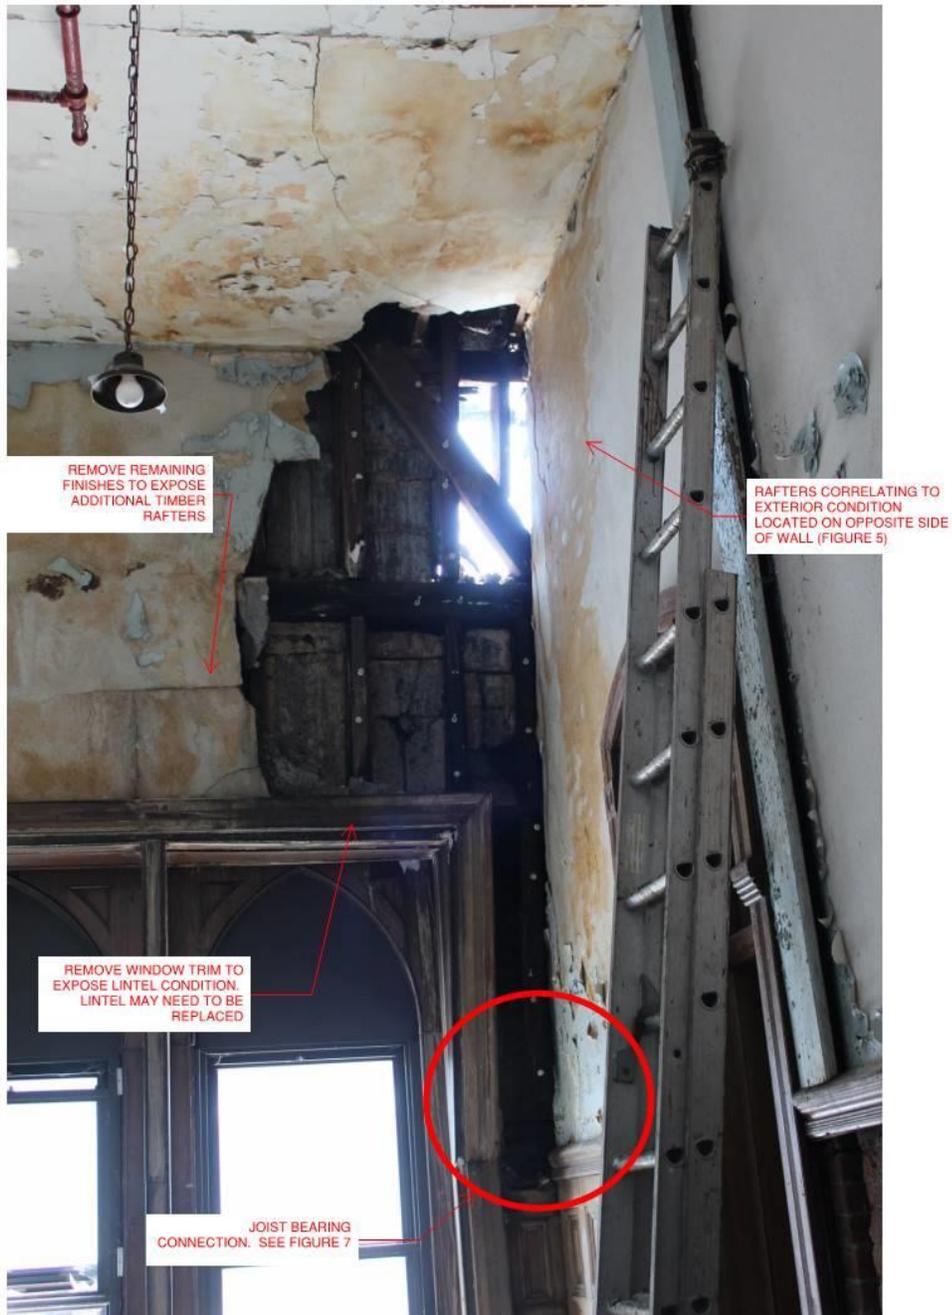
From the interior, it was observed that the bearing connection of the rafter adjacent to the window is completely dislodged and the lintel around the window is compromised (Figures 6 and 7) . Both conditions should be immediately addressed.

Figure 6: Interior Structure - West Wing, East Roof Face

- At the location where the bearing connection is deteriorated (see Figure 6 and 7), a new rafter shall be sistered in kind to the existing and full bearing restored between the roof and the masonry wall.

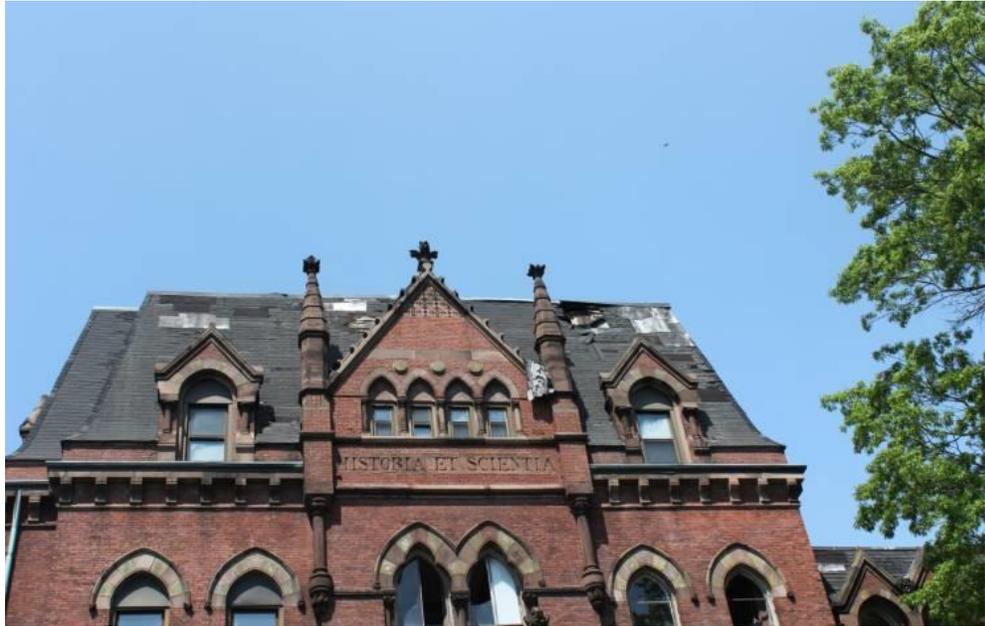
Another major breach in the building envelope and exposure of the underlying support structure is visible on the east façade roof above the building entrance along Rockaway Avenue (see Appendix D for overall location). Figures 8 and 9 below show both the exterior and interior conditions.

Figure 8: East Facade - Rockaway Avenue

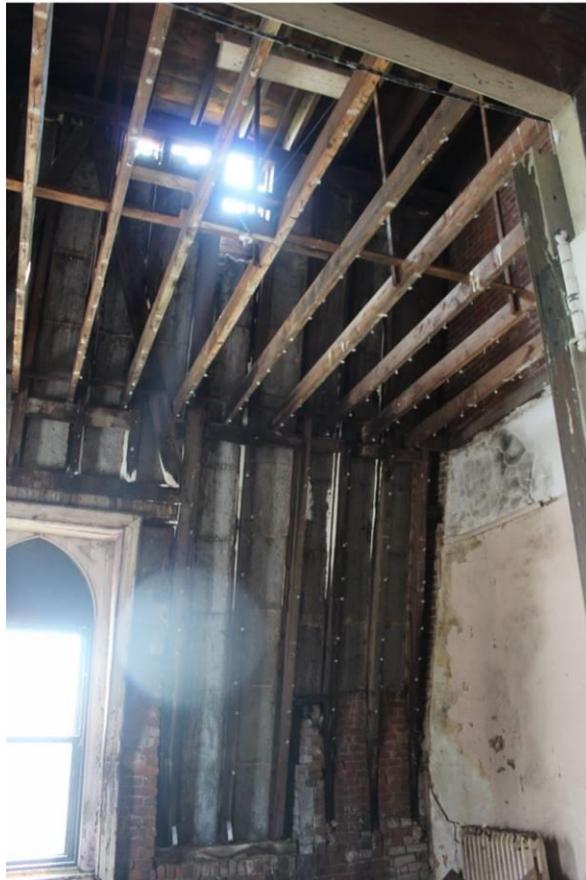
From our observations to date, this condition appears to be predominantly a loss of roofing. The timber rafters, observed on the interior (Figure 9), appear to be in sound condition. Roofing replacement is required and should proceed per sections 1.00 and 2.00. As construction continues, any uncovered structural deficiencies observed in this area can be reviewed and evaluated as needed.

Figure 9: East Facade Roof Penetration - Interior Condition

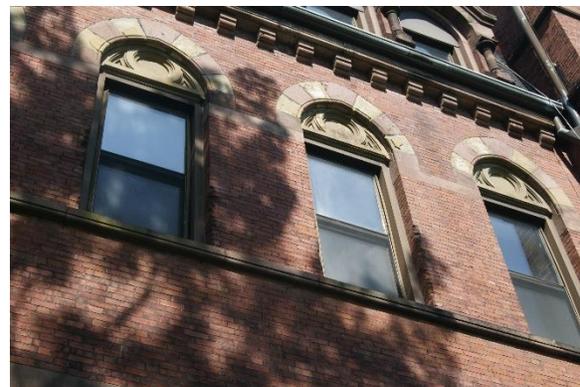
Photo 5. East façade: Open mortar joints in brick masonry. Stone surface delamination.

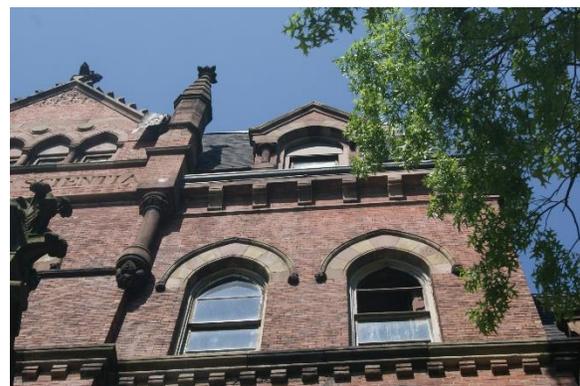
Photo 6. East façade: Missing glass. Detached roofing patch.

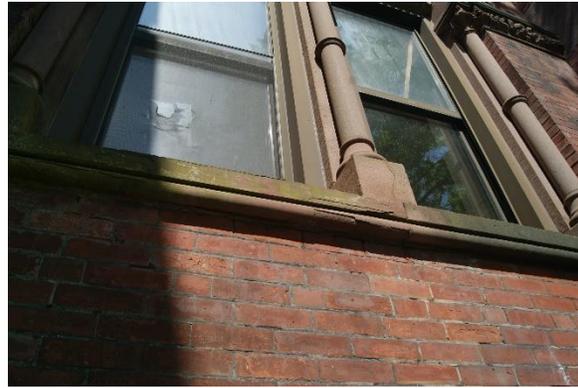
Photo 10. East façade: Open mortar joints in brick masonry. Stone surface delamination. Stone cracks.

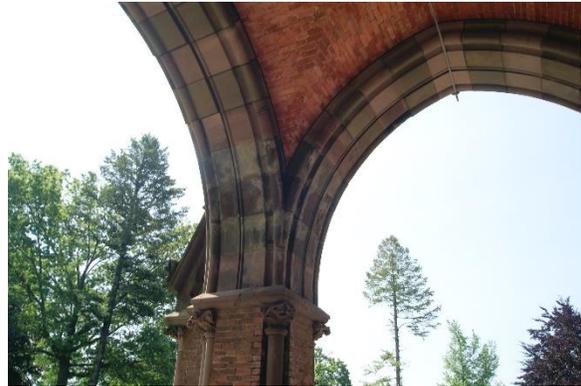
Photo 30. East façade: Stone surface delamination. Weathered joints in brick masonry.

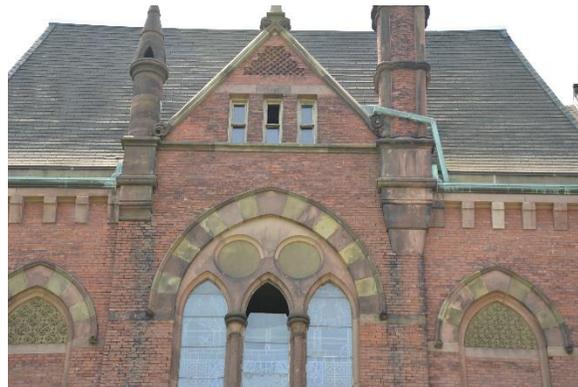
Photo 38. North façade: Missing window glass. Soiled masonry. Stone delamination. Displaced downspouts.

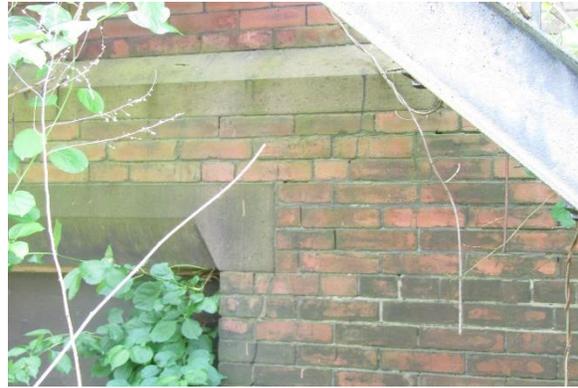
Photo 42. North façade: Open mortar joints. Soiled masonry.

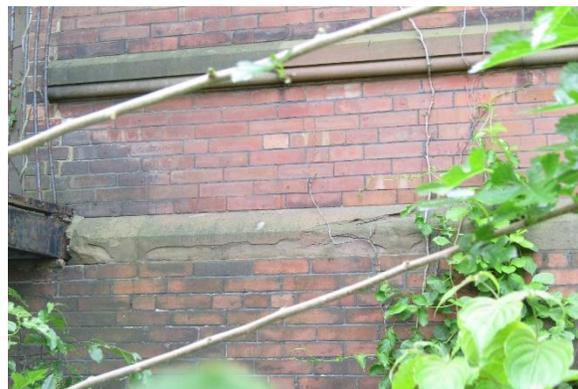
Photo 50. North façade: Stone delamination. Soiled masonry.

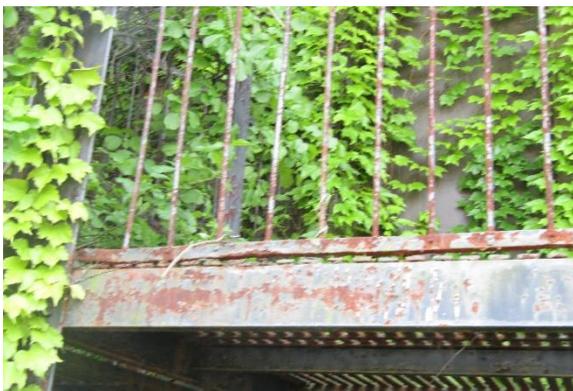
Photo 52. North façade: Corroded fire escape.

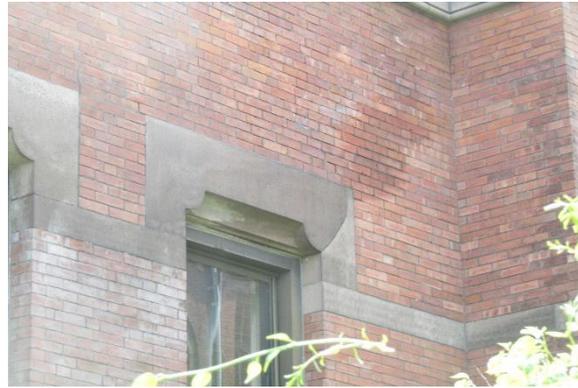
Photo 54. North façade: Efflorescence. Cracked stone lintel.

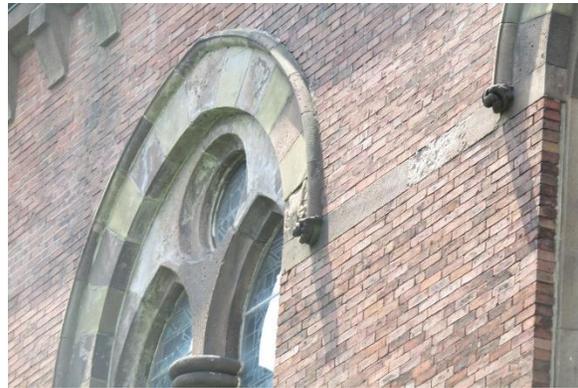
Photo 55. North façade: Stone delamination.

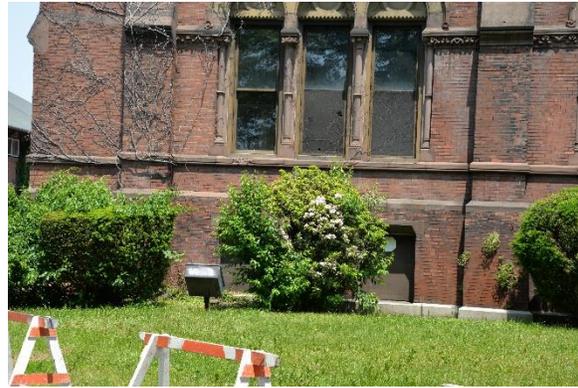
Photo 60. West façade: Open mortar joints. Deteriorated stone sill. Soiled masonry. Open mortar joints. Bio-growth.

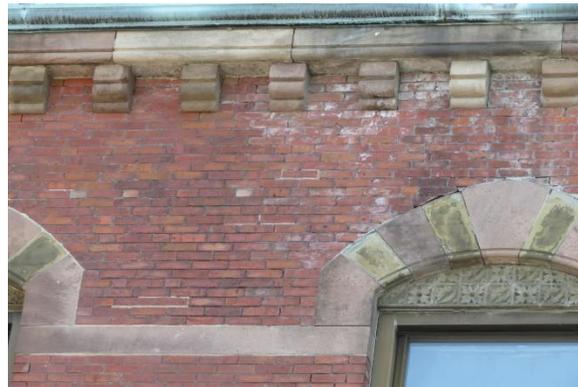
Photo 80. West façade: Stone delamination. Efflorescence. Cracked stone. Open mortar joints.

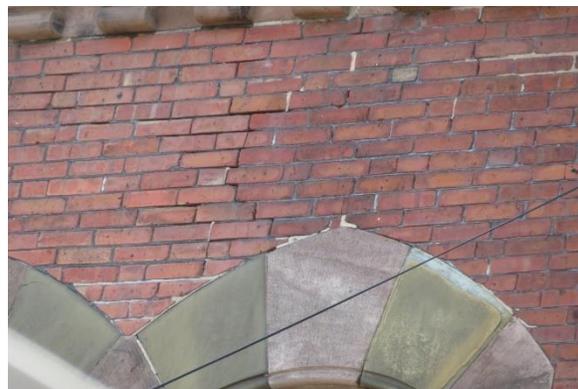
Photo 91. West façade: Step crack in brick masonry. Stone delamination. Weathered mortar joints.

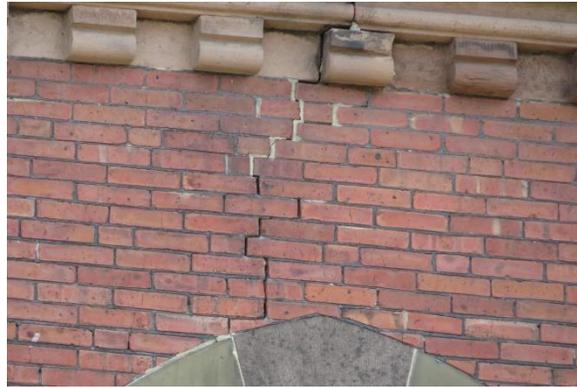
Photo 102. West façade: Brick masonry crack. Failed previous crack repair.

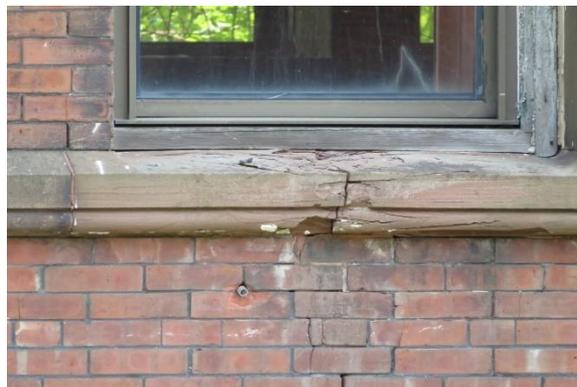
Photo 109. West façade: Stone surface delamination. Open and weathered mortar joints. Soiled masonry. Deteriorated wood window frames. Cracked stone. Cracked brick masonry. Miscellaneous weep.

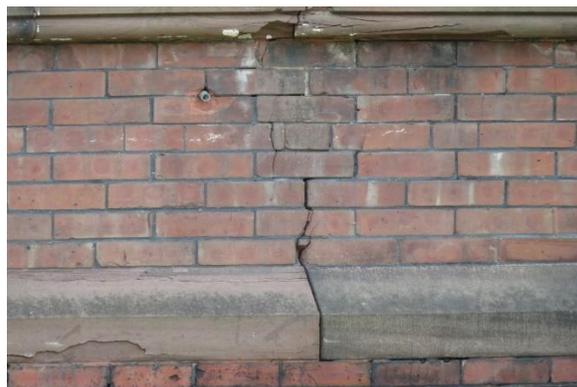
Photo 110. West façade: Stone surface delamination. Open and weathered mortar joints. Soiled masonry. Cracked stone. Cracked brick masonry. Miscellaneous weep.

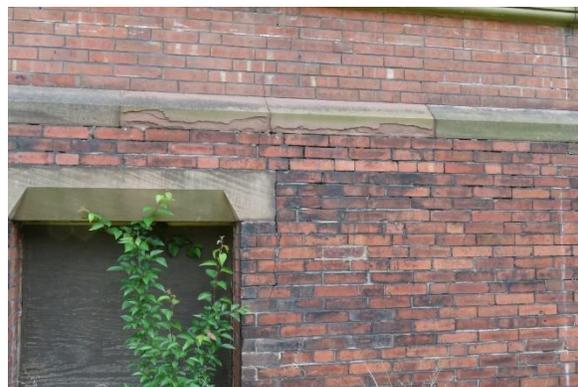
Photo 116. West façade: Stone surface delamination. Open and weathered mortar joints. Soiled masonry. Cracked stone. Cracked brick masonry.

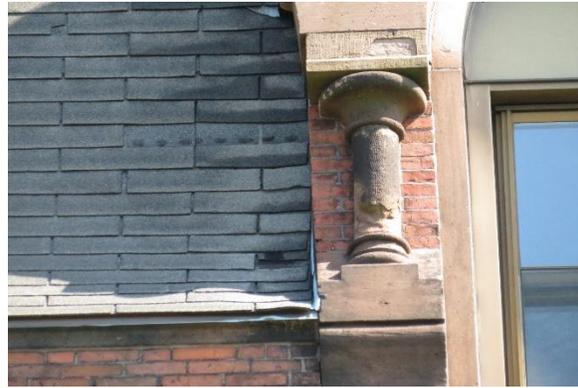
Photo 120. South façade: Stone surface delamination. Weathered mortar joints. Soiled masonry.

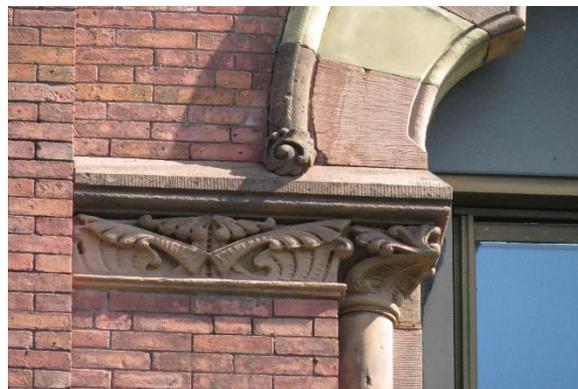
Photo 133. South façade: Open mortar joints.

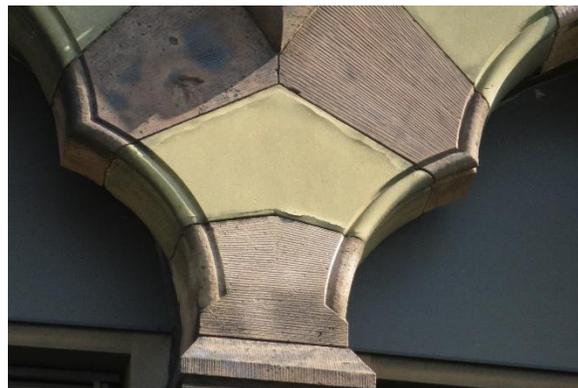
Photo 134. South façade: Stone surface delamination.

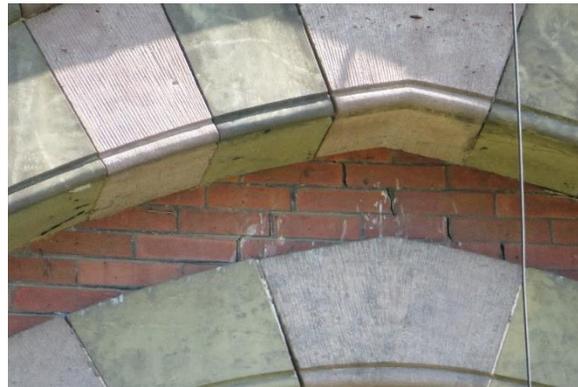
Photo 140. South façade: Step crack in brick masonry. Weathered and open mortar joints.

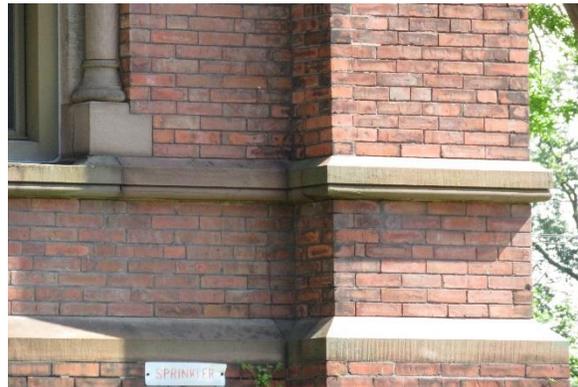
Photo 146. South façade: Open and weathered mortar joints. Stone surface delamination.

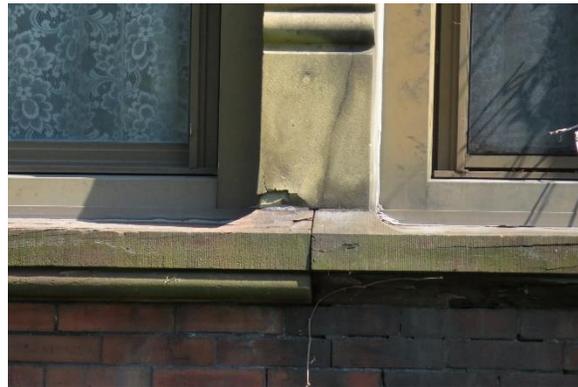
Photo 164. South façade: Stone surface delamination. Cracked stone. Open and weathered mortar joints.

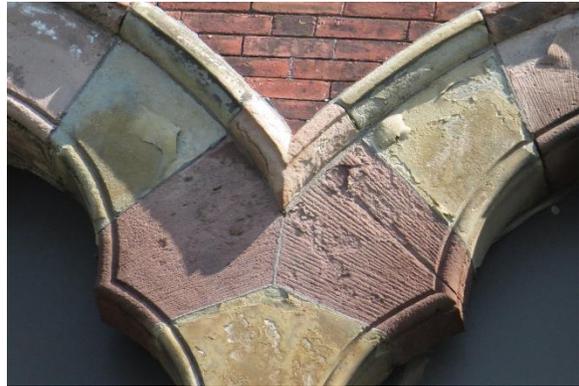
Photo 168. South façade: Stone surface delamination.

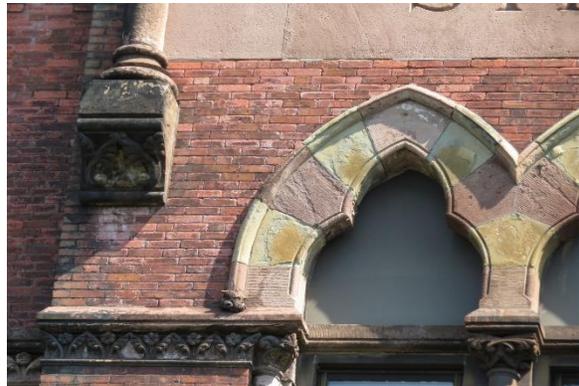
Photo 169. South façade: Stone surface delamination. Cracked and open mortar joints. Efflorescence. Soiled masonry.

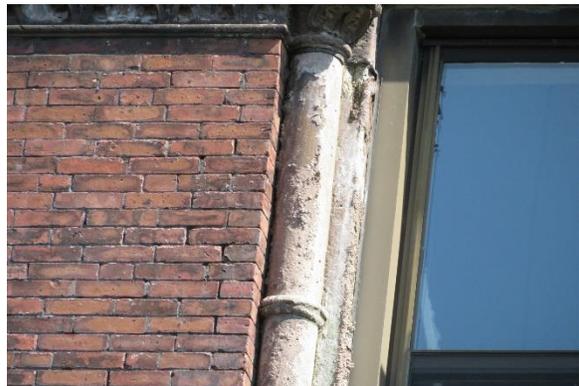
Photo 170. South façade: Stone surface delamination. Cracked and open mortar joints.

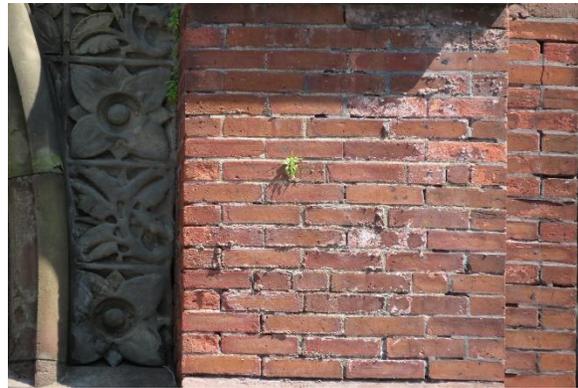
Photo 193. South façade: Weathered and open mortar joints. Efflorescence. Biological growth.

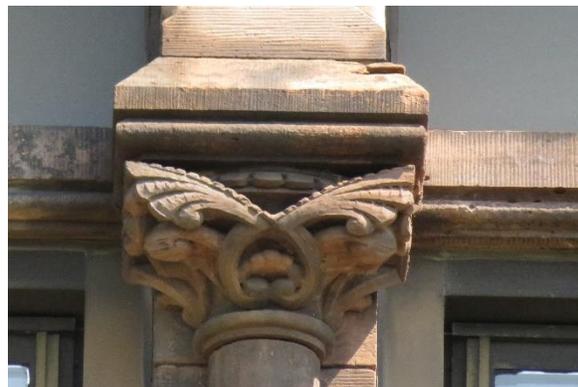
Photo 199. South façade: Spalled stone.

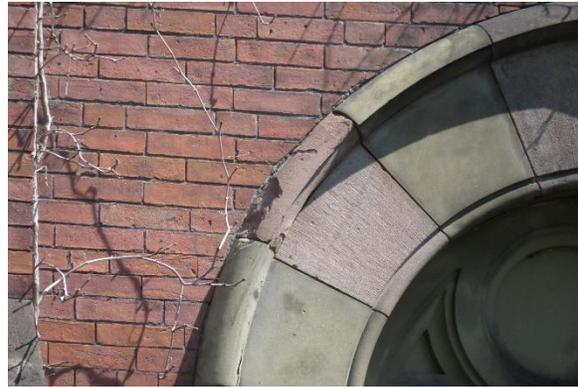
Photo 204. South façade: Stone delamination. Stone spall.

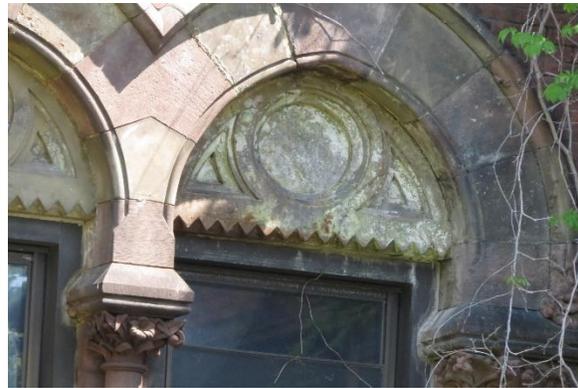
Photo 205. South façade: Efflorescence. Stone delamination. Soiled masonry.

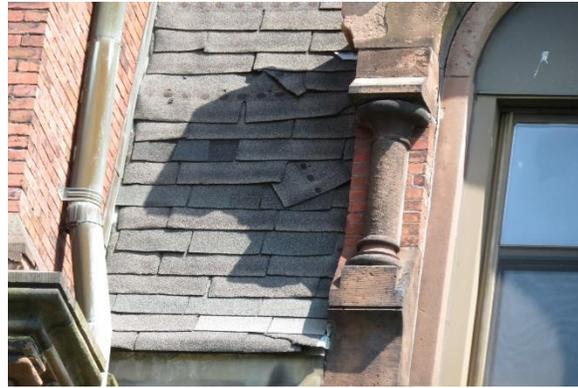
Photo 210. South façade: Stone delamination.

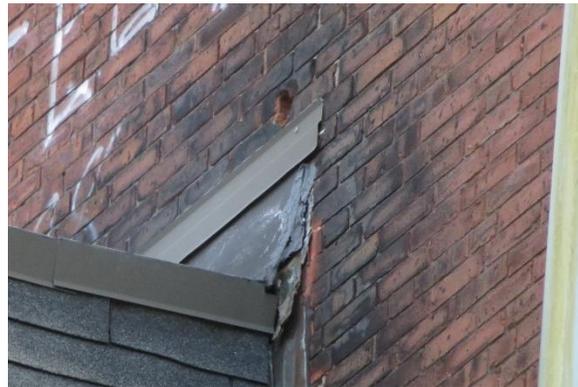
Photo 224. South façade: Missing flashing. Soiled masonry. Spalled brick.

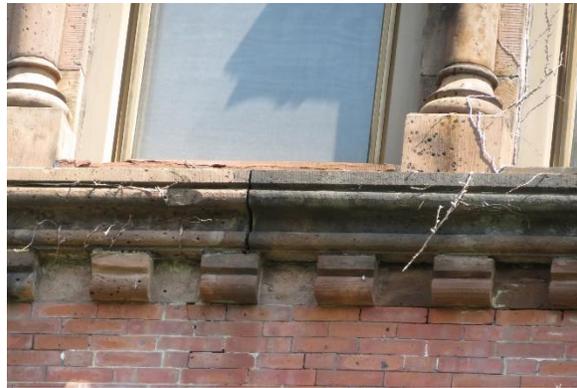
Photo 235. South façade: Stone delamination. Open mortar joints. Spalled stone.

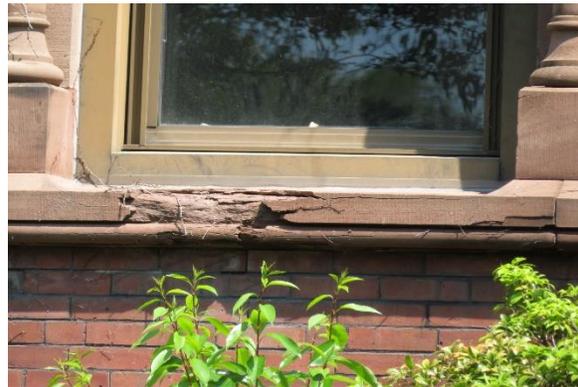
Photo 242. South façade: Stone delamination. Cracked stone. Open mortar joints.

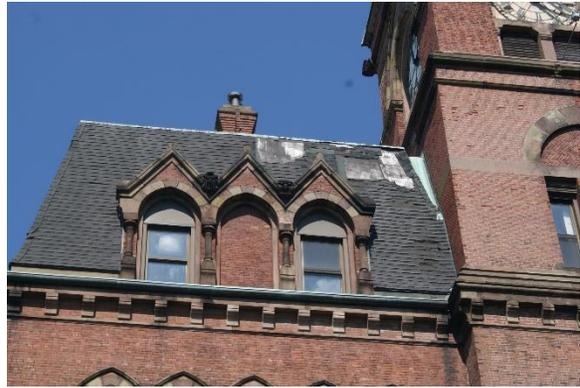
Photo 246. Roof: Failed previous roof patches.

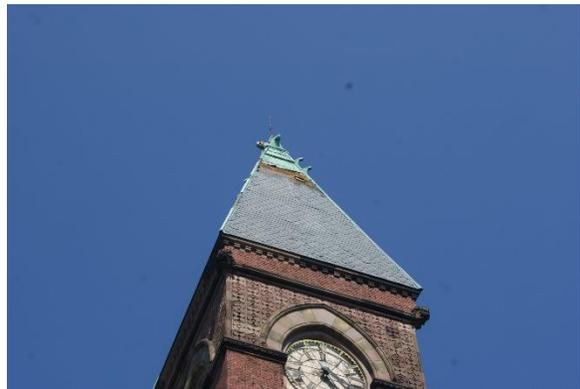
Photo 247. Roof: Missing ridge elements. Missing shingles.

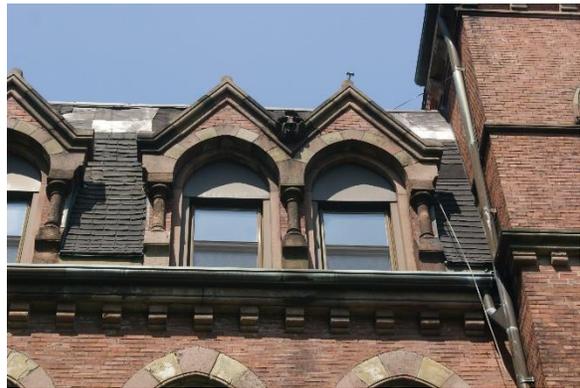
Photo 248. Roof: Failed previous roof patches. Deteriorated shingles.

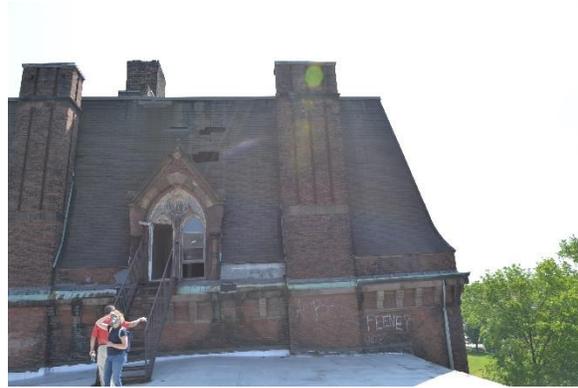
Photo 252. Roof: Failed previous patches. Deteriorated shingles. Damaged egress stairs. Deteriorated window frame.

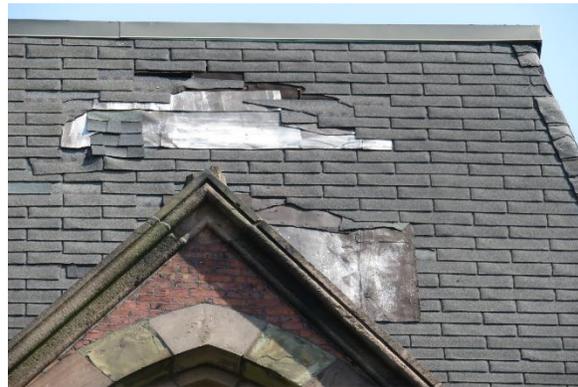
Photo 260. Roof: Damaged roofing. Failed previous roof patches.

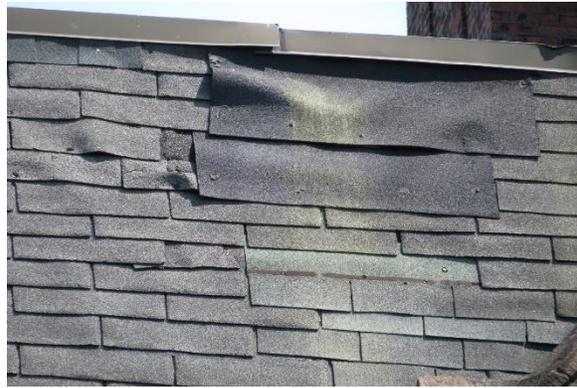
Photo 264. Roof: Damaged roofing. Failed previous roof patches.

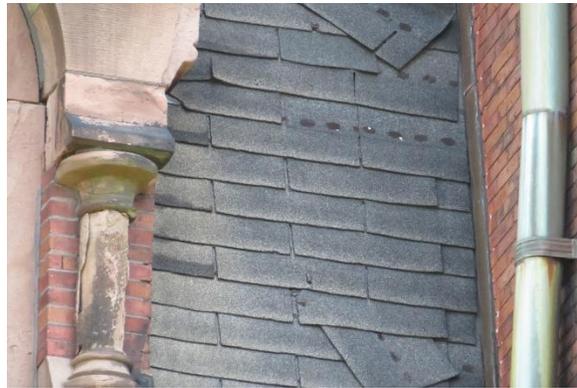
Photo 265. Roof: Loose shingles.

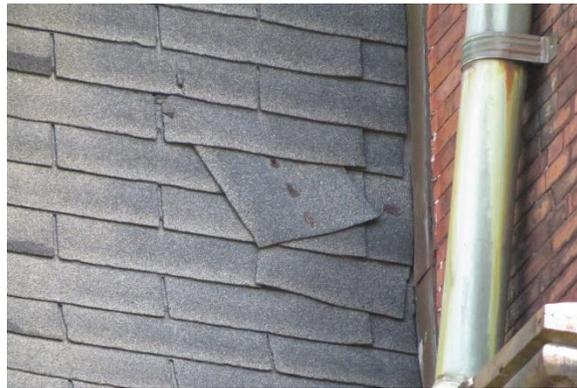
Photo 266. Roof: Loose shingles.

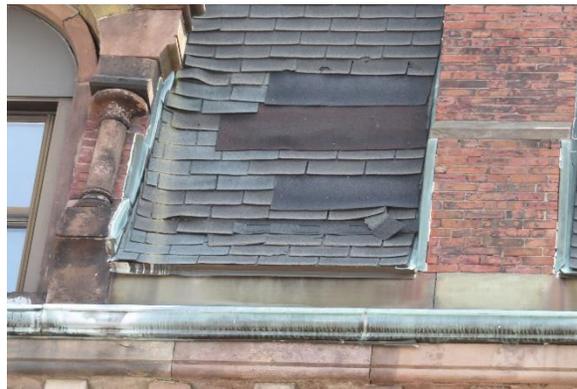
Photo 271. Roof: Damaged roofing. Failed previous roof patches.

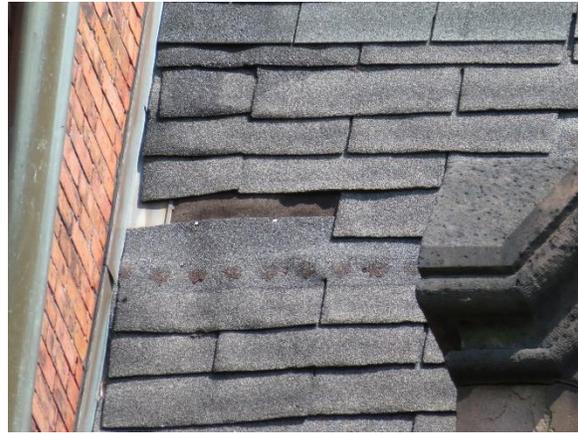
Photo 276. Roof: Missing shingles.

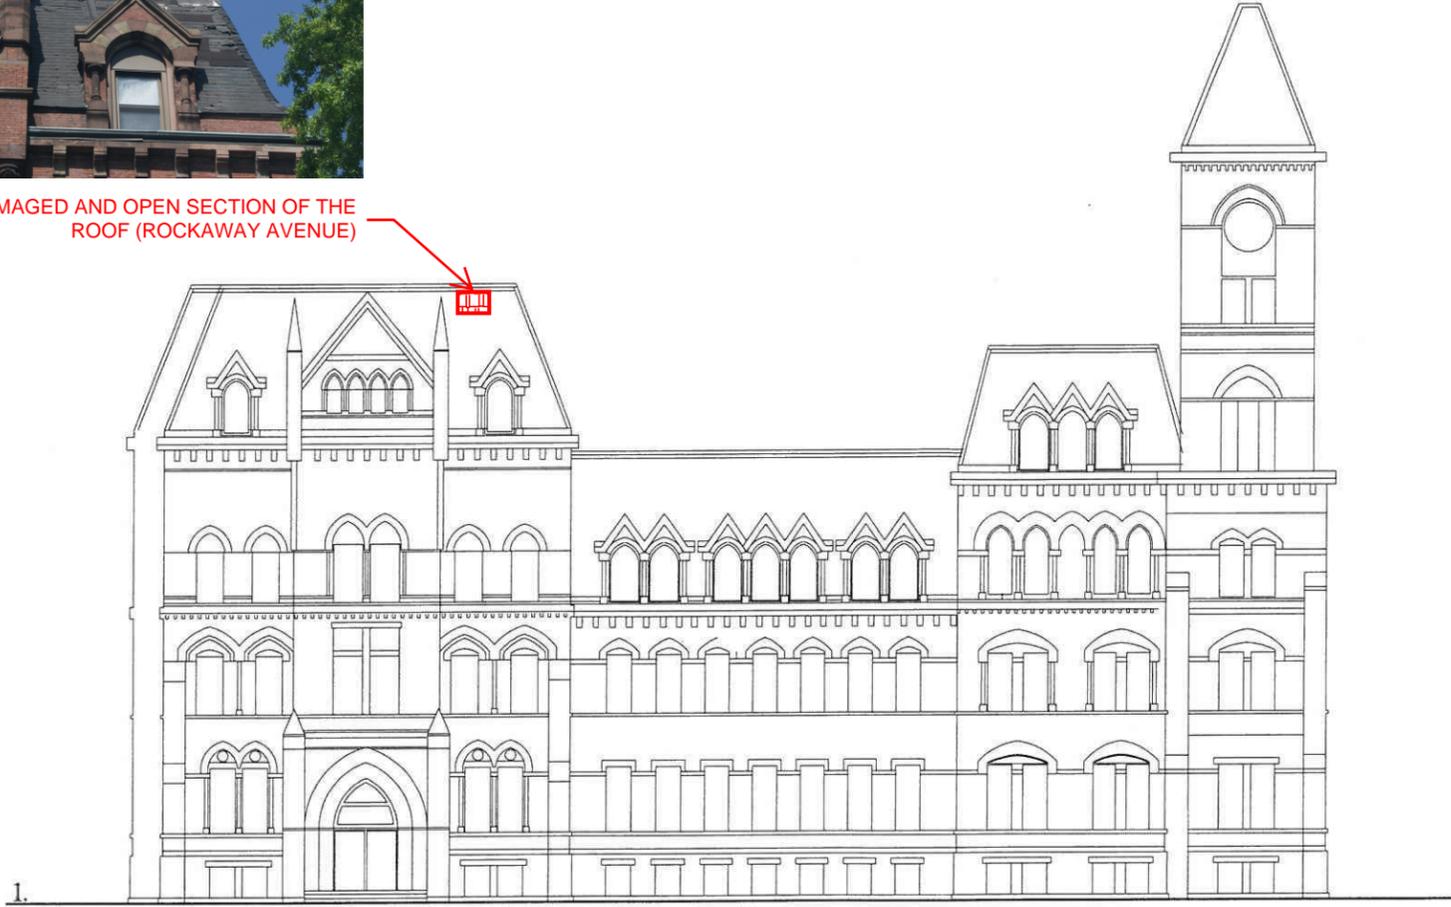
1.

DAMAGED AND OPEN SECTION OF THE ROOF (ROCKAWAY AVENUE)

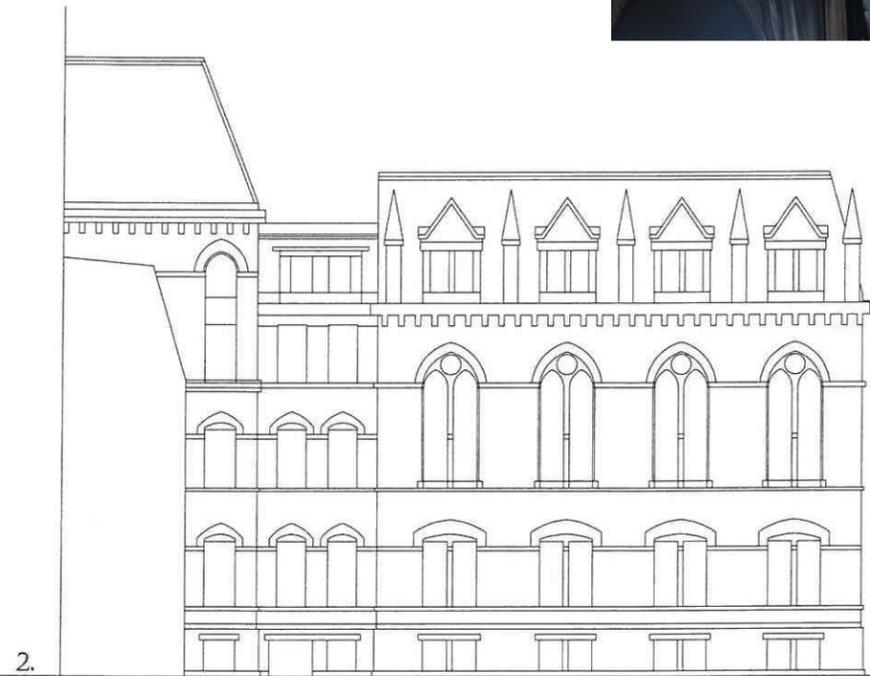
2.

DAMAGED AND OPEN SECTION OF THE ROOF (EAST SIDE - WEST WING)

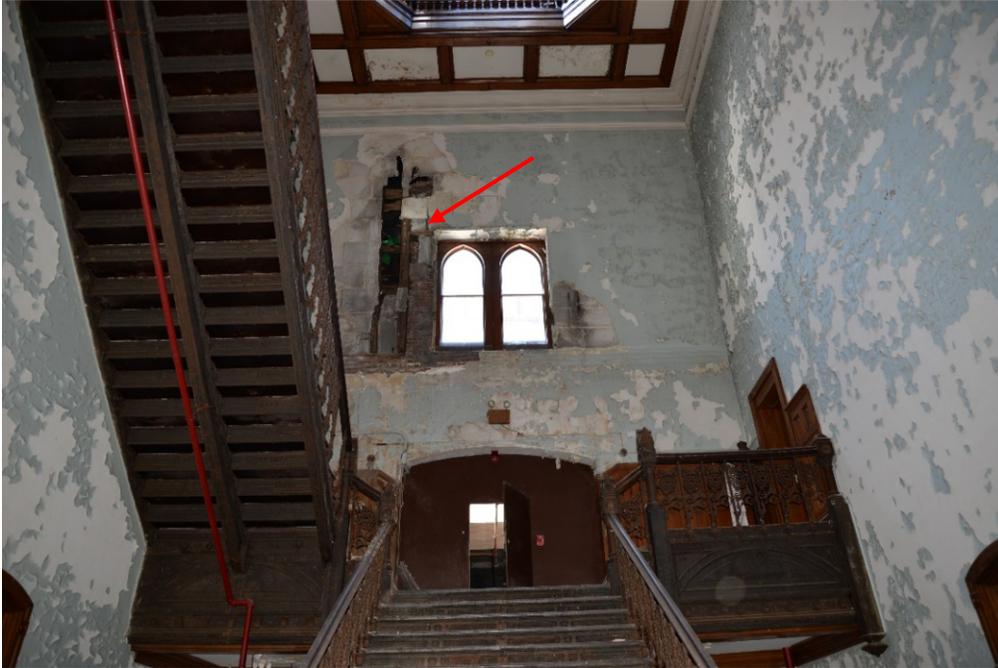
Photo 1: Area of deteriorated wood framing above stair landing

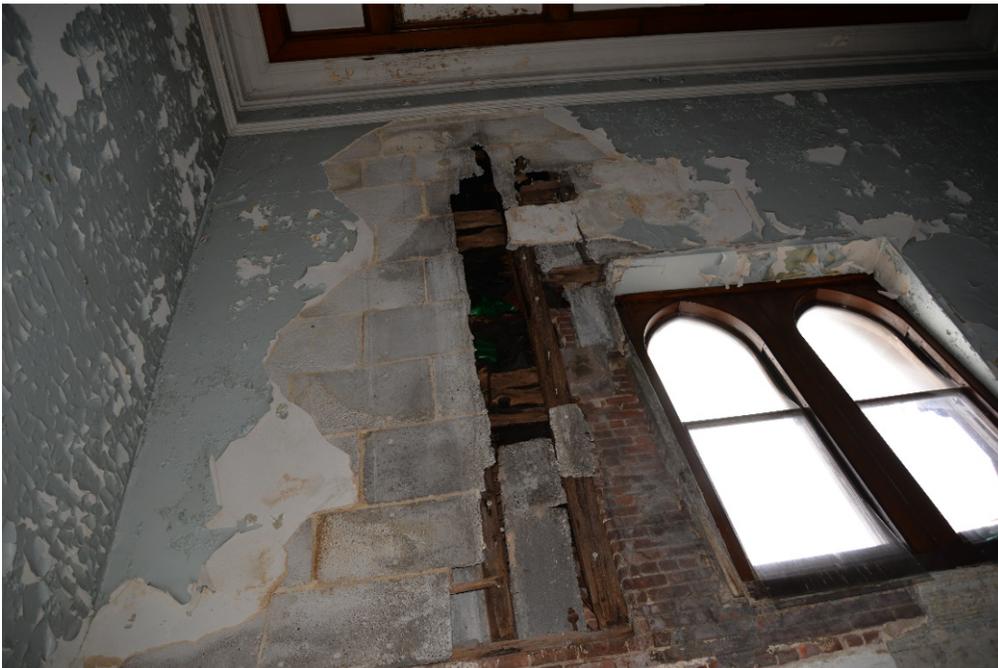
Photo 2: Deteriorated wood wall framing

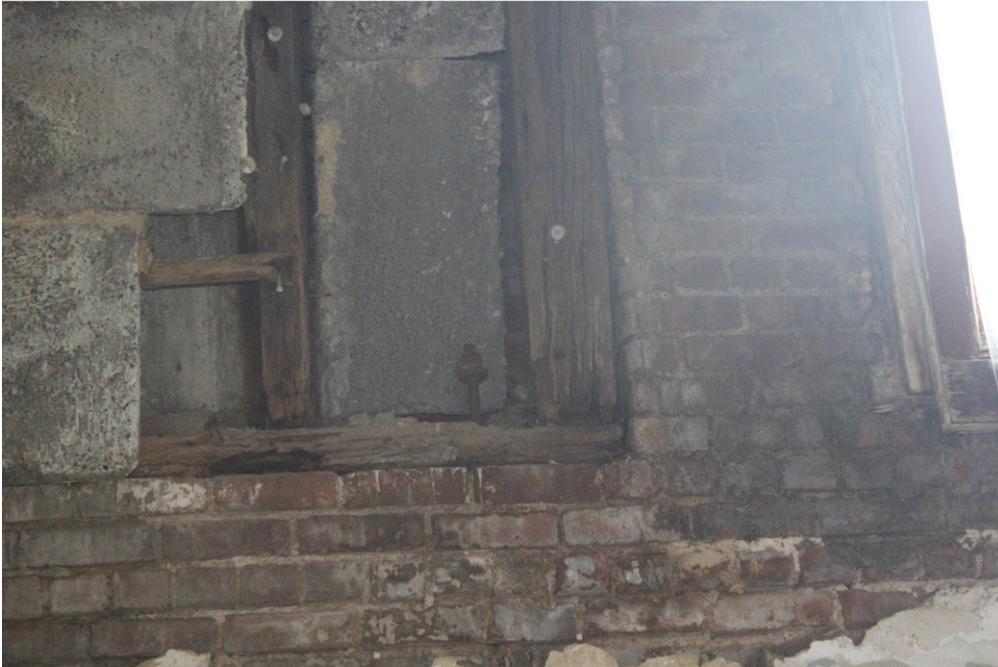
Photo 3: Close-up of deteriorated wood framing

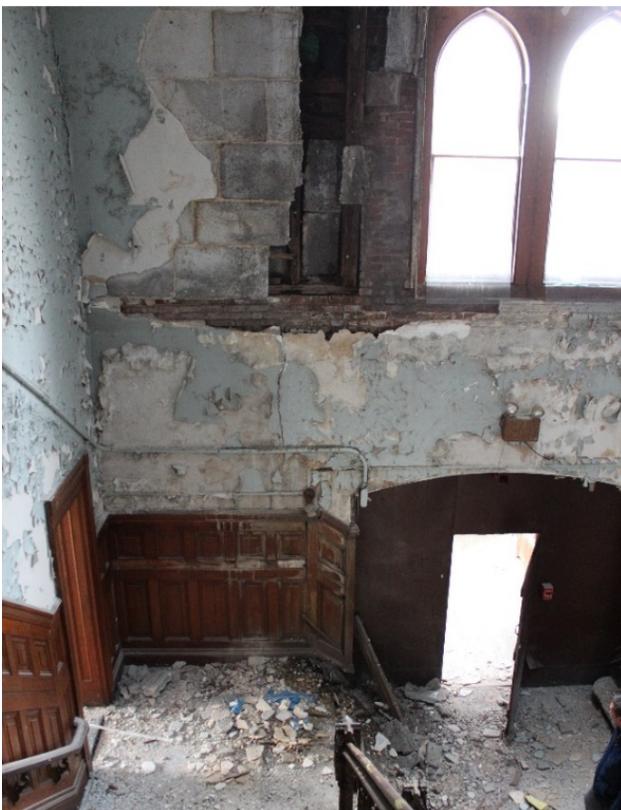
Photo 4: Debris below deteriorated wall framing
