St. Paul's School
Garden City, NY

Building Envelope and Structural Condition
Assessment Report

July 19, 2019

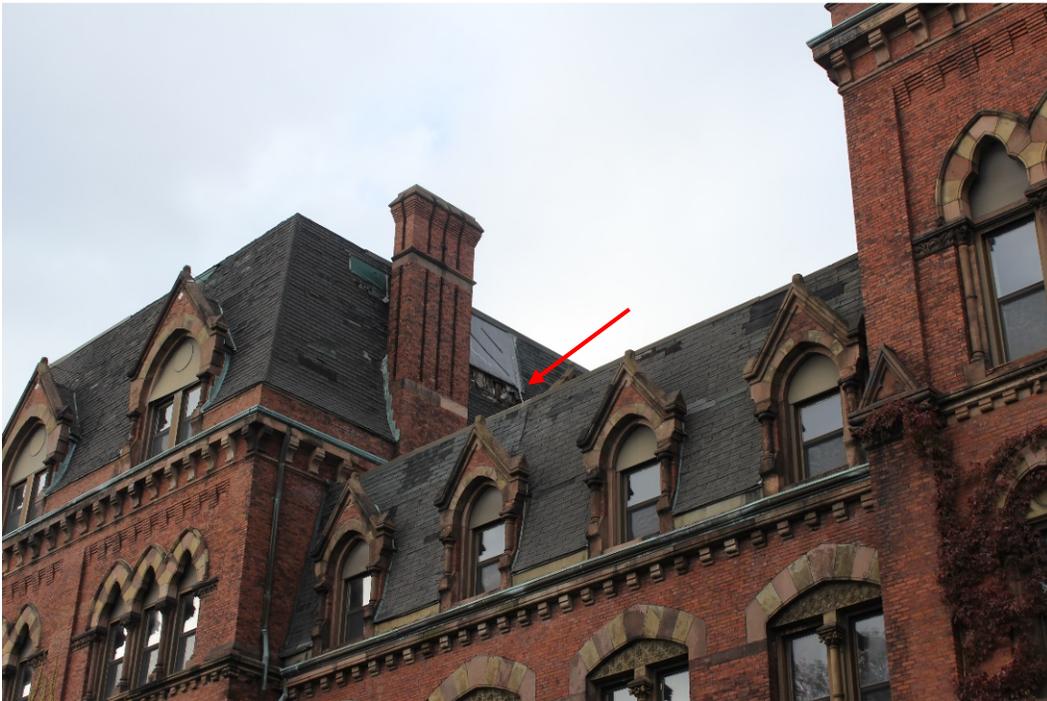
Photo 5: Exposed structural framing at roof patch repair at the west wing
