## I. GOALS AND OBJECTIVES

The Facilities and Apparatus Needs Analysis Subcommittee was tasked with evaluating the assets of the Garden City Fire Department (Fire Department). The intent of the analysis was to provide a status assessment of the facilities and apparatus and identify actionable recommendations for the Village. Where possible, quantifiable financial commitments have been estimated for recommendations.

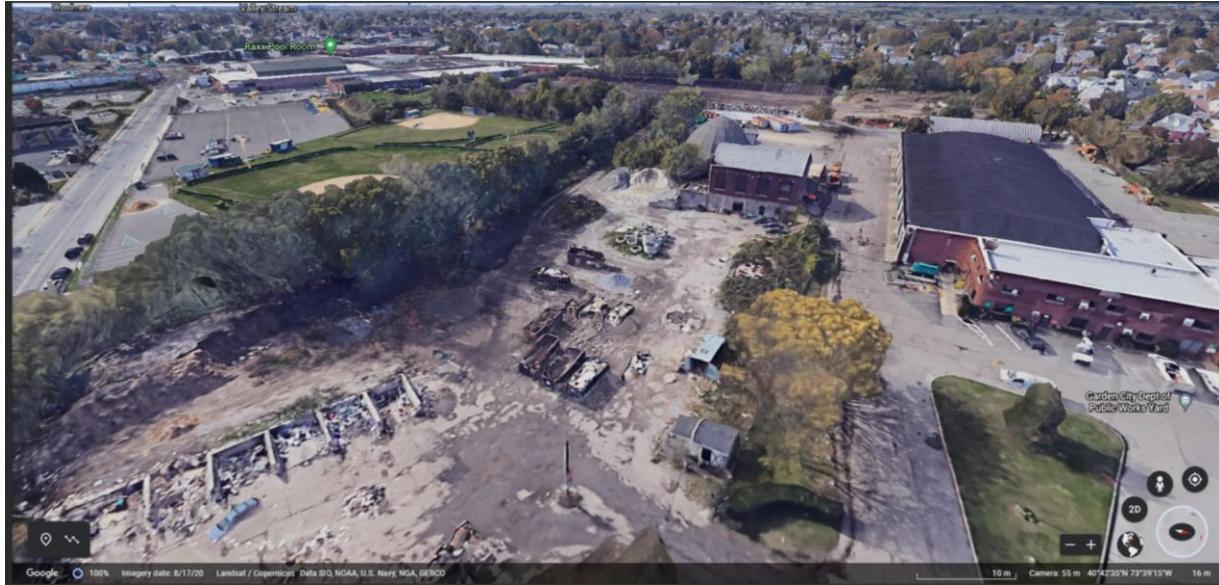
*View From Cherry Valley Avenue*

- a. Adjacent to the existing Village yard facility is an open exterior space currently used for exterior storage of dry well drainage materials. This site is underutilized and already has adequate truck access. Relocating this exterior storage can provide the exterior space necessary to accommodate a new enclosed training facility and associate exterior operational space.

- b. Site work will be necessary to accommodate the required infrastructure including regrading, construction of a retaining wall or other retaining construction (i.e., ISO shipping containers used also for storage), and utility work. It is our understanding that the Village is currently embarking on a project to construct a retaining wall at the location necessary to accommodate the facility. This project should be revised to accommodate some of the needs of this effort to economize both projects.

- c. Installation of a permeable surface below a prefabricated training structure to facilitate drainage.
- d. Installation of an impermeable surface, such as asphalt, around the perimeter of the training structure to permit Department operations.
- e. Installation of a new fire hydrant/s within the training area.
- f. Installation of a perimeter fence to protect the Village's investment and secure the facility.
- g. Procurement and installation of a training structure, such as the FTS Manhattan System (see attached product literature in Appendix C), which complies with NFPA 1402 and provides the required firefighting training features outlined above.
- h. Acquisition of a portable heating and cooling unit for use prior to training events. Conversations with other users indicate that the stagnant training structures can have untenable hot or cold conditions during weather extremes.

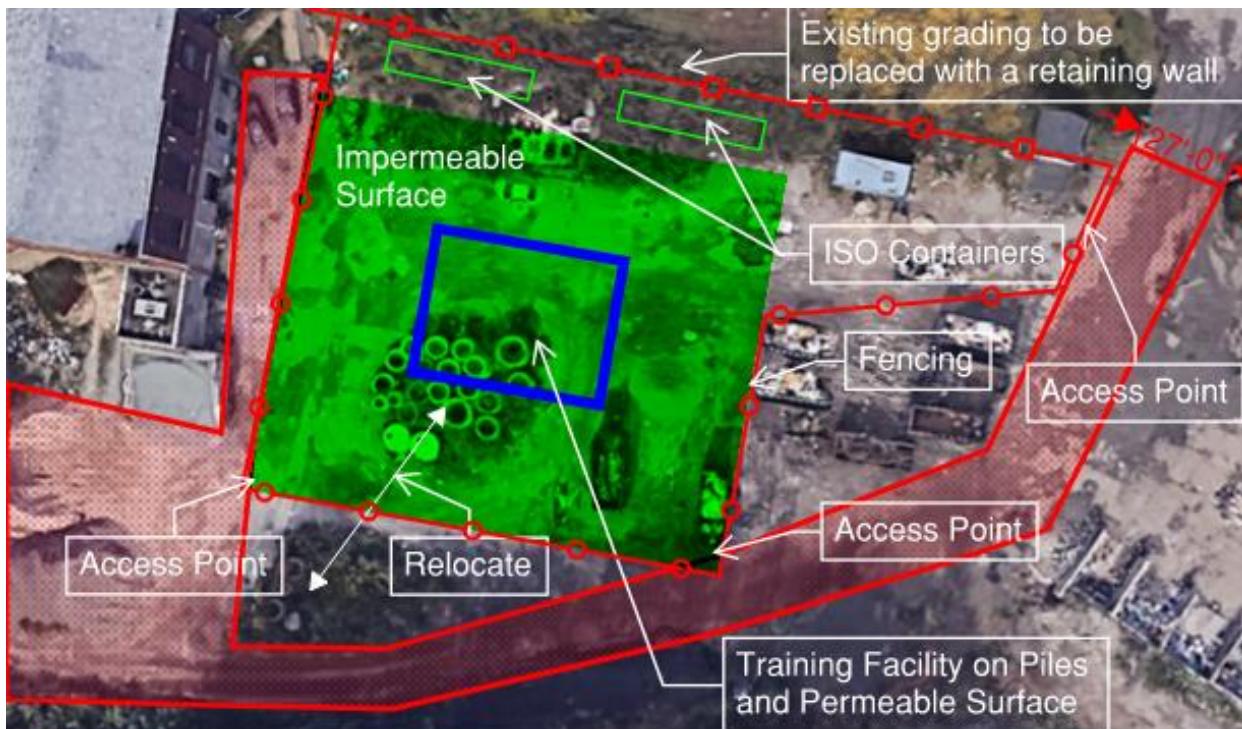
A civil/site plan was not available for the location, so an aerial view was modified to illustrate a potential solution. It should be noted that multiple options may be available to provide the necessary space for Department operations, while maintaining site access for other Village employees at the yard.

The layout above is intended to address the needs of the Department for internal training. However, a recommendation by the Emergency Action and Response Plan Subcommittee indicates that there is an increasing reliance on the mutual aid system of Nassau County. The mutual aid agreements in place ensure that if there is a transmission of a working fire, mutual aid departments will automatically be operating on scene. It is imperative that the Department be training regularly for these situations.

The layout above is also intended to facilitate training with mutual aid departments in addition to GCFD only internal trainings. The multiple access points and 360-degree operating space will provide opportunities for the Department to train with the primary mutual aid departments as they would at a fire scene.
