Garden City
Fire Department

Firehouse #1, #2 & #3

Existing Conditions
Documentation & Recommendations
DRAFT

February 2, 2018

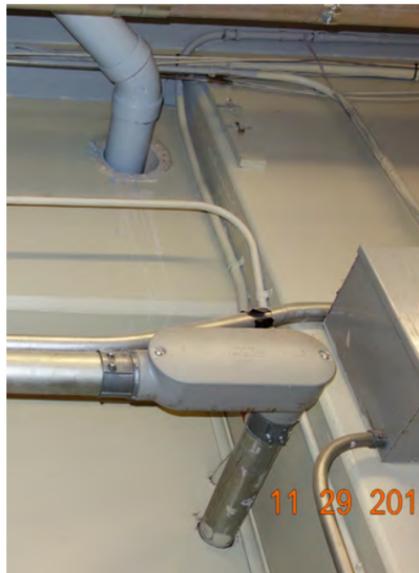
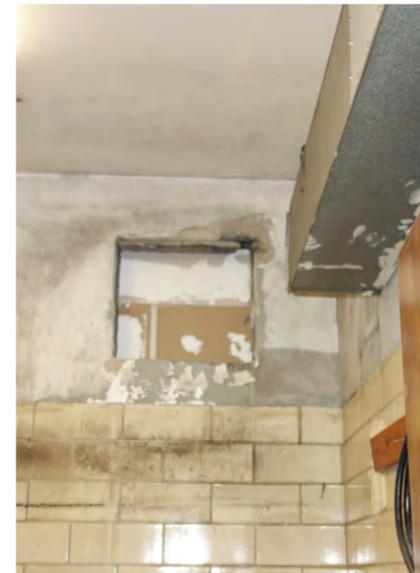
- **Pipe penetrations** in multiple locations are not fire stopped / safed at South Apparatus Room wall. In violation of Code.
- **Pipe penetration** not fire stopped at underside of the 2nd floor assembly in Electrical Closet. In violation of Code.
- **Ductwork penetration** not fire stopped/ safed at South Apparatus Room wall. In violation of Code.
- **Washing machine** is penetrating South Apparatus Room wall into the Electrical Closet. Holes all around washing machine. Opening is not fire stopped/ safed. Wall in this area is not fire rated construction. In violation of Code.
- **Hole** in concrete masonry unit at fire rated Corridor wall and in Electrical Closet at ceiling level. In violation of Code.
- **No doors** at openings between Corridor to Office and between Vestibule to Conference and Sitting Rooms. In violation of Code.

Figure 2.1_1 Apparatus Room - Pipe Penetrations (left), Hole in CMU (right)

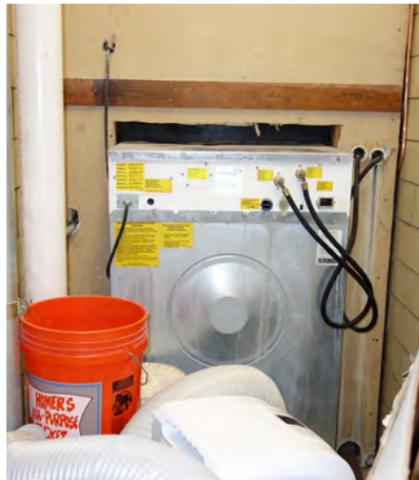
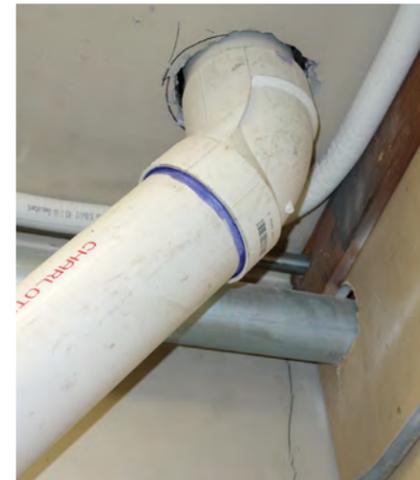
Figure 2.1_2 Electrical Closet - Wash. M. Opening & Pipes Not Fire Stopped

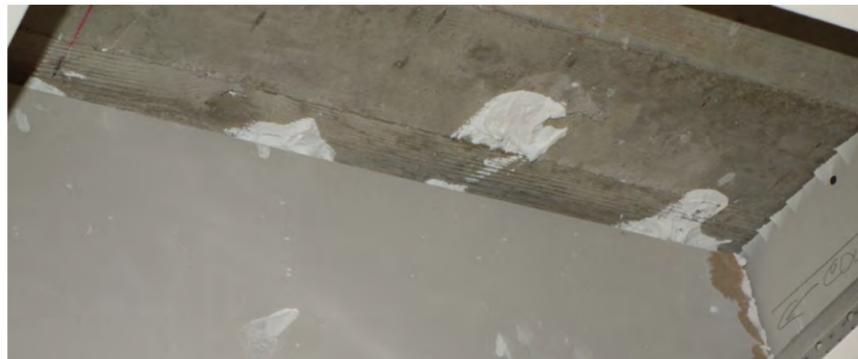
Figure 2.1_3 Meeting Rm - No Fire Stopping At Top of Wall & Bottom of Slab

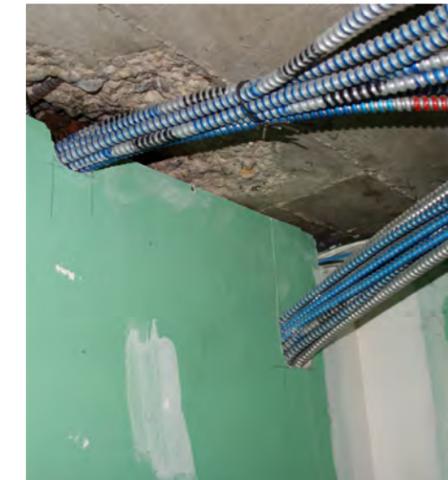
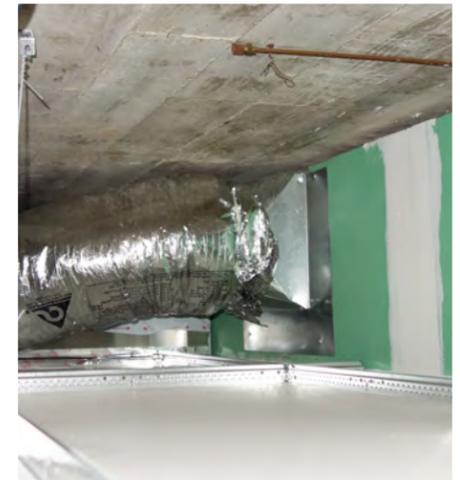
- **Flexible metal conduit penetrations** in multiple locations are not fire stopped/ safed between the Kitchen and Corridor wall.
- **No fire stopping / safing** at the bottom of slab and top of wall between Kitchen and Corridor as well as Meeting Room and Corridor walls.
- **Ductwork penetration** not fire stopped/ safed at wall between Kitchen and Corridor. No fire damper visible.

Figure 2.1_4 Kitchen - Flexible Metal Conduit & Duct Penetrations

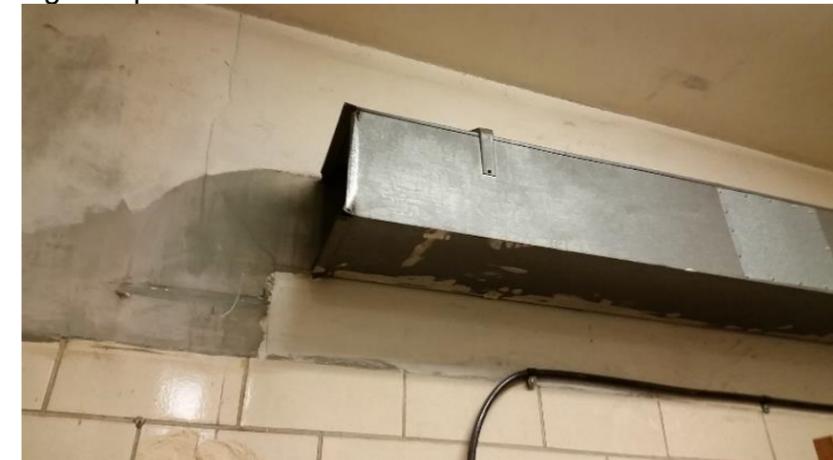
- 4) Observed deficiency: Oxygen/compressed gas storage room ventilation duct must have exhaust fan to keep room under negative pressure

Recommended fix: Install an exhaust fan in the oxygen room duct. A Cook Gemini fan is an inexpensive option, though it is designed for suspended ceilings. A Cook ACED-EC is a slightly more costly option suitable for open ceilings.

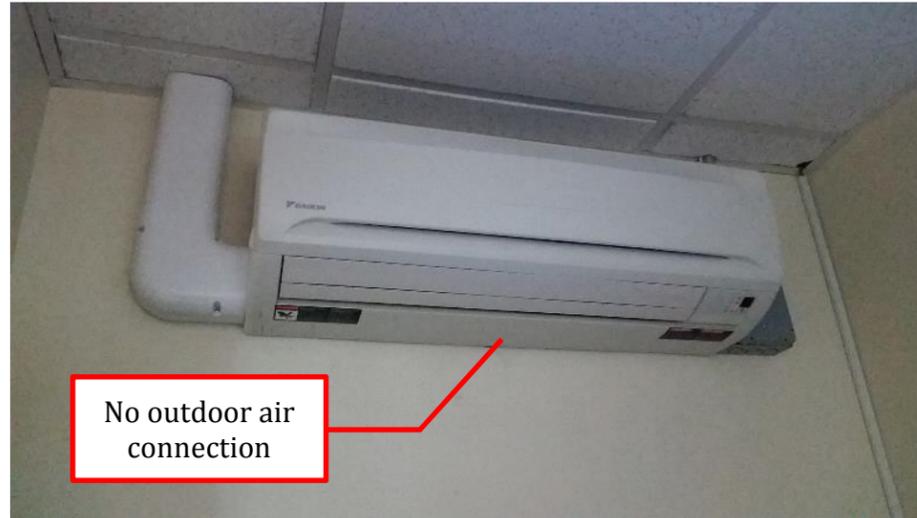
- 5) Observed deficiency: Egress corridor, dispatch room & other connected interior spaces require mechanical ventilation per the New York State Mechanical Code.

Recommended fix: Ventilation could be provided via the VRF make-up air unit described in Mechanical item 3. Ductwork would be distributed to all spaces requiring ventilation.

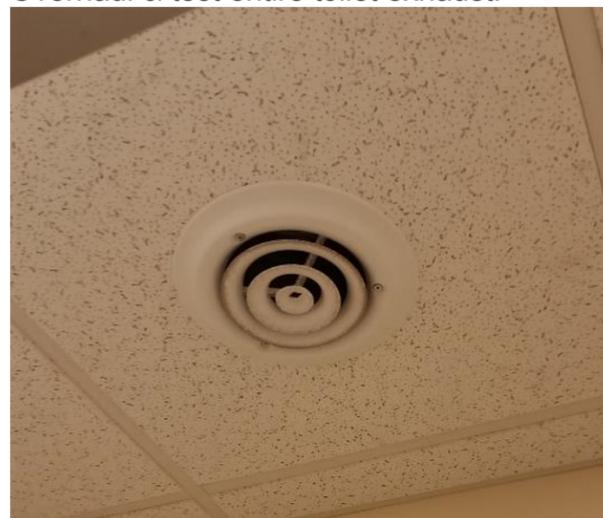
- 6) Observed deficiency: Toilet exhaust grille not functional. Toilet exhaust is required per New York State Mechanical Code. Overhaul & test entire toilet exhaust.

Recommended fix #1: The entire exhaust ductwork system to be surveyed by Cameron Engineering and evaluated for re-use. Portions which are deemed not useful would be replaced.

Recommended fix #2: A new exhaust fan would be installed, see previous Mechanical item 2.

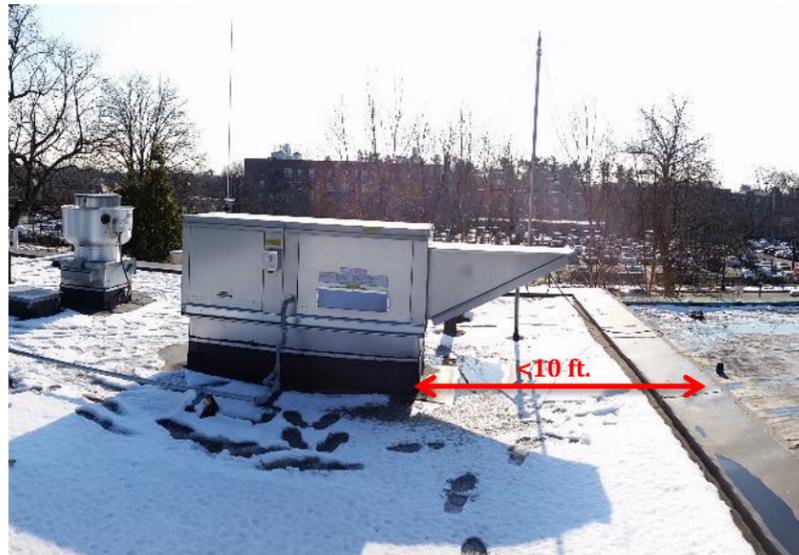
9) Observed deficiency: Make-up air unit less than 10-feet from roof edge, which exceeds 30-inches to adjacent low-roof. OSHA and the New York State Building Code require railing/guard for occupational safety.

Recommended fix: A railing could be installed along the parapet near the make-up air unit. Alternatively, the make-up air unit could be relocated, although this would require modifications to the ductwork in the ceiling below and a new roof penetration.

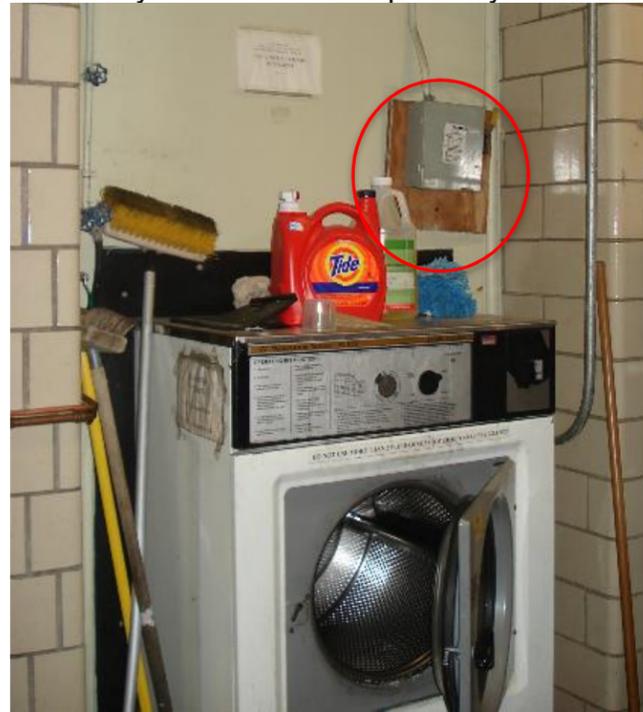
- 2) Observed Deficiency: Disconnect switch above washing machine not readily accessible as required by NEC:

Recommended fix: Relocate switch to readily accessible location near washing machine.

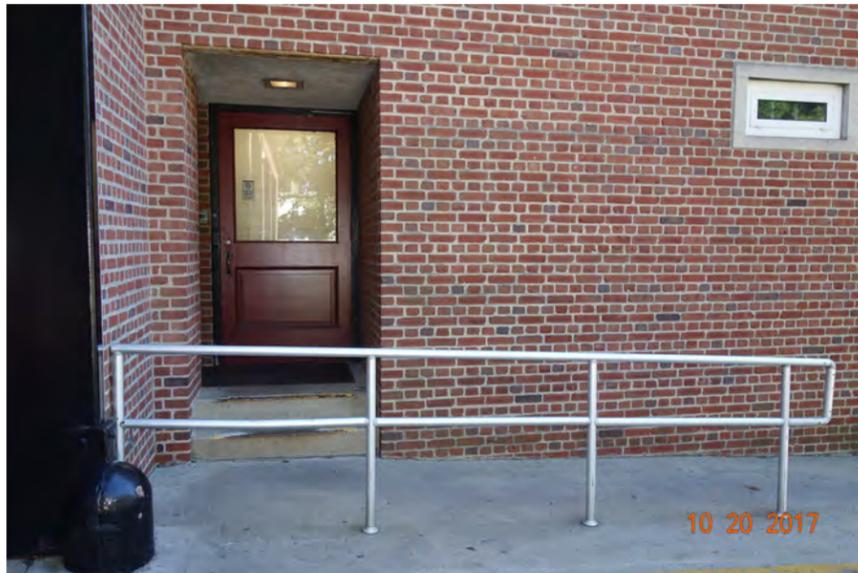
Figure 2.2_1 Exterior Entrance - Walkway Not Accessible

1. Provide new exterior accessible walkway and landing to the First Floor elevation.
2. Modify vestibule walls, doors, and door openings, to provide accessible clearances at the exterior entrance vestibule door.

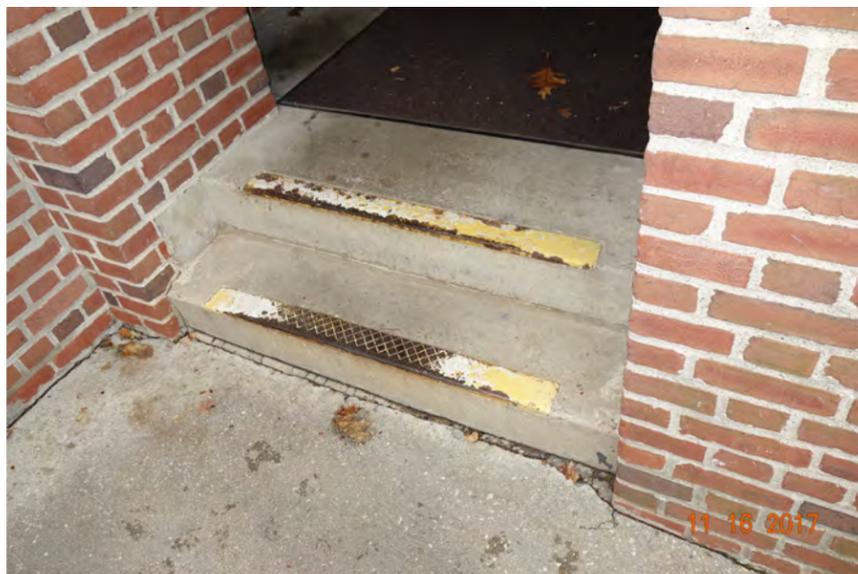
Figure 2.2_2 Exterior Entrance - Steps Not Accessible

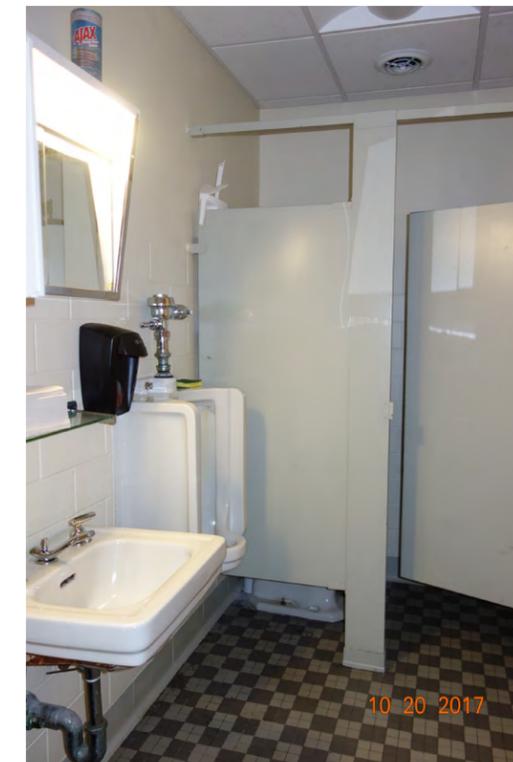
Figure 2.2_3 First Floor Toilet

- **Accessible door clearances** not provided at main entrance vestibule door.
- **Accessible hardware** not provided at main entrance and police station vestibule egress doors.
- **Public toilet room** is not accessible. Accessible fixture and door clearances not provided.

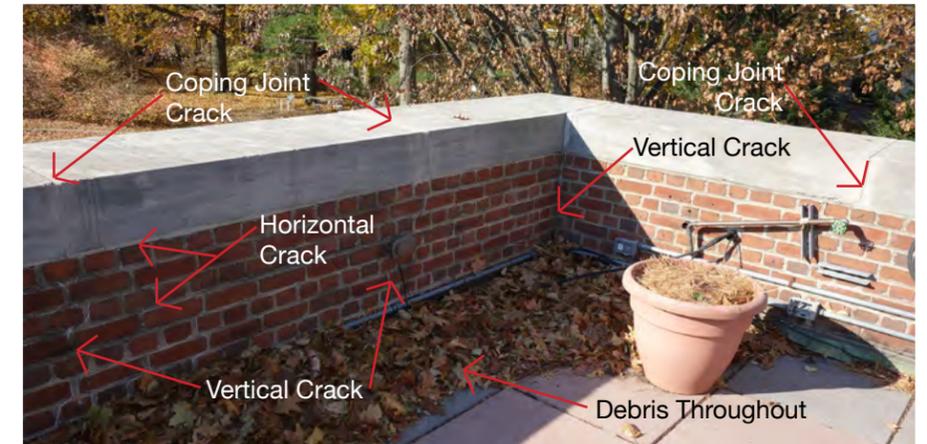
- **Cracks in limestone coping mortar joints** and failed caulked joints have allowed water to infiltrate the wall and roof system.
- **Horizontal cracks** between the limestone coping and brick has allowed water to infiltrate the terrace side and exterior parapet faces. The water then goes through freeze/thaw cycles and has created mortar failures. The cracks are more pronounced on the terrace parapet face.

- **Vertical cracks** are located randomly throughout the parapet and also generally align under the coping stone joint. Water infiltration and possible thermal movement, especially on the North-South facing parapet walls, have caused differential movement in the parapet.

Figure 2.3_4 Parapet Wall - Northwest Corner - Horizontal & Vertical Cracks

1. **Option 1:** Demolish the parapet and rebuild it with proper detailing: coping stone securement, flashing, adequate drip edge, and wall expansion joints. All cracks should be repaired. Option 1 is a long term solution to the water infiltration problem.
2. **Option 2:** Remove and reset the existing coping stone to address failure issues. Provide proper flashing and reset the stone so it has an adequate drip edge. In areas of minor cracking the brick should be re-pointed. In areas of medium severity cracking new brick should be stitched in. In areas of severe cracking the wall should be rebuilt. Control joints should also be installed as needed to address thermal movement. Although Option 2 is less costly, it may only be a short to moderate term solution.

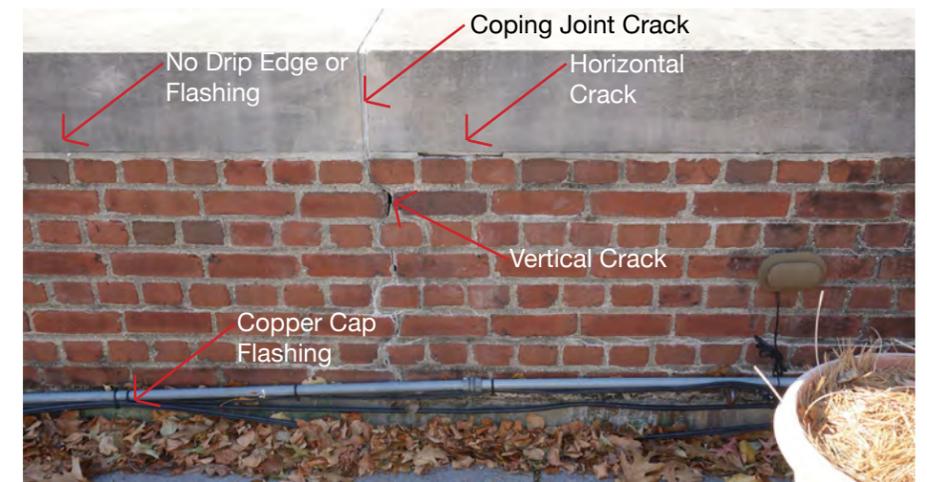
Figure 2.3_5 Parapet Wall - North - Horizontal & Vertical Cracks

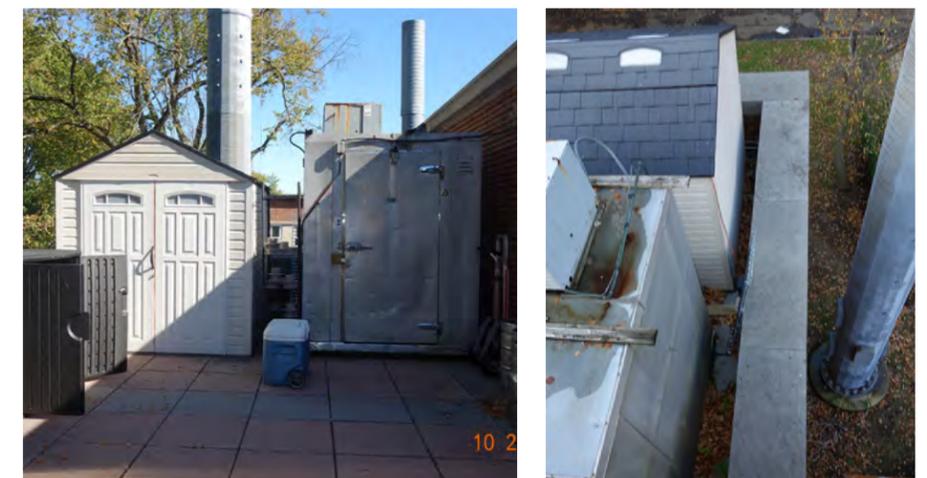
- **Copper cap flashing** is visible, but the embedment into the brick is unknown.
- **Storage shed and Cooler unit** are located close to the parapet wall and is trapping moisture near the wall.

Figure 2.3_6 Parapet Wall - East - Storage Shed & Cooler Unit

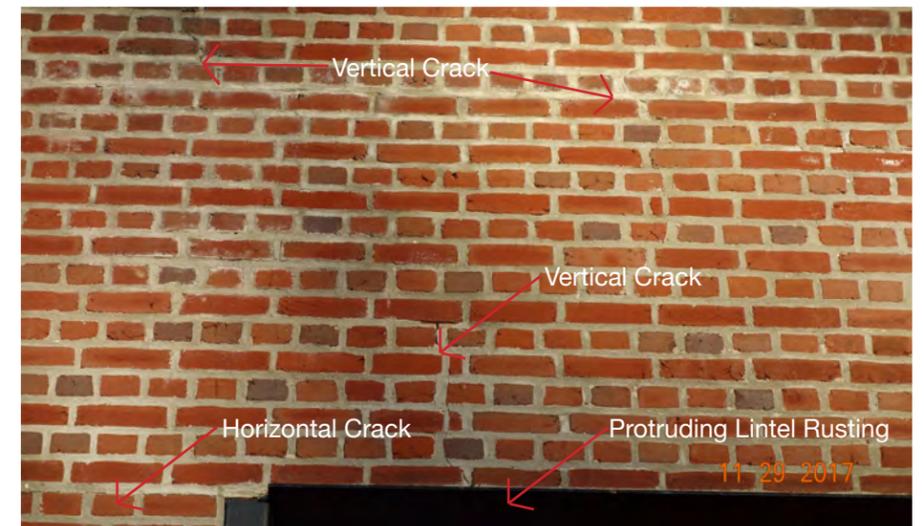
- **Horizontal and vertical cracking** along the lintel line from the Apparatus door opening up to the Parapet Wall and between door openings. The cracks and movement in the wall are related to the lintel.
- **Lintels** above the Apparatus doors project beyond the brick face, holding water, causing rust and causing the lintels to corrode and expand.
- **Water infiltration from parapet** allows water to hit the steel lintels, deteriorate and rust.

Figure 2.3_9 Front (West) Facade - Horizontal & Vertical Cracks, Lintel Rusting

1. Replace the window lintels with new hot dipped galvanized lintels and provide proper flashing and weep holes.
2. Windows should be replaced to meet the current NYS Energy Conservation Code.

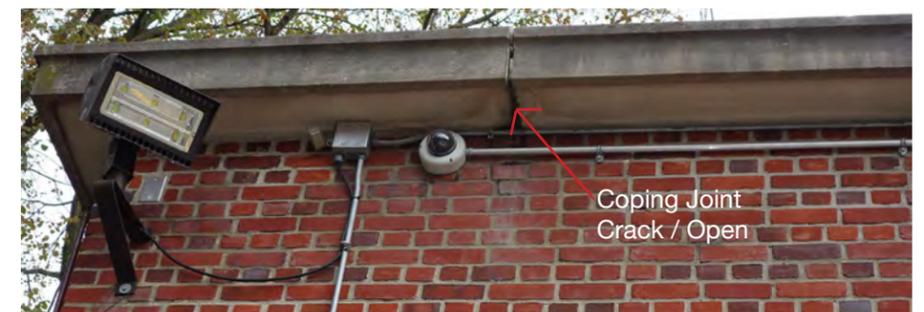
Figure 2.3_10 Front (West) Facade - Open Coping Stone Joint

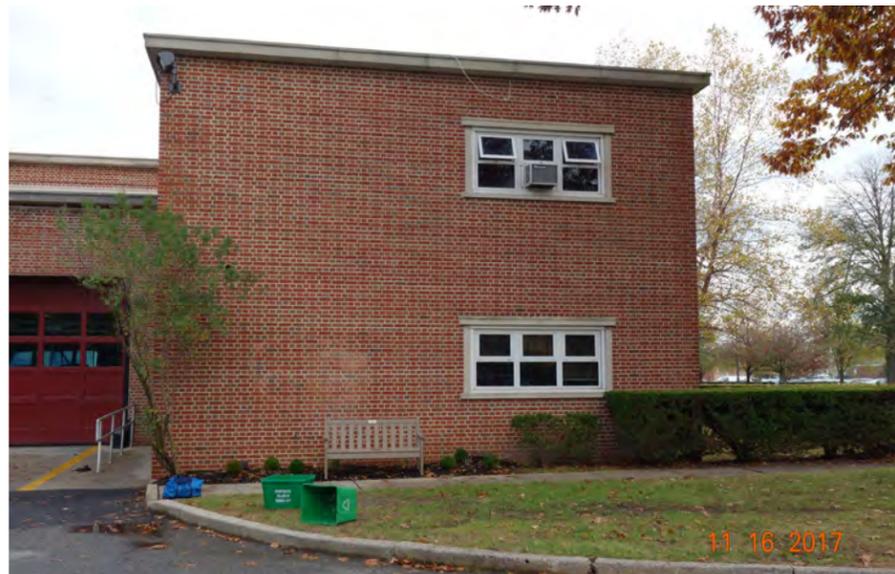
- The facade has been previously **completely re-pointed**.
- **New cracking** is evident, which is most likely due to the failed roof above and open coping stone joints.

Figure 2.3_11 Front (South-West) Facade - Re-pointed with New Cracks

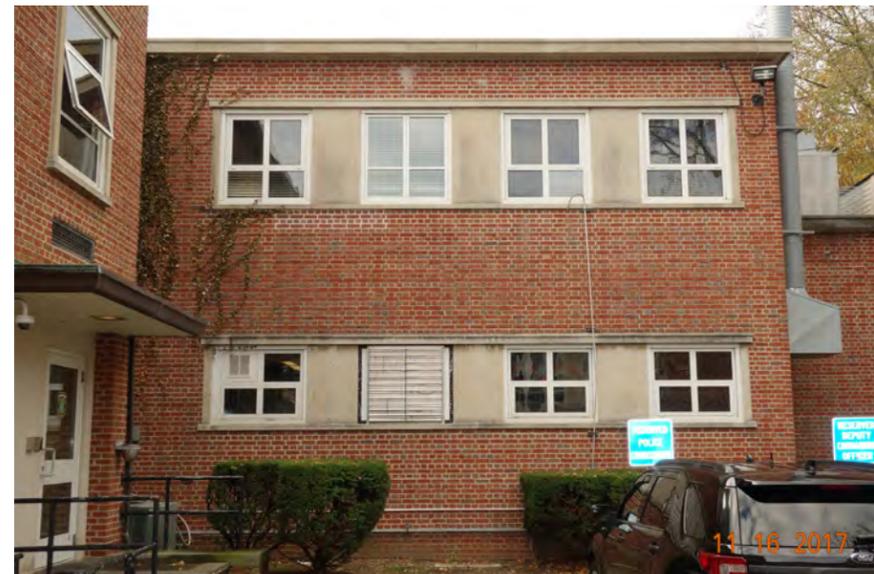
- **Limestone window surround joints** are open, allowing water to infiltrate and cause the lintels to rust and crack the limestone in places.
- **All coping stone joints** are severely worn, cracked or open and failing.

Figure 2.3_13 East Facade - Coping & Limestone Surround Open Joints

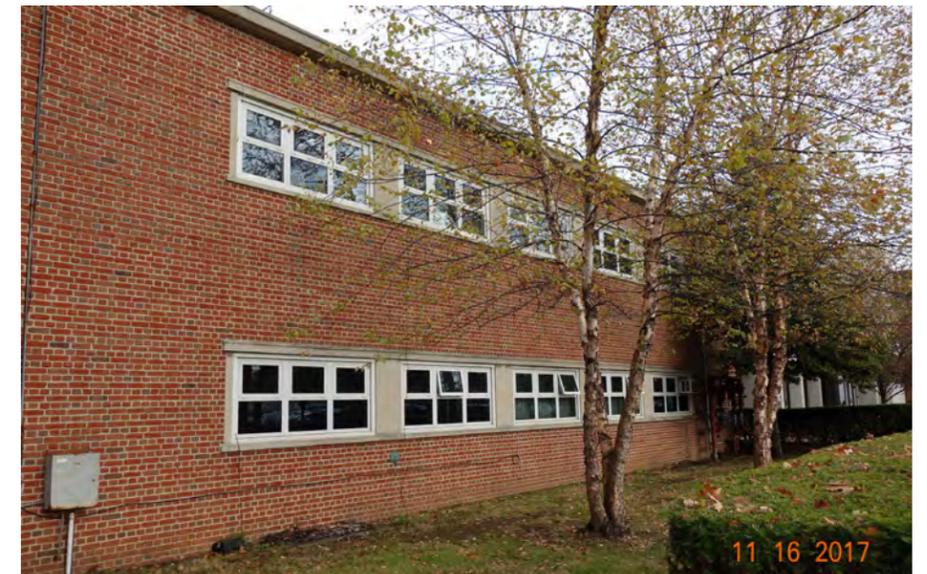
Figure 2.3_15 South Facade - Coping & Limestone Surround Open Joints

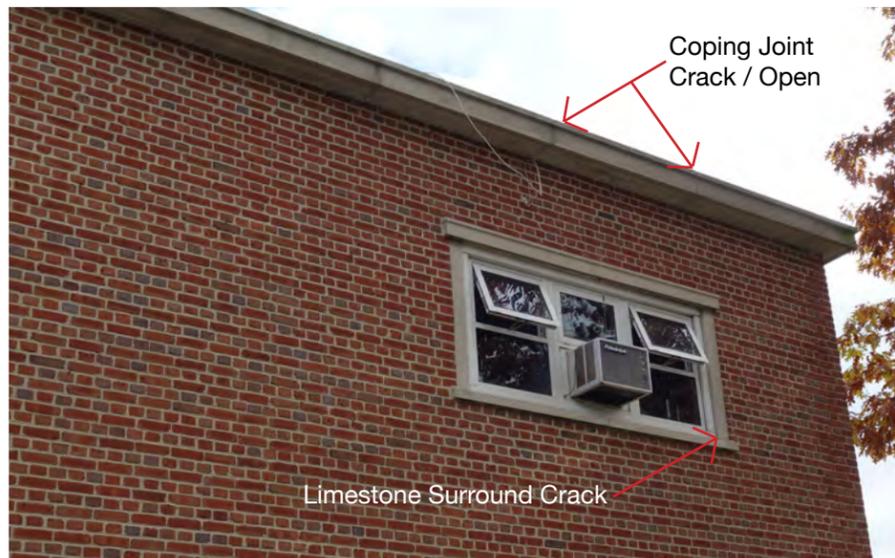
Figure 2.3_12 Front (South-West) Facade - Coping & Limestone Surround

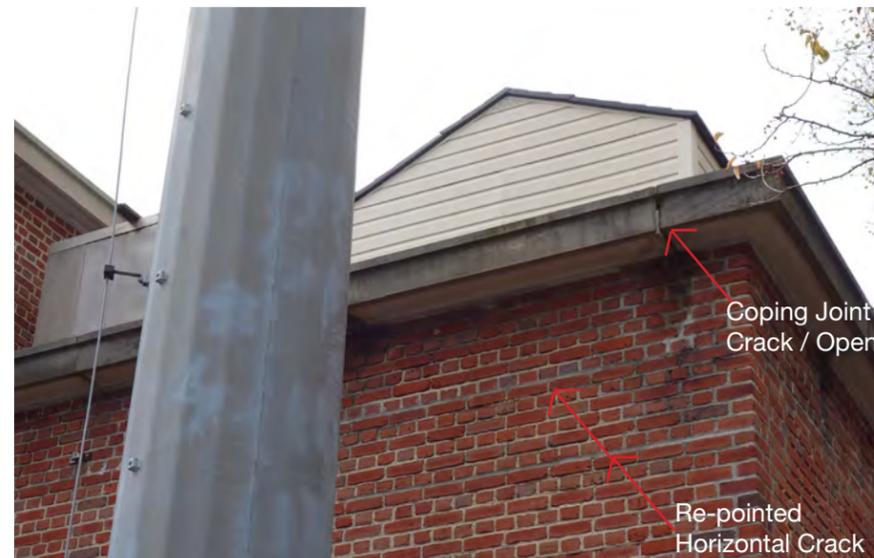
Figure 2.3_14 East Facade - Coping Stone Open Joints

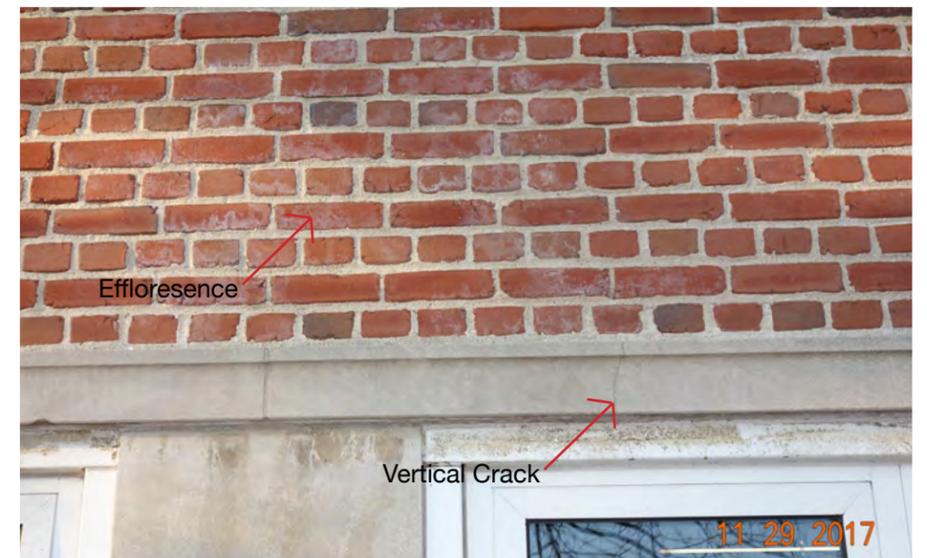
Figure 2.3_16 South Facade - Limestone Surround Open Joints

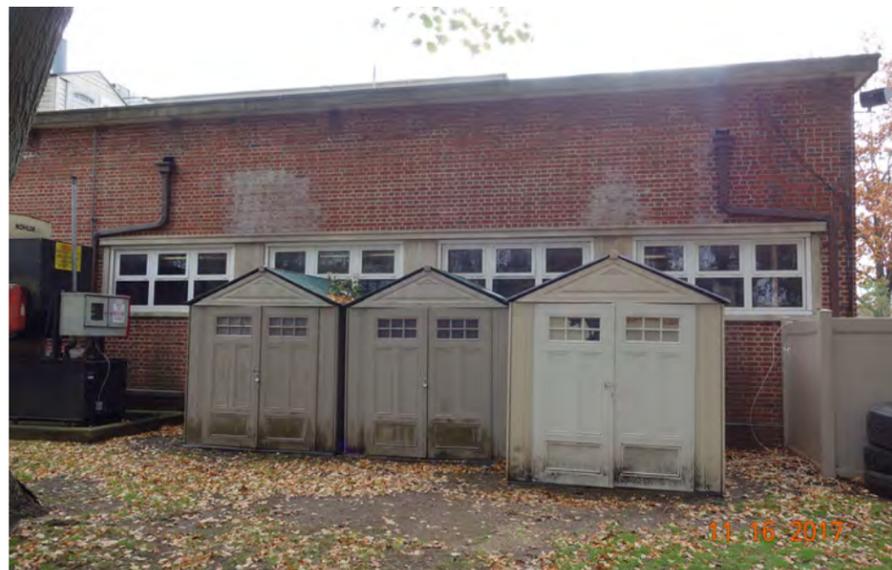
- **Storage Sheds** located right against the Facade are not allowing wall to dry out, trapping moisture.
- **Duct penetration** does not appear to be properly flashed as there is water staining below the penetration. There also may not be a lintel.

Figure 2.3_17 North Facade - Storage Sheds

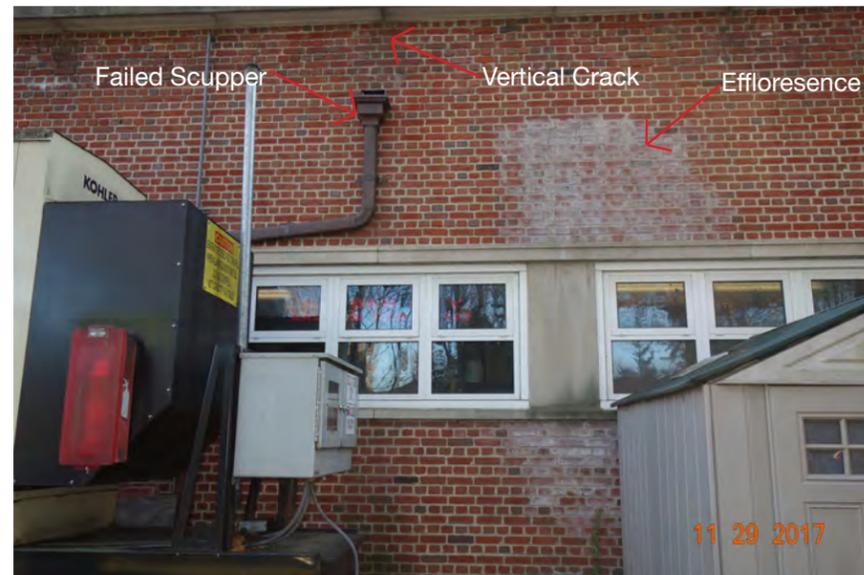
Figure 2.3_18 East Facade - Efflorescence, Cracking, Scupper

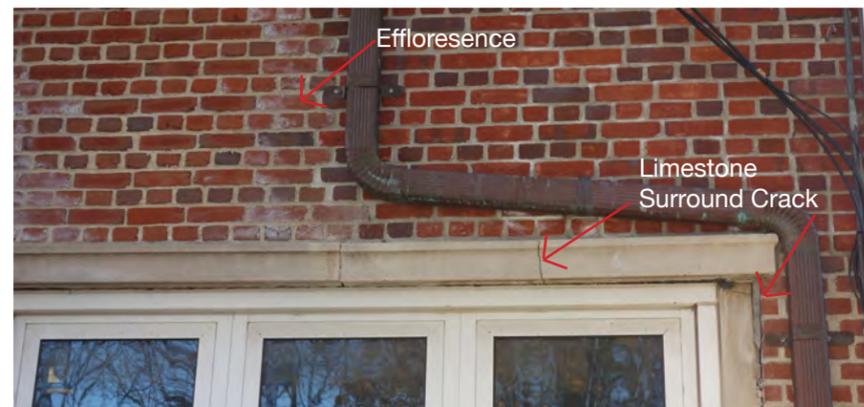
Figure 2.3_19 East Facade - Limestone Surround Cracks, Efflorescence

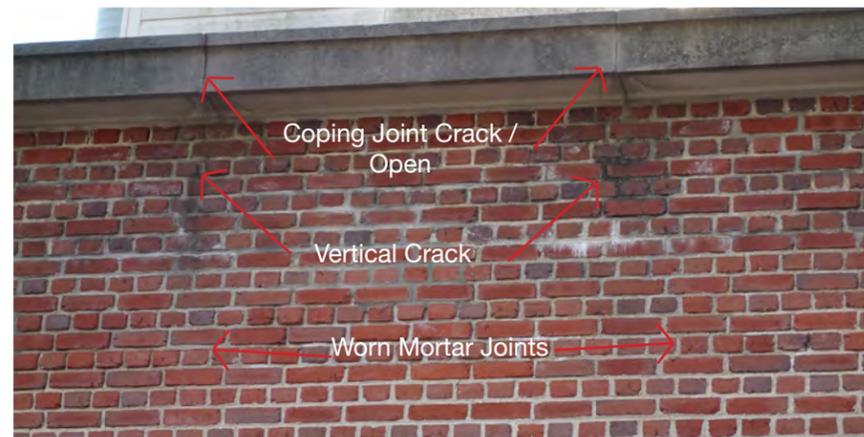
Figure 2.3_20 East Facade - Coping Stone Open Joints, Cracks, Worn Joints

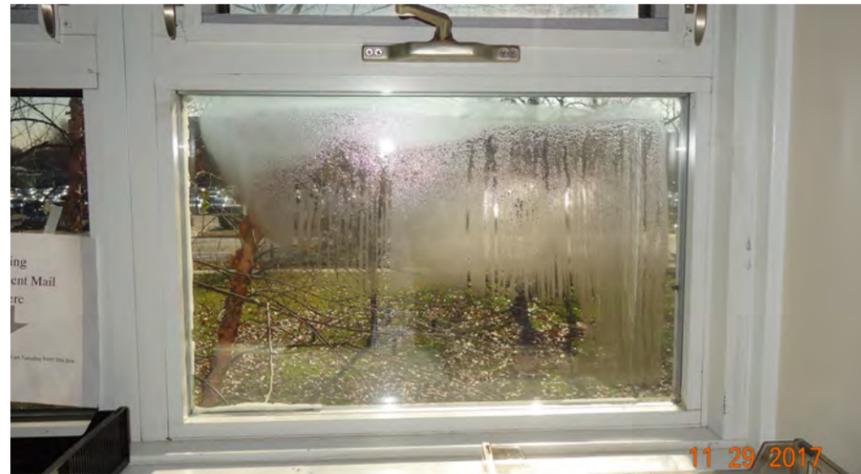
Figure 2.3_21 South Facade - Failed Insulated Glass Unit, Condensation

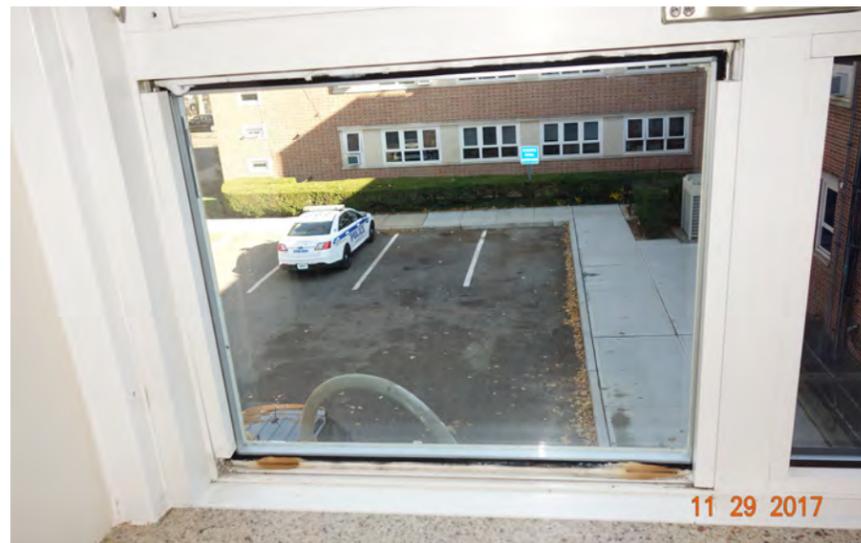
Figure 2.3_22 East Facade - Aluminum Stops Missing

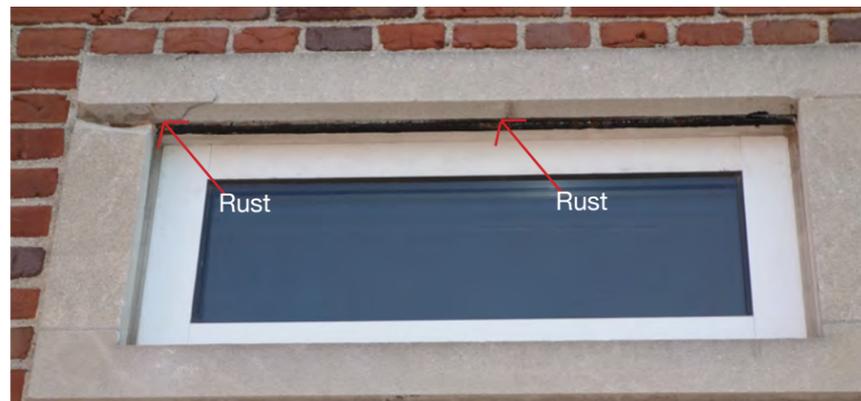
Figure 2.3_23 North Facade - Lintel Paint Deterioration & Rust

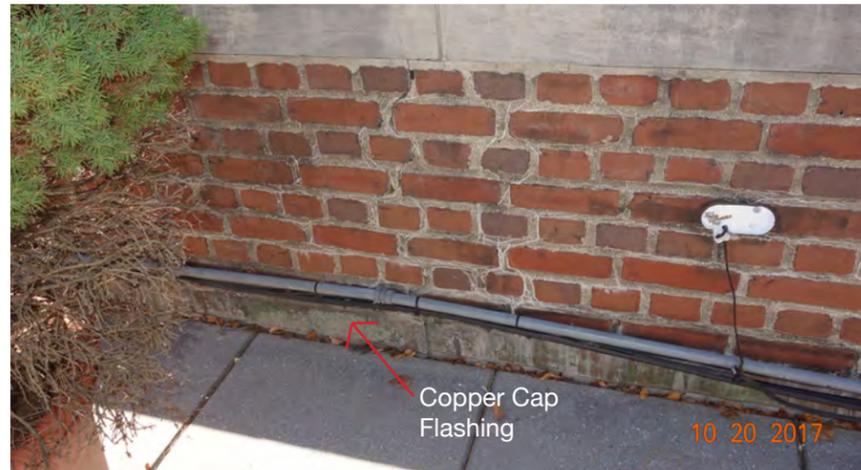
- **Copper coping stone flashing** is beyond its useful life and no expansion joints were provided.
- **Base Flashing** at curbs and the coping stone are beyond their useful life. Flashing repairs have poor workmanship and quality. Ponding at base in areas.

Figure 2.4_1 Rooftop Terrace - Copper Cap Flashing Beyond Useful Life

1. **Rooftop Terrace:** New base and cap flashing should be provided. This work should be performed with the overall roofing system, parapet wall, and scupper repairs.
2. **Lower Roof:** New base flashing should be provided. The pitch of the roofing materials should not allow water and snow to pond at the base of curbs, etc. New coping stone flashing should be provided with proper detailing to allow for expansion and contraction. This work should be performed with the overall roofing system and limestone coping stone repairs.
3. **Upper Roof:** Repair flashing.

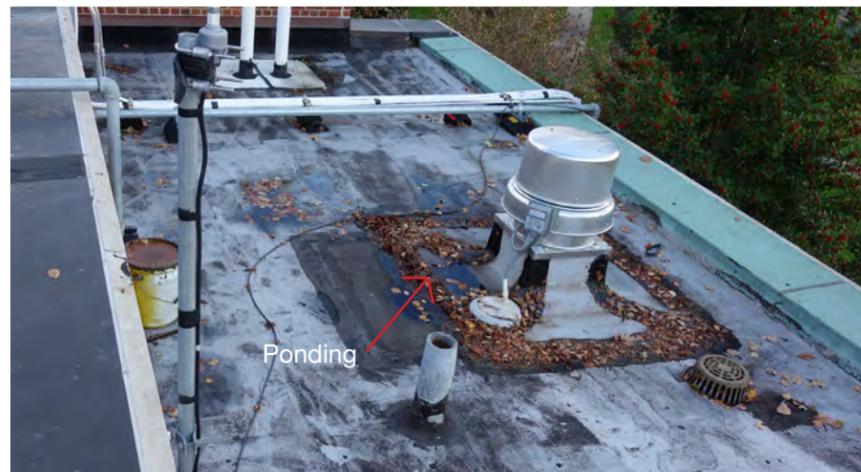
Figure 2.4_2 Lower Roof - Base Flashing Ponding & Poor Condition

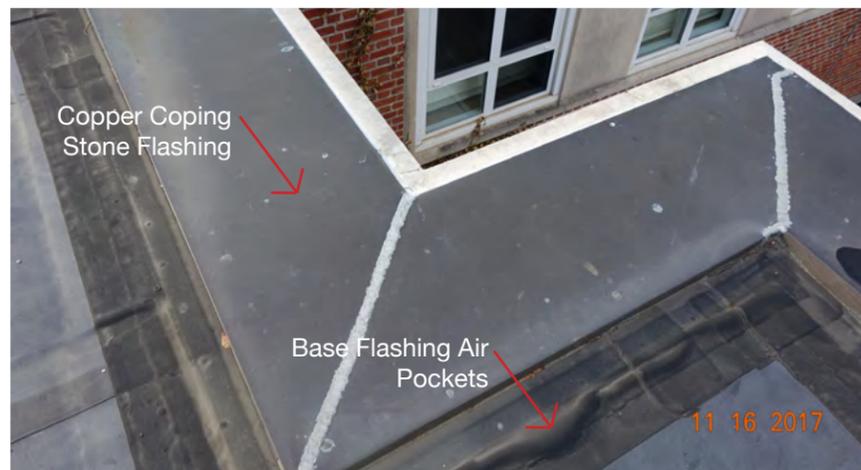
- **Copper coping stone flashing** appears to have been replaced relatively recently, but no expansion joints were provided. Some ponding on top of copper coping stone flashing.
- **Base Flashing** at curbs and the coping stone appear to have been replaced relatively recently. Some air pockets are visible along the perimeter base flashing.

Figure 2.4_3 Upper Roof - Copper Coping Stone Flashing - No Exp. Joints

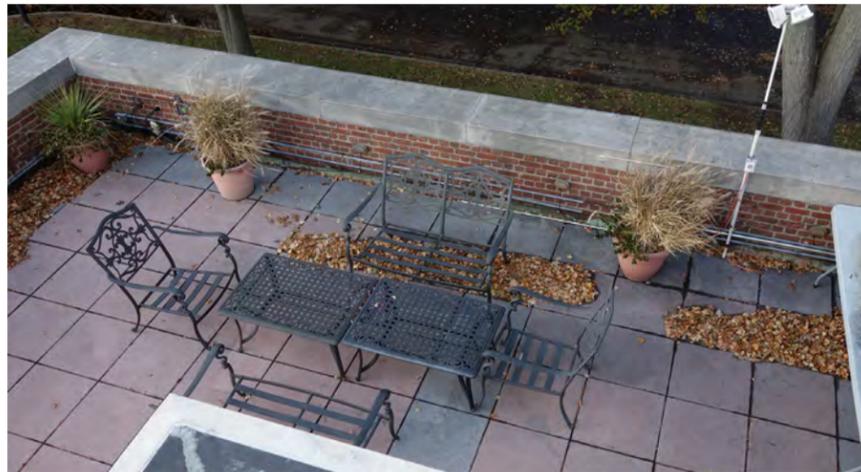
- **Paver Pedestal System** is difficult to maintain and clean out debris under pavers. One paver is cracked.
- **Roofing materials** under paver system is unknown. There is a black fabric felt applied loosely under pavers.

Figure 2.4_4 Rooftop Terrace - Pavers

1. **Rooftop Terrace:** A new liquid-applied fleece-reinforced roofing system is recommended. This system can be walked upon to avoid pavers and their difficult maintenance.
2. **Lower Roof:** A new multi-ply SBS-Modified Bitumen roofing system is recommended. This work should be performed with the limestone coping stone repairs.
3. **Upper Roof:** Repair roofing in areas of ponding.

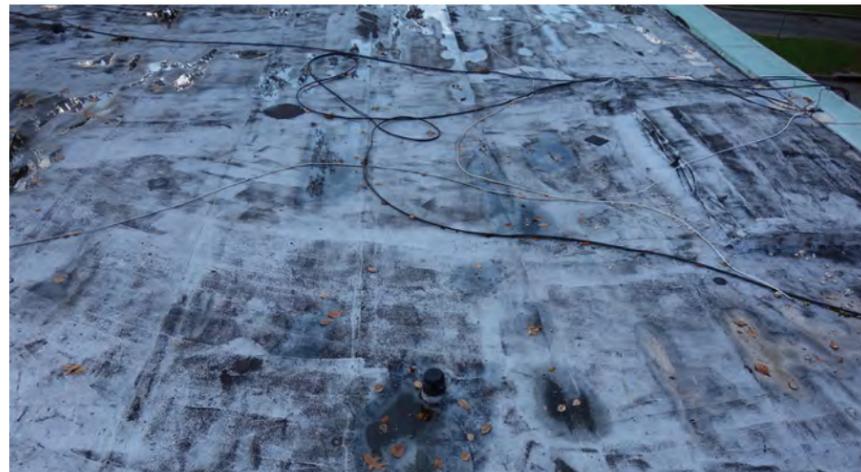
- **Roofing materials** are beyond its useful life and poor condition. Ponding throughout roof.

Figure 2.4_5 Lower Roof - Poor Condition & Ponding

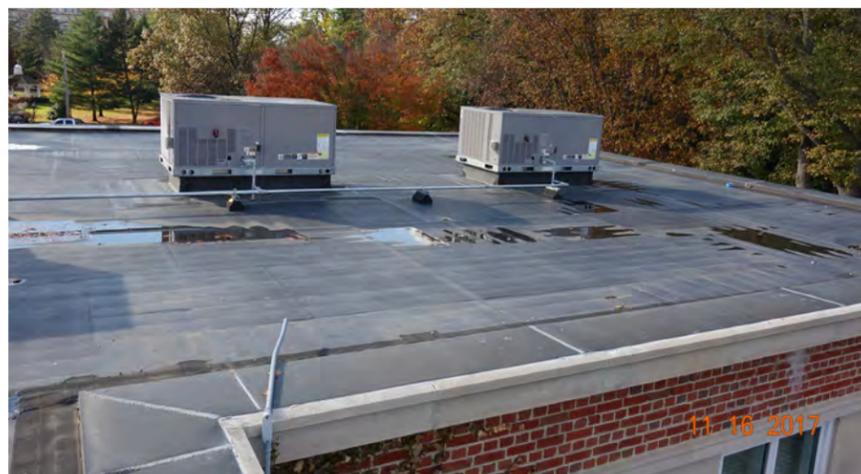
- **Roofing materials** appears to have been replaced relatively recently and in fair condition. Ponding in two areas of the roof.

Figure 2.4_6 Upper Roof - Relatively New & Fair Condition

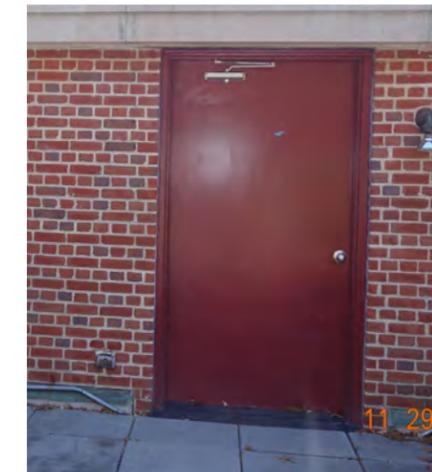
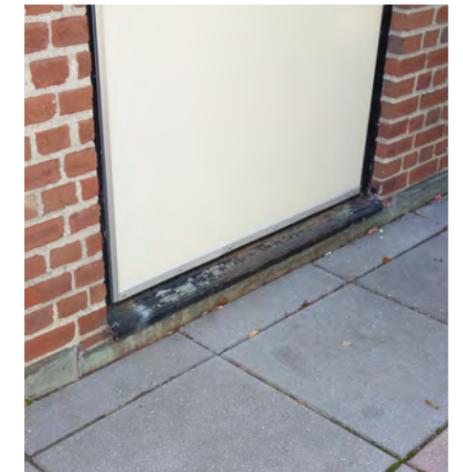
- The **height** of the Meeting Room door sill is very low relative to the pavers and the Egress Stair door sill aligns with the pavers. Water and snow that accumulates at the Terrace level may infiltrate into the Meeting Room and Stair.
- If the **new insulation** and roofing level is higher than the sills, the doors will have to be modified.

Figure 2.4_7 Rooftop Terrace - Egress Stair (left) & Meeting Rm (right)

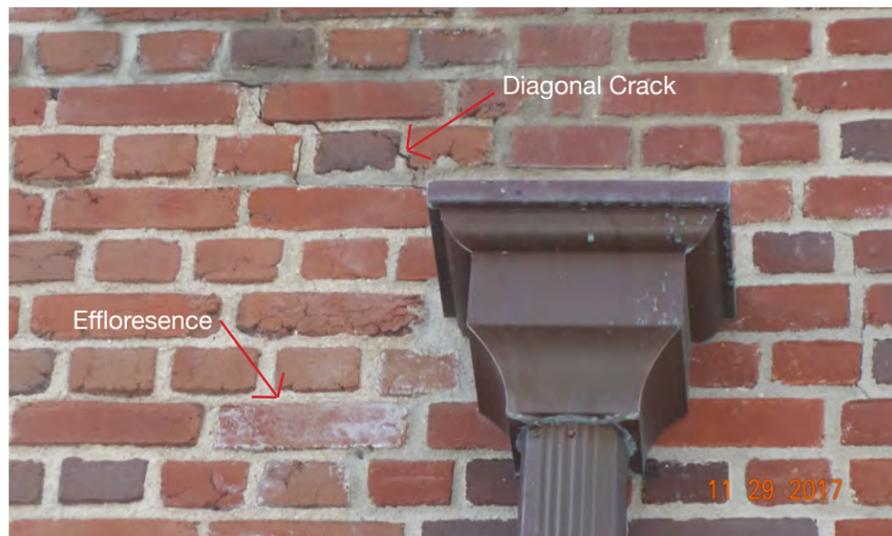
- **Debris** is accumulating under the pavers and throughout the paver surface and joints. This is most likely inhibiting proper drainage to the scuppers.
- **Scuppers and conductor heads** from the Roof Terrace above are not properly flashed, may be clogged with debris and are allowing water to infiltrate the wall. This is causing efflorescence and cracks.

Figure 2.4_8 Scupper - Efflorescence & Cracks at Scupper

1. **Rooftop Terrace:** New scuppers, conductor heads, and downspouts should be provided. Scuppers to be properly flashed and waterproofed. The new roofing system should be pitched for positive drainage to the new scuppers. This work should be performed with the roofing repairs. Please see roofing material recommendations.
2. **Lower Roof:** Provide new roof drains. This work should be performed with the roofing repairs. Please see roofing material recommendations.
3. **Upper Roof:** Repair roof pitch and taper at areas of water ponding. Provide new roof drain cover.

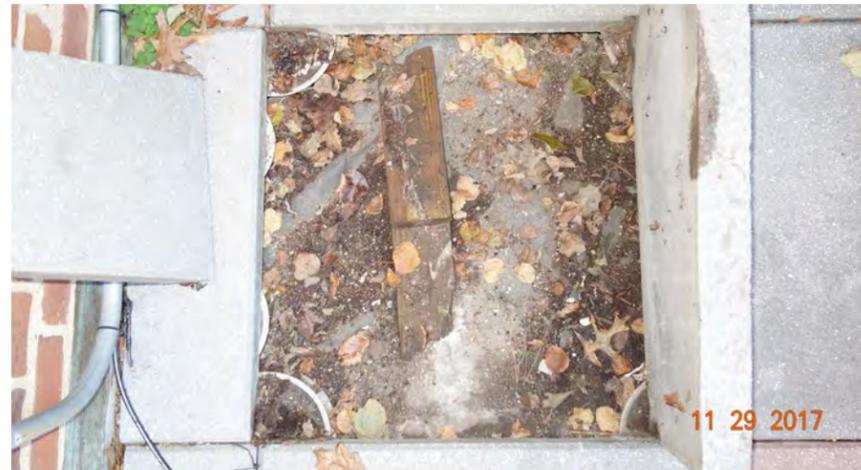
Figure 2.4_9 Rooftop Terrace - Debris under Paver

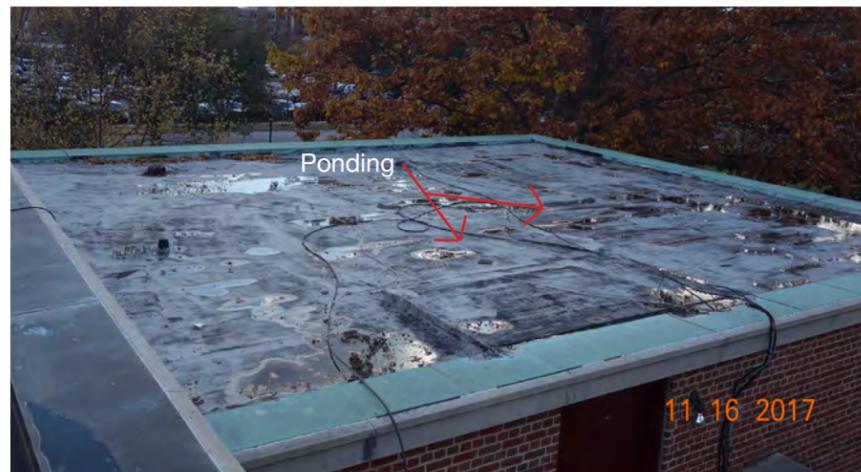
Figure 2.4_10 Lower Roof - Inadequate Pitch to Drains & Water Ponding

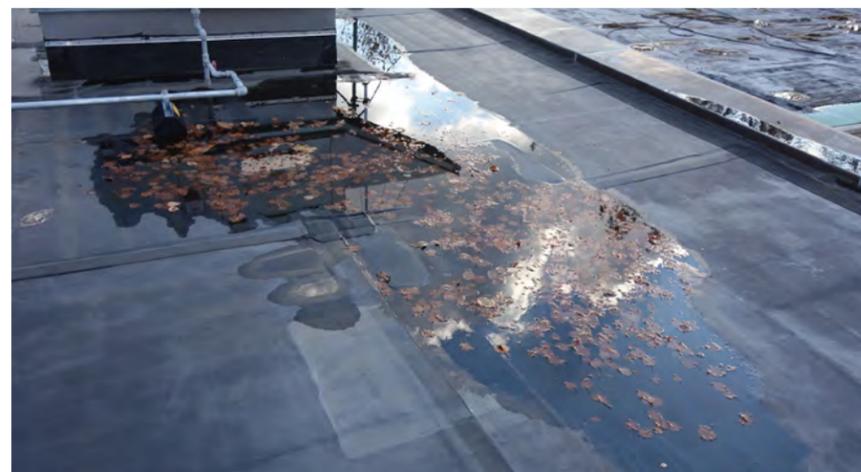
- The **roof pitch** is not allowing for adequate drainage in some areas of the roof. Ponding in two areas of the roof.
- A roof drain cover is missing on one of the drains.

Figure 2.4_11 Upper Roof - Water Ponding in Areas
