Garden City
Fire Department

Firehouse #1, #2 & #3

Existing Conditions
Documentation & Recommendations
DRAFT

February 2, 2018

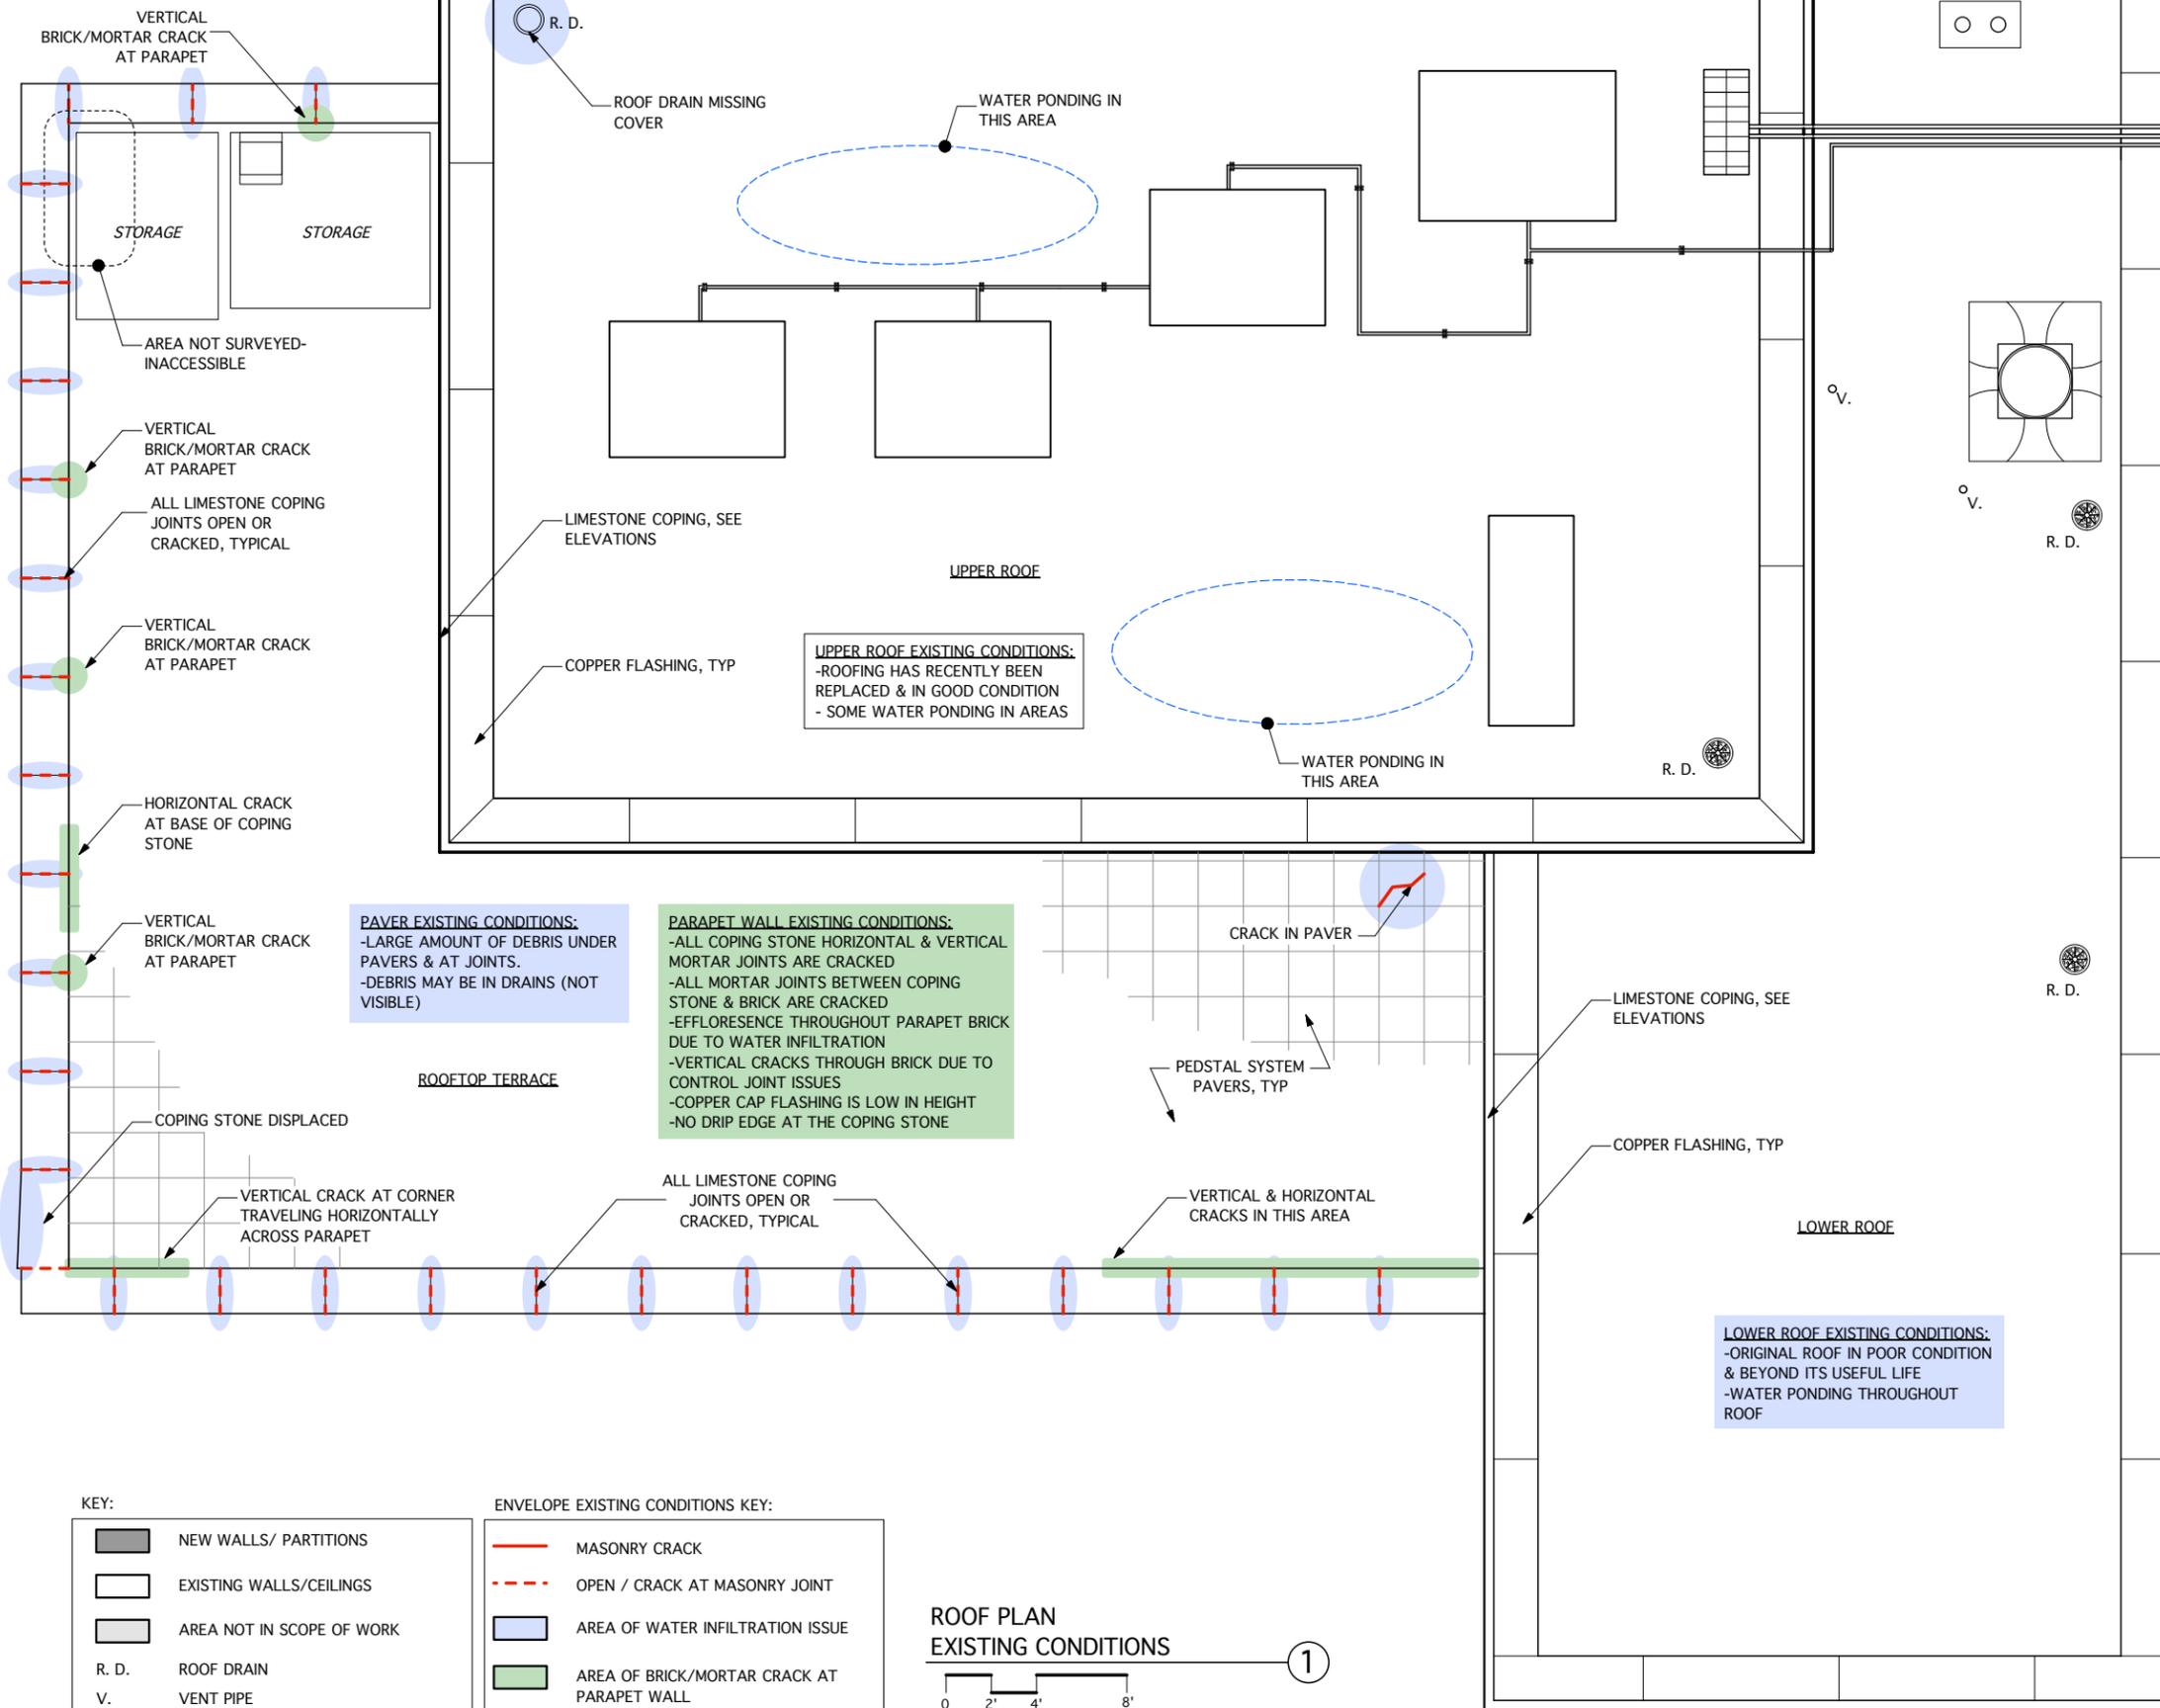
**ROOF PLAN
EXISTING CONDITIONS**

PAVER EXISTING CONDITIONS:
 -LARGE AMOUNT OF DEBRIS UNDER PAVERS & AT JOINTS.
 -DEBRIS MAY BE IN DRAINS (NOT VISIBLE)

PARAPET WALL EXISTING CONDITIONS:
 -ALL COPING STONE HORIZONTAL & VERTICAL MORTAR JOINTS ARE CRACKED
 -ALL MORTAR JOINTS BETWEEN COPING STONE & BRICK ARE CRACKED
 -EFFLORESCENCE THROUGHOUT PARAPET BRICK DUE TO WATER INFILTRATION
 -VERTICAL CRACKS THROUGH BRICK DUE TO CONTROL JOINT ISSUES
 -COPPER CAP FLASHING IS LOW IN HEIGHT
 -NO DRIP EDGE AT THE COPING STONE

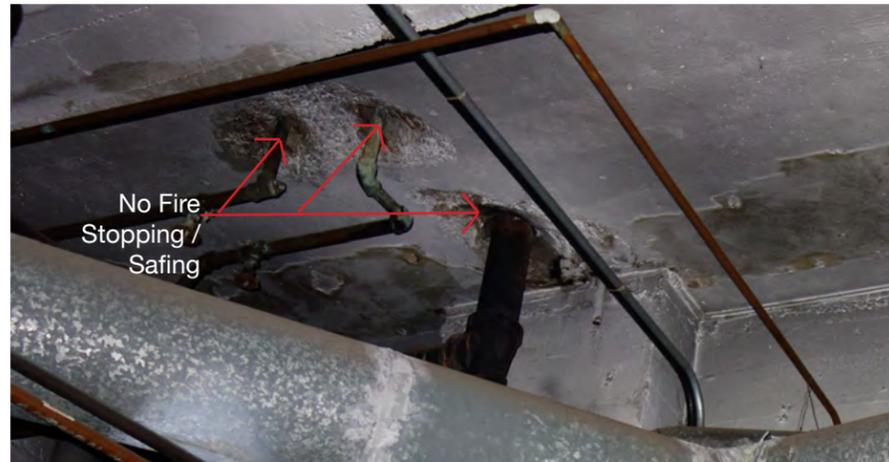
Figure 2.1_1 Basement - Pipe Penetrations Code Violation

1. All pipe penetrations should be fire stopped and fire safed to maintain fire rated construction
2. Repair First Floor structural concrete slab. Repair details to be prepared by the Structural engineer.

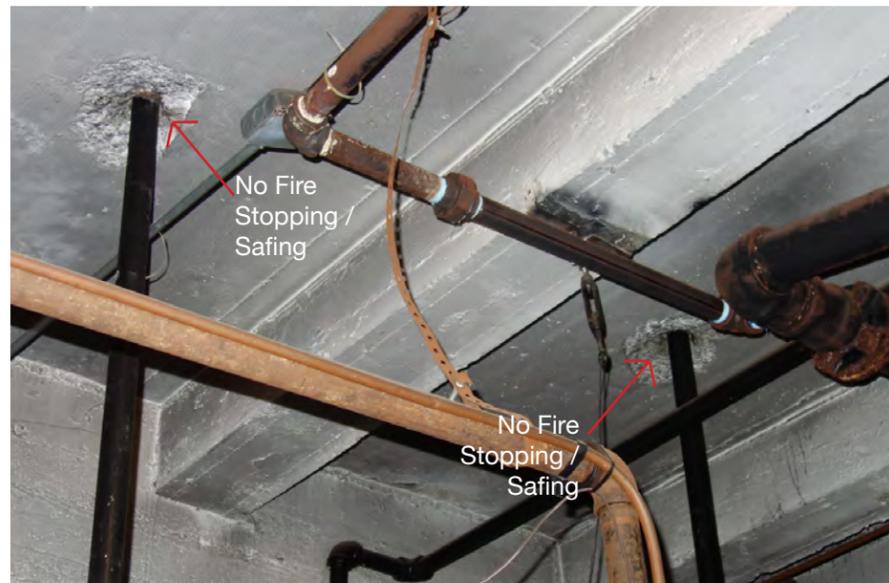
Figure 2.1_2 Basement - Pipe Penetrations Code Violation

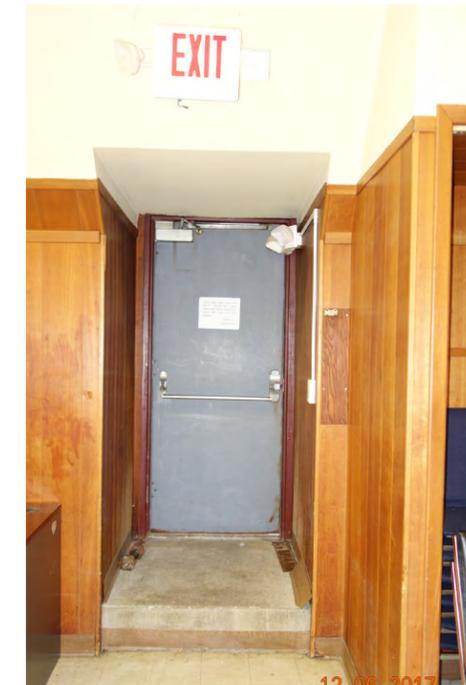
Figure 2.1_6 Meeting Room Egress Step

1. Provide new egress stair from Meeting Room to meet Code requirements to replace the exterior metal stair. (Option B)
2. Provide new Second Floor egress stair in Tower to meet Code requirements.
3. Remove exterior dormer to provide clear access to egress door from Meeting Hall to Tower egress stair.
4. Remove step and modify elevation change configuration of path of egress out of Meeting Hall to meet Code requirements.
5. Provide exit signs at the Apparatus Room and Hall doors.

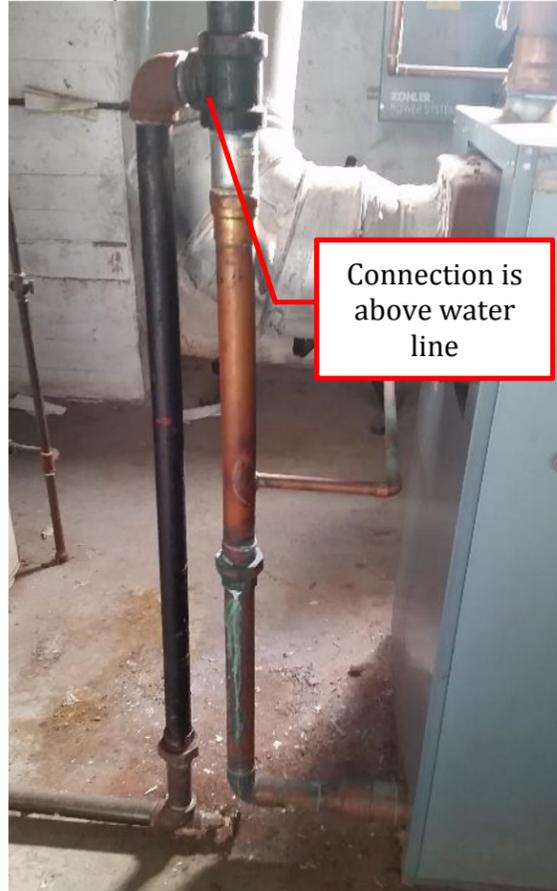
- 1) Observed deficiency: Hartford steam connection at boiler not code compliant. The connection is above the boiler water line.

Recommended fix: The Hartford connection could be relocated to 2" below the boiler water line as per New York State Mechanical Code.

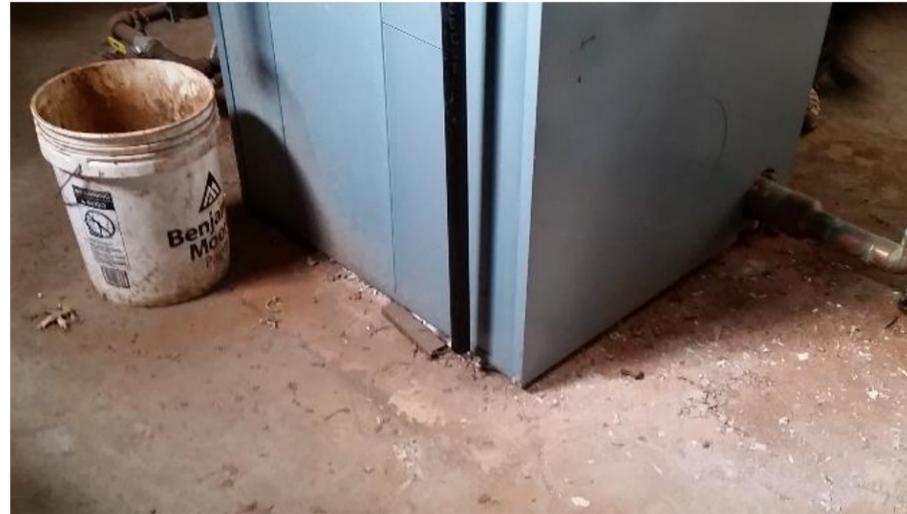
- 3) Observed deficiency: Equipment (boiler, water heaters, etc.) not mounted on required concrete housekeeping pads per New York State Mechanical Code:

Recommended fix: Equipment must be disconnected and temporarily removed so that new 4-inch high (minimum) concrete housekeeping pads may be installed to raise mechanical equipment for proper drain-down and maintenance. Housekeeping pads to extend a minimum of 3-inches beyond the extents of the equipment on all sides.

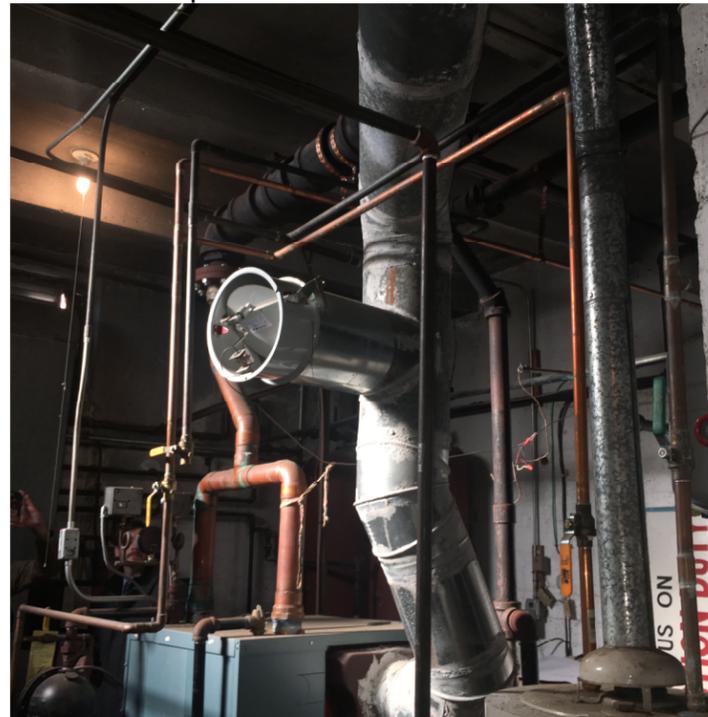
- 2) Observed deficiency: Cold and hot water piping not insulated in uninsulated spaces.

Recommended fix: All water piping should be cleaned and thermally insulated in accordance with Table C403.2.10 of the New York State Energy Conservation Code.

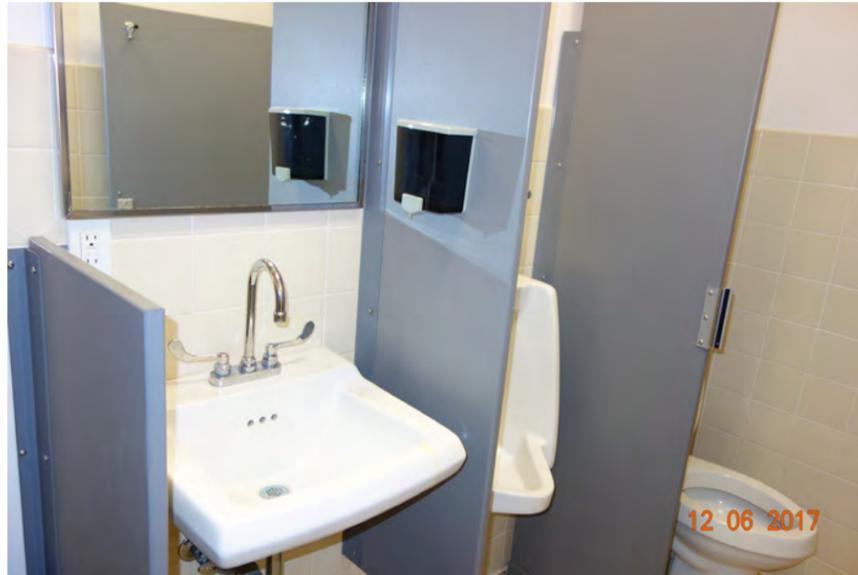
- **Men’s and Women’s** bathrooms are not accessible. Accessible fixture and door clearances not provided.
- **No accessible access** provided for public Meeting Room.

Figure 2.2_2 Second Floor Men’s Bathroom

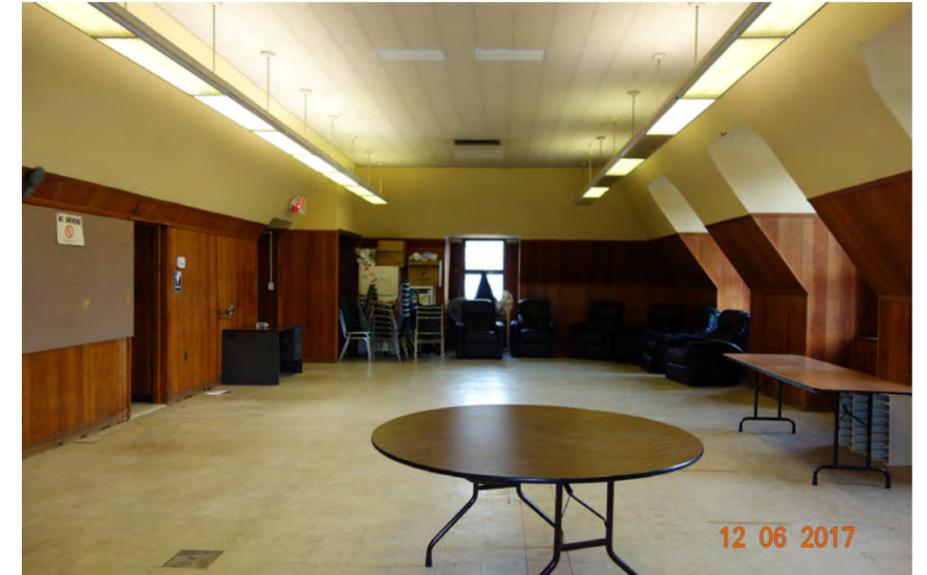
Figure 2.2_4 Second Floor Meeting Hall

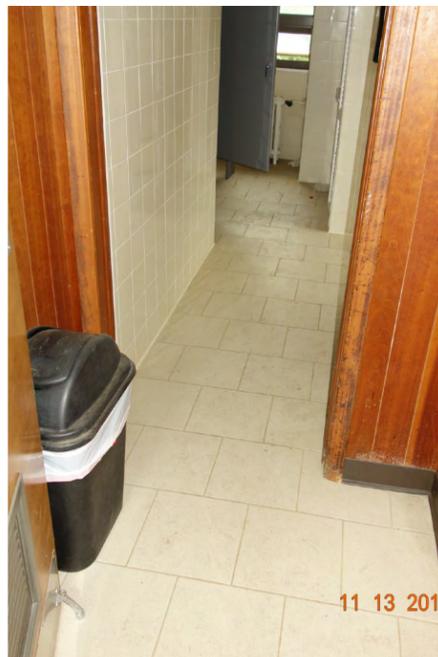
Figure 2.2_1 Second Floor Women’s Bathroom

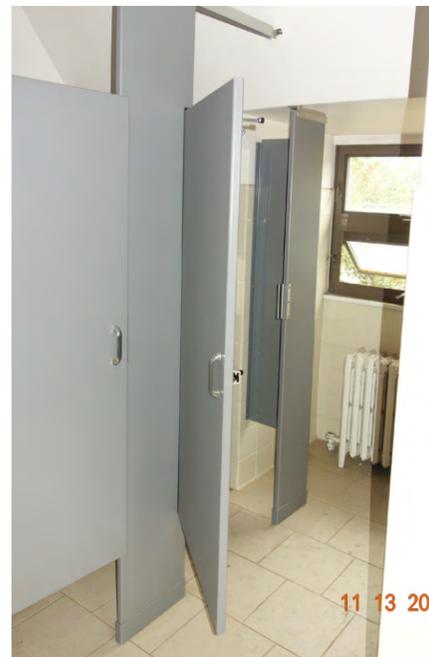
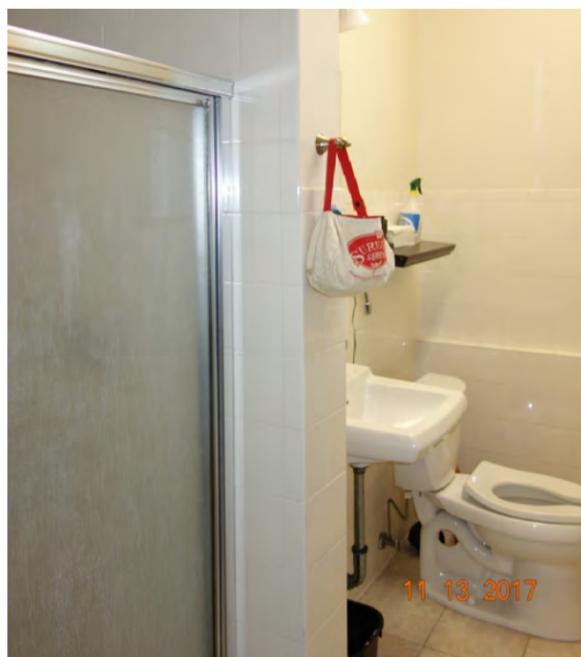
Figure 2.2_3 First Floor Toilet Room

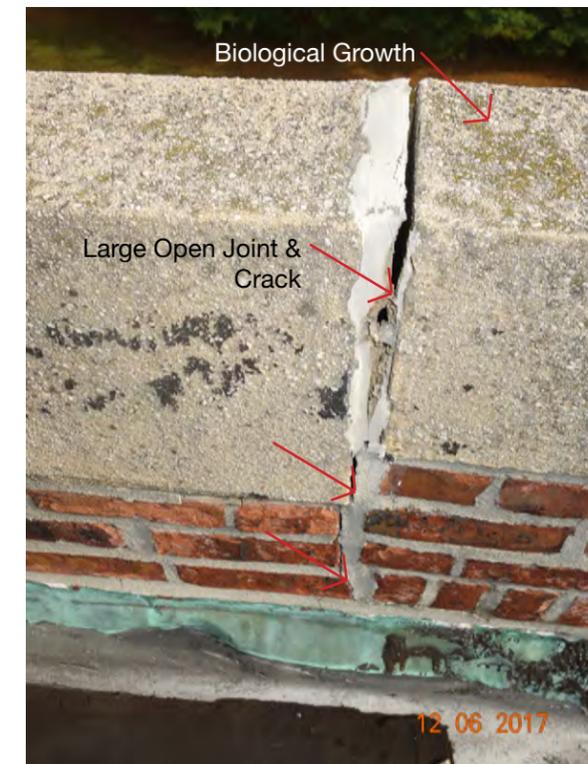
Figure 2.3_4 Parapet Wall - Coping Stone Crack & Open Joint

- **Re-pointed joints** have cracked and have not arrested the brick and cast stone failures.
- **Crack at underside of concrete deck**, between concrete deck edge and brick wall.

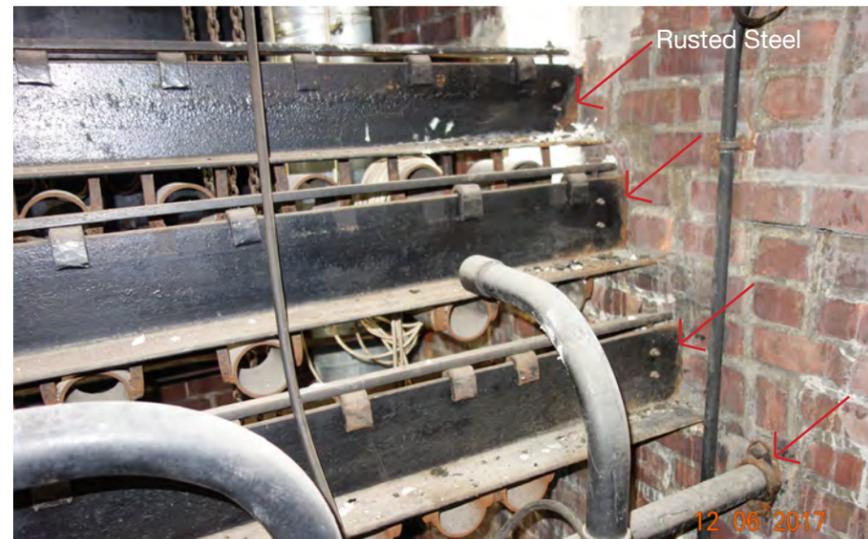
Figure 2.3_5 North Tower Wall - Rusted Hose Hoisting Steel

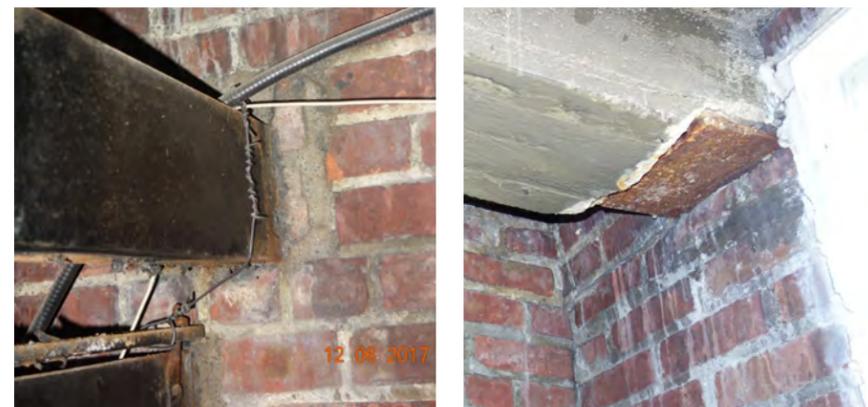
Figure 2.3_6 Hose Hoisting Steel (left), Concrete Encased Steel Beam (right)

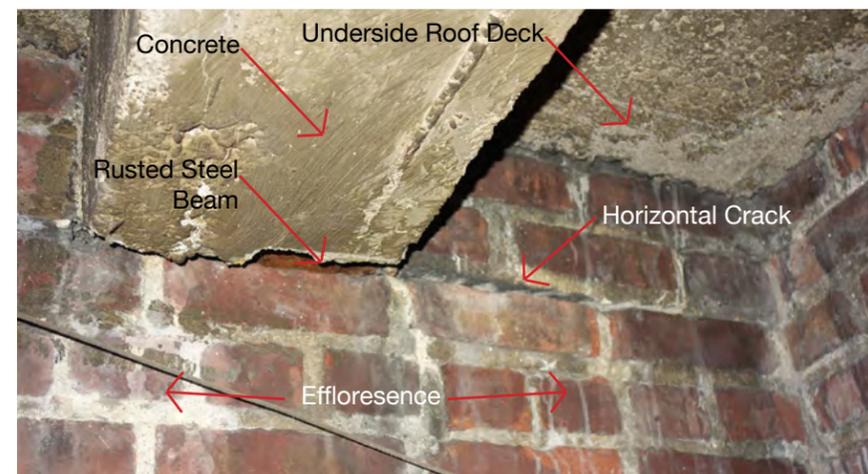
Figure 2.3_7 Rusted Steel Beam Plate & Horizontal Cracks

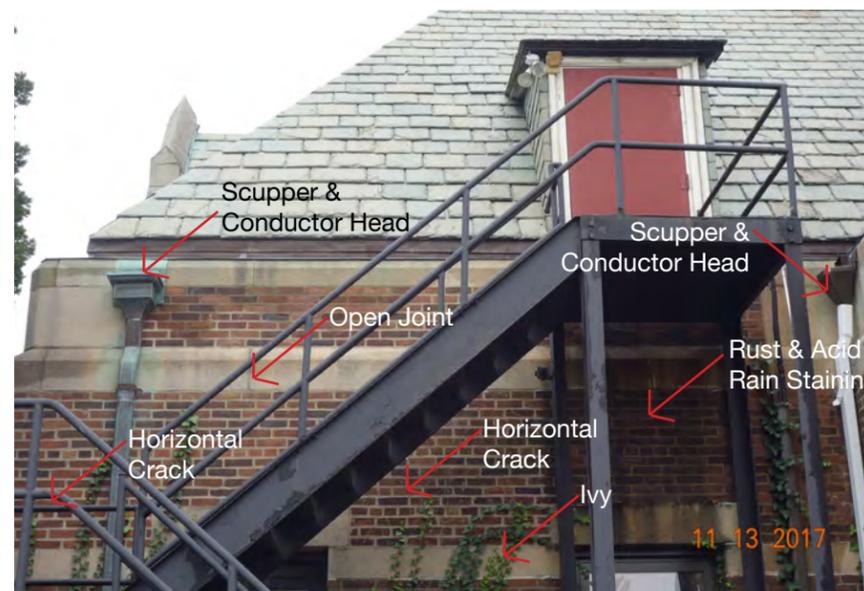
Figure 2.4_4 South Facade - Copper Scuppers & Conductor Heads

1. New scuppers and conductor heads should be provided. Scuppers to be properly flashed and waterproofed.
2. New built in gutters system. Pitch for positive drainage to the new scuppers.
3. New downspouts, straps, and splash block. Re-grade to drain run off away from building.
4. Clean and repair wall at Basement.
5. The main hip roof drainage system should studied further, investigating other systems that may perform better and have better durability than a built in gutter system; such as a new eave and hung gutter system.

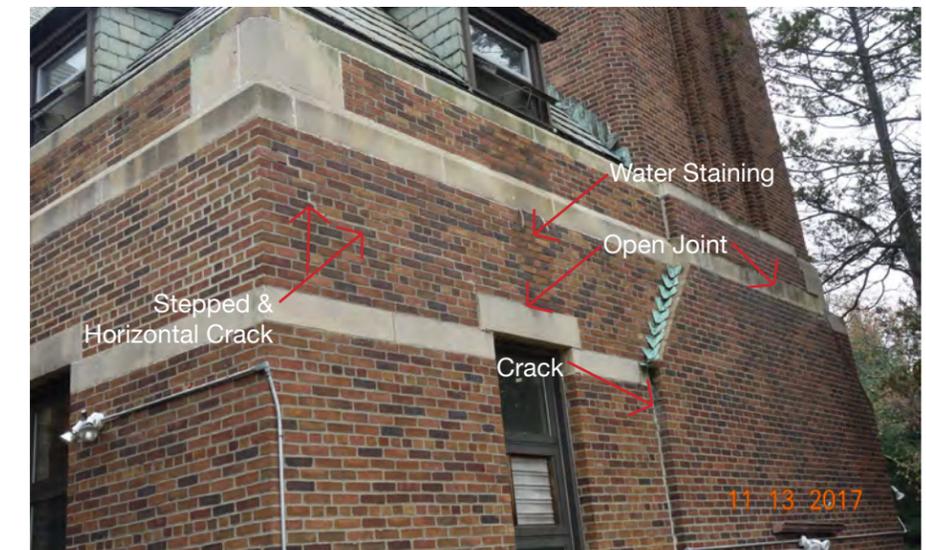
- **Stepped and horizontal brick cracking** along the lintel line from window head up to the cast stone band.
- **Cast stone band, window head and sill joints** are open or poorly caulked and failed.
- **Acid rain and rust staining** at upper brick and cast stone above windows. After rain, cast stone was seen to be saturated with water.
- **Vertical cracks** at concrete base.
- **Ivy** growing on east portion of facade.

Figure 2.5_1 South Facade - Cracks, Open Joints, Staining

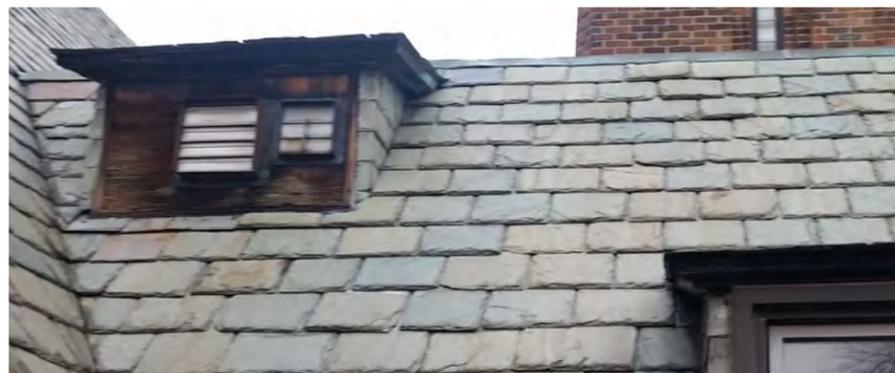
- **Window lintels** are rusted due to water infiltration. Severe to moderate deterioration.
- **Window head, jamb and sill** plaster finishes are cracked and spalling. Severe to moderate deterioration. Ceilings are stained.
- **Dormer window** on West Facade has been removed and replaced with wood and metal louvers. Wood is severely deteriorated.
- **Tower entrance** door and transom lintel is rusted and severely deteriorated. Wood frame deteriorated.
- **Second Floor Meeting Hall door** opening lintel is rusted and severely deteriorated.
- **Second Floor window** heads' gypsum board finish have vertical cracks.
- **South Facade door** wood head and lintel are deteriorated and rusted. Stucco jambs are cracked.
- **Basement window** pane broken and steel frame rusted.
- **Aluminum windows** near end of life. Most likely do not meet the current NYS Energy Conservation Code.

Figure 2.5_6 Modified Dormer

1. Replace all window lintels with hot dipped galvanized lintels. Provide proper flashing and weep holes.
2. Windows and doors should be replaced to meet the current NYS Energy Conservation Code.
3. Repair all deteriorated interior finishes, jambs, heads, stools, and frames.
4. Replace dormer wood cladding and louvers with new insulated panel and louvers.

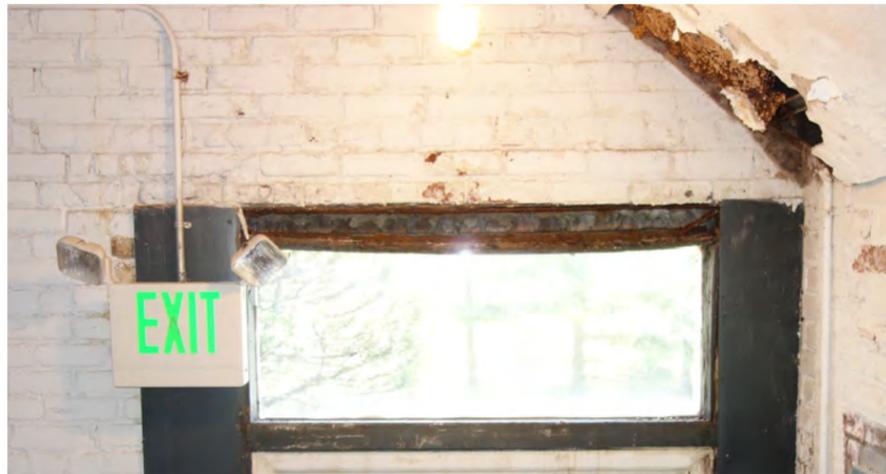
Figure 2.5_7 Tower Door/Transom Lintel Deterioration & Rust

Water infiltration into the wall system has caused the steel lintels to deteriorate and rust. In order to repair and replace the lintels the windows and doors will have to be removed.

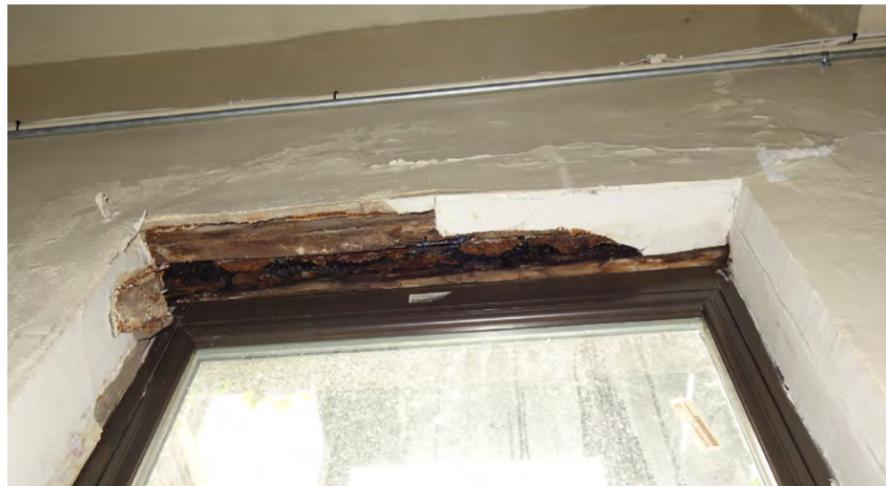
Figure 2.5_8 Window Lintel & Plaster Deterioration & Rust

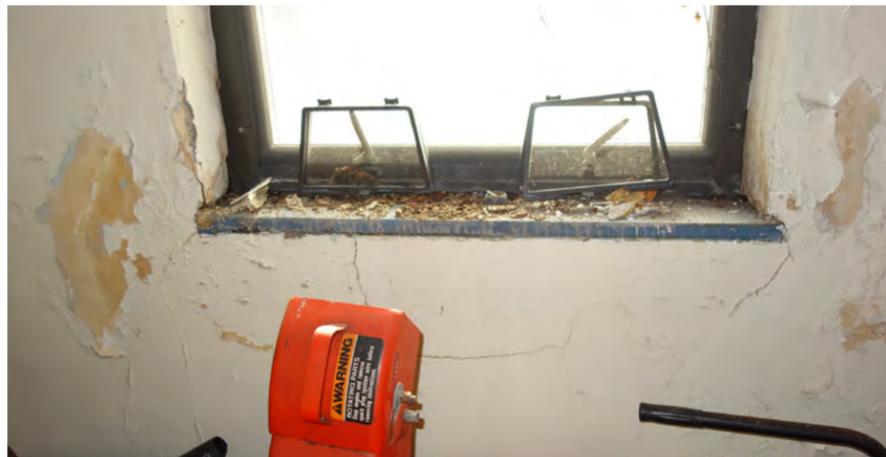
Figure 2.5_9 Window Stool & Plaster Cracks & Deterioration

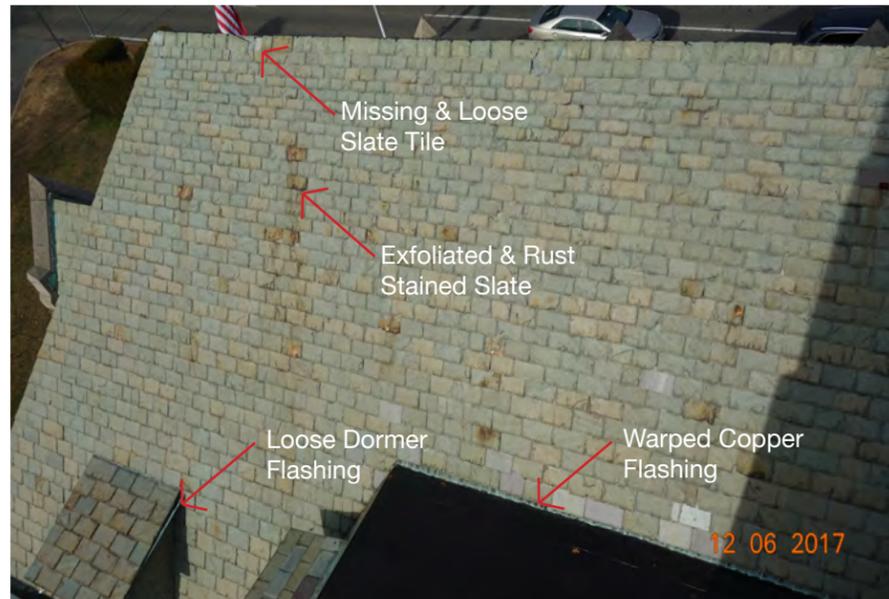
- **Dormers:** Where visible, copper flashing appears to be in **poor condition; loose and warped**. Flashing under existing slate tiles not surveyed.
- **Hip Roofs:** Flashing not visible. In areas of ridge and hip slate tiles missing, flashing also **deteriorated**.
- **Flat Roofs:** Copper flashing appears to be in **poor condition; loose and warped**.
- **Copper stepped flashing** at brick ledge in poor condition; loose and warped.

Figure 2.6_1 Slate Hip Roof, Dormer & Copper Flashing

1. **Dormers:** New copper flashing should be provided. This work should be performed with the overall dormer slate roof repairs.
2. **Hip Roofs:** New flashing should be provided at ridge and hips. This work should be performed with the overall slate roof repairs.
3. **Flat Roofs:** Repair flashing. This work should be performed with the overall slate roof repairs.
4. Provide new copper stepped flashing at brick ledge.

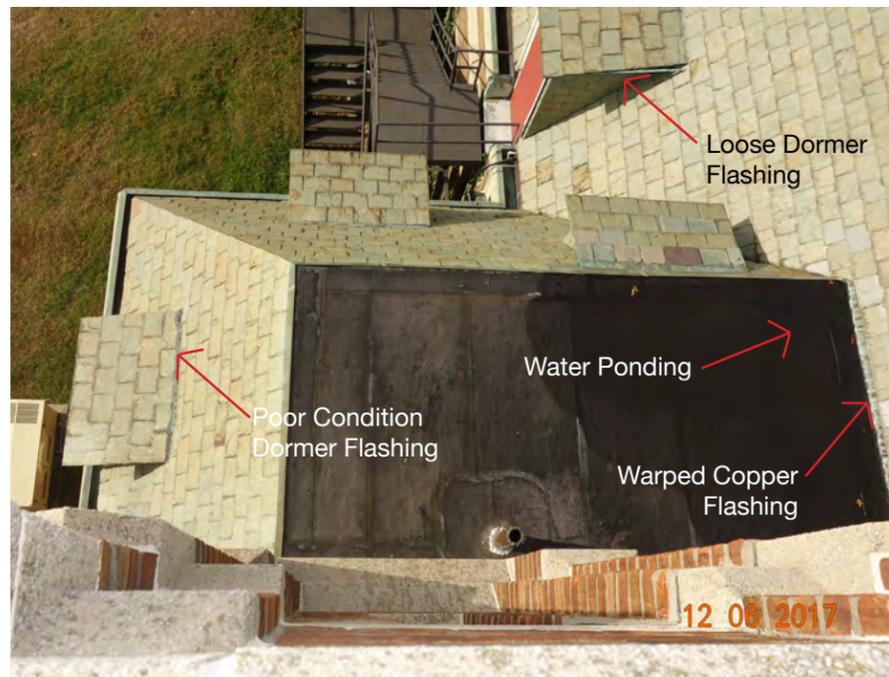
Figure 2.6_2 Slate Hip Roof, Flat Roof, Dormers & Copper Flashing

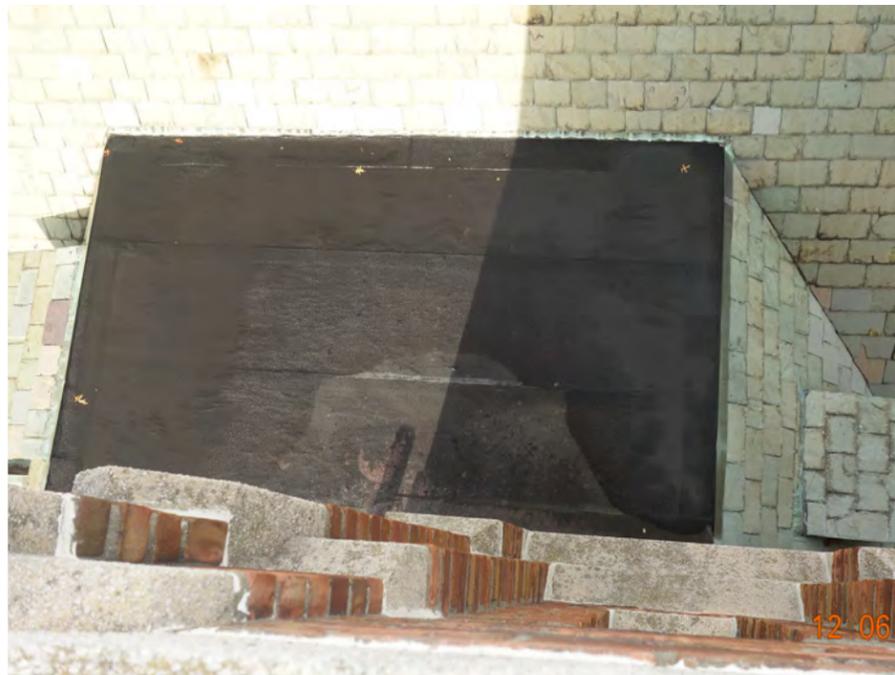
- **Roofing materials** appear to be in fair condition. Water ponding in an area of the roof. Further survey of the roofs is required.

Figure 2.6_4 Flat Roof

Further up close survey is required for the roofs existing conditions to be investigated and repair recommendations determined.

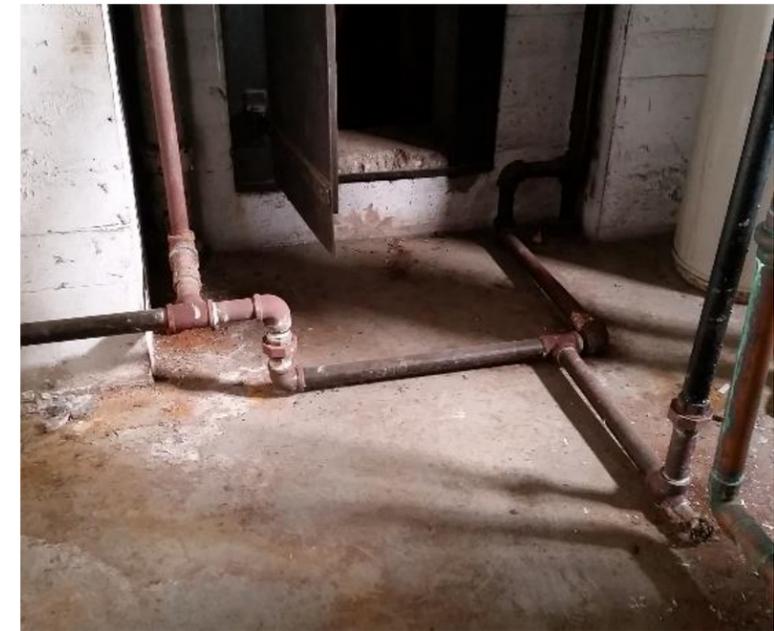
- 3) Boiler appears deteriorated & neglected, re-build of room is strongly recommended (see also 'exterior site' discussion regarding prevention of stormwater from infiltrating into cellar).

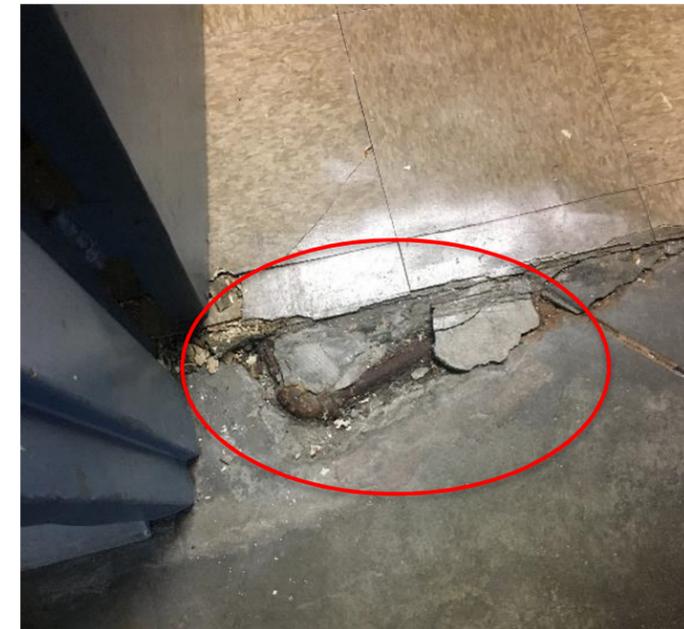
- 3) Piping (likely natural gas) embedded in apparatus slab. Should verified to be abandoned & removed to facilitate renovations:

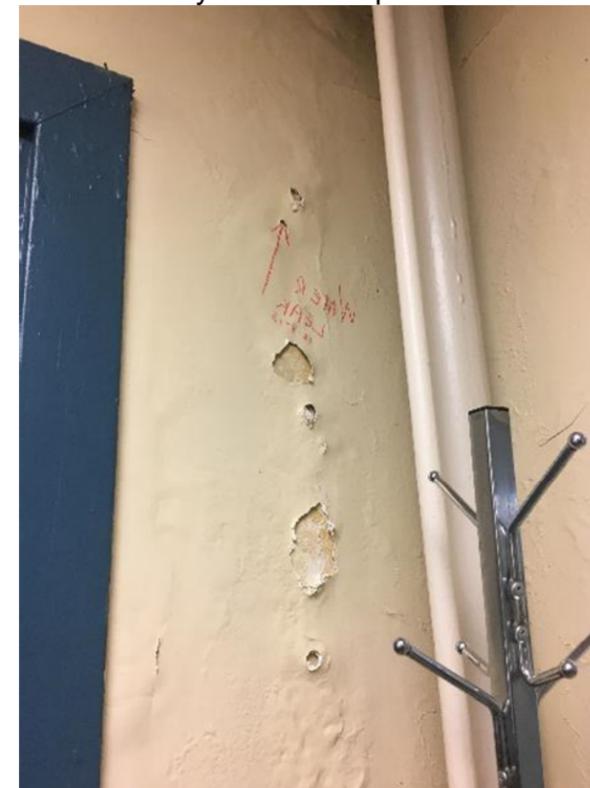
- 4) Water leakage noted near first floor bathroom, recommend opening wall to identify source & repair at source.

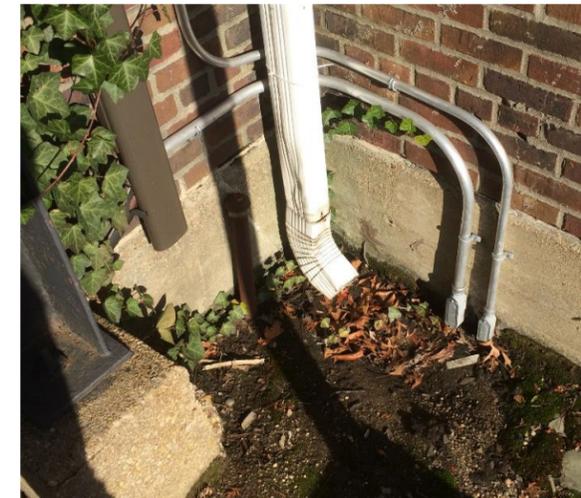
- 1) No splash-block or stones at bottom of downspout near exterior steel staircase, water drains underground & against foundation wall (see Mechanical discussion of degraded cellar equipment per water infiltration & other sources). Also adjust downspout to avoid splashing onto electrical conduits:

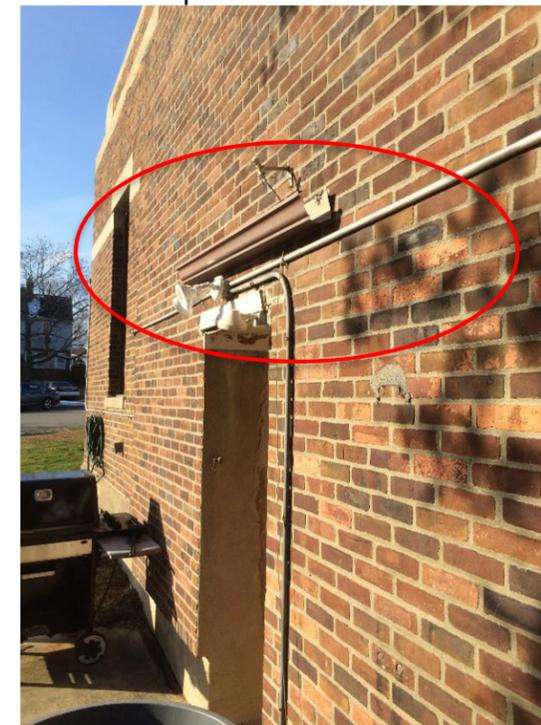
3) Recommend replacing make-shift gutter over rear door with awning & downspout:

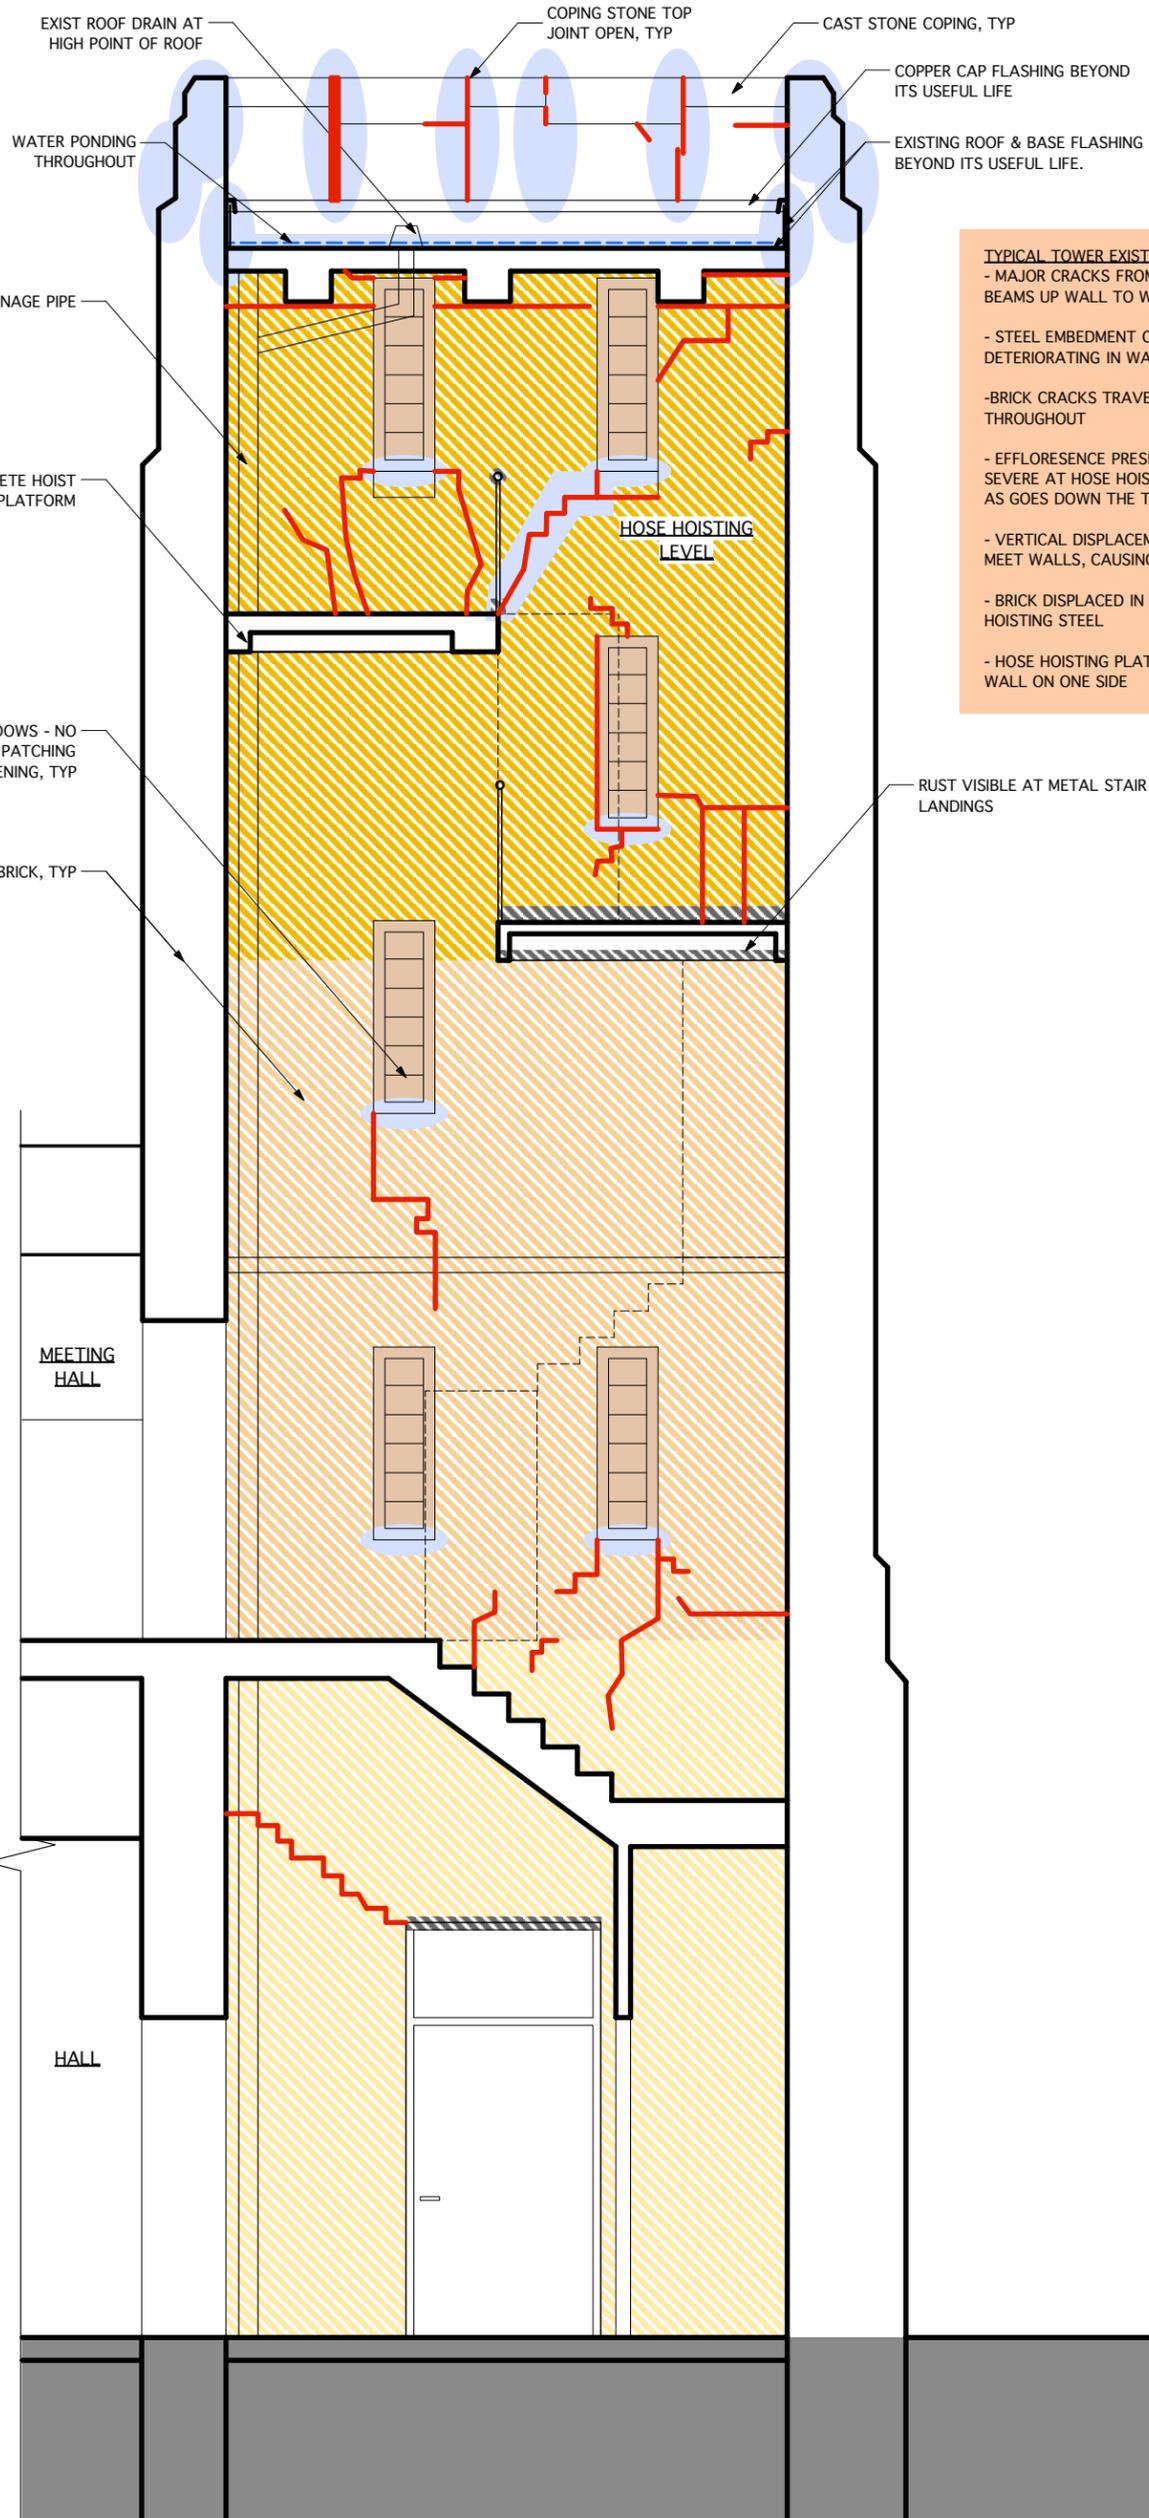
- MAJOR CRACKS FROM HOSE HOISTING PLATFORM FROM BEAMS UP WALL TO WINDOWS
- STEEL EMBEDMENT OF HOSE DRYING STEEL DETERIORATING IN WALL & CRACKING EXTERIOR WALL.
- BRICK CRACKS TRAVELING FROM WINDOWS TO CORNER & THROUGHOUT
- EFFLORESCENCE PRESENT THROUGHOUT TOWER. MOST SEVERE AT HOSE HOISTING PLATFORM LEVEL & DECREASES AS GOES DOWN THE TOWER.
- VERTICAL DISPLACEMENT OF BRICK WHERE ROOF BEAMS MEET WALLS, CAUSING CRACKS.
- BRICK DISPLACED IN HORIZONTAL PLANE AT HOSE HOISTING STEEL
- HOSE HOISTING PLATFORM SEPARATED FROM WALL ON ONE SIDE

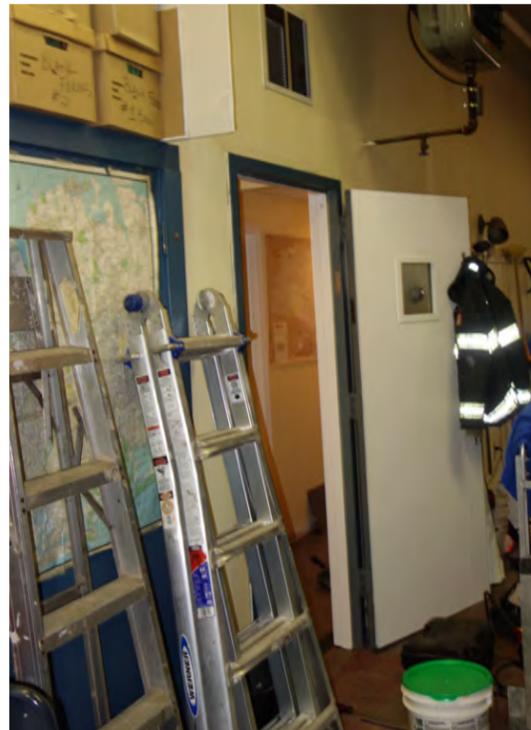
Figure 2.1_3 No Illuminated Exit Signs Code Violation

1. Provide new emergency lighting.
2. Provide new illuminated exit signs.
3. Remove step and provide landing and walkway. See ADA Compliance recommendations.

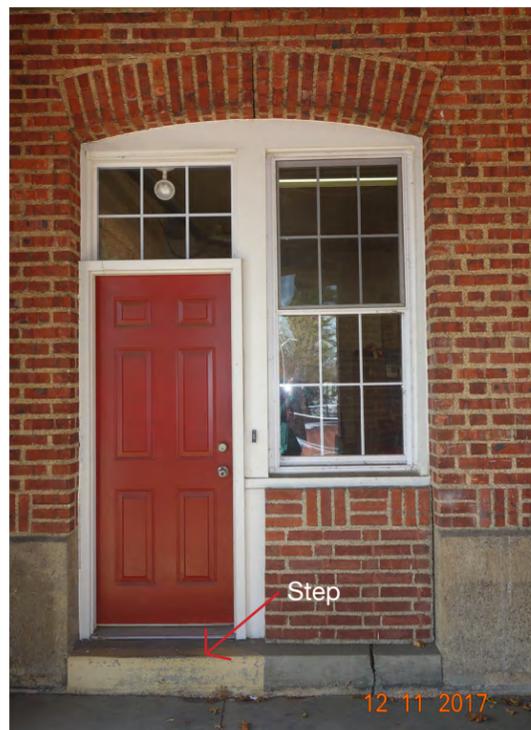
Figure 2.1_4 Egress Door Step Code Violation

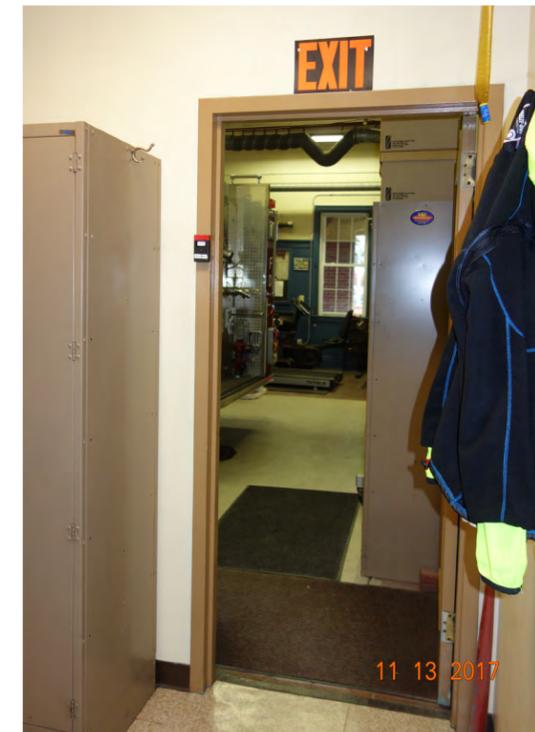
Figure 2.1_5 No Illuminated Exit Signs Code Violation
