Garden City
Fire Department

Firehouse #1, #2 & #3

Existing Conditions
Documentation & Recommendations
DRAFT

February 2, 2018

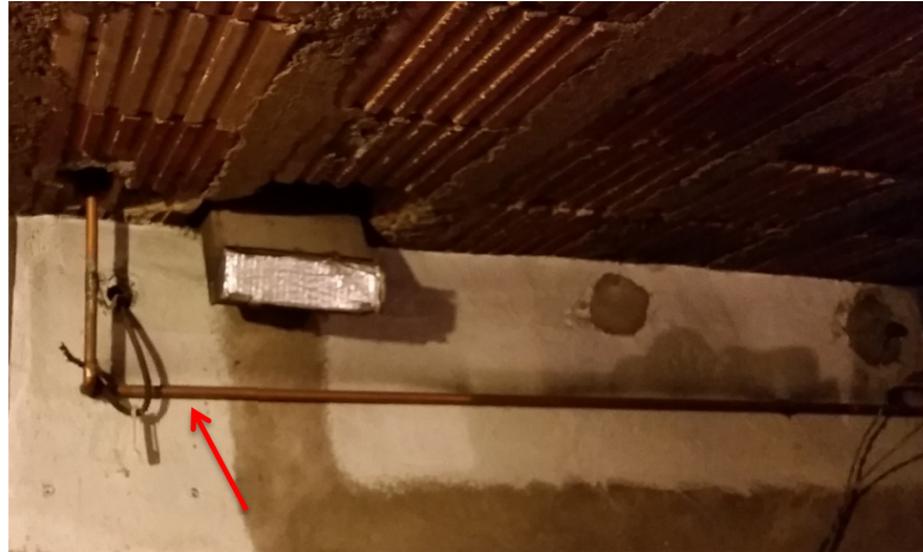
- 2) Observed deficiency: Hot water supply and return piping uninsulated:

Recommended fix: All uninsulated piping and fittings should be cleaned, insulated, and provided with a service jacket as per New York State Energy Conservation Code. In addition to resolving the code-compliance problem, insulating this piping will lead to reduced energy consumption and operating costs.

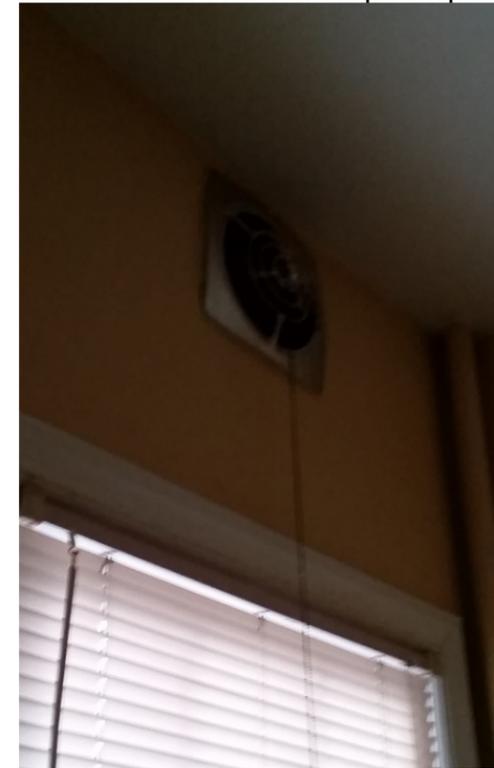
- 5) Observed deficiency: Bathroom exhaust fan not functional. Mechanical exhaust is required per NY State Mechanical Code:

Recommended fix: The bathroom exhaust fan should be replaced. A Cook Gemini exhaust fan with 4 inch diameter ductwork and a weather cap on the exterior would suffice provided there is a suspended ceiling in the space. Alternatively, an inline exhaust fan along could be installed and ducted to both the bathroom and the janitor's closet.

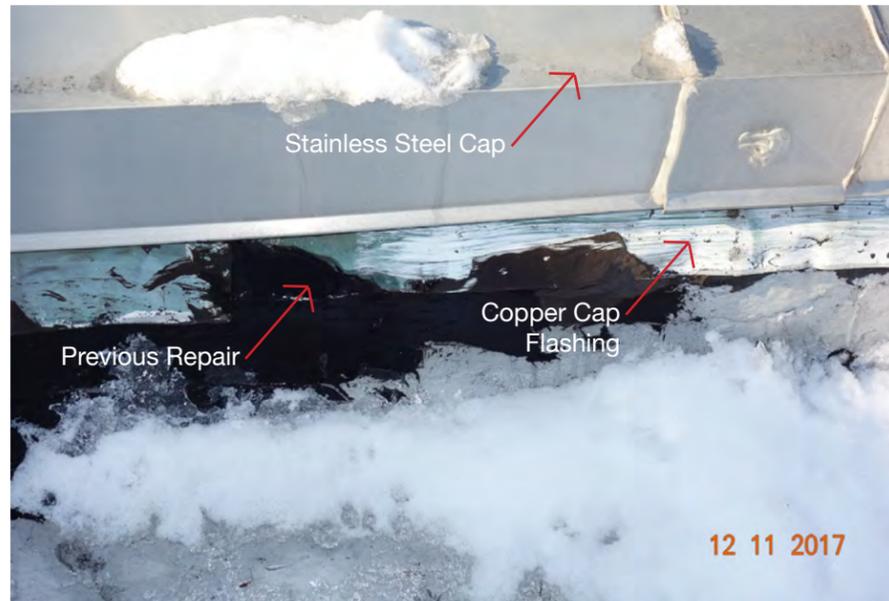
Figure 2.6_1 SS Cap & Copper Cap Flashing

1. **Flat Roof:** New cap, base and coping flashing should be provided. This work should be performed with the overall roof repairs.
2. **Hip Roof:** New flashing should be provided where missing or failing. This work should be performed with the overall slate roof repairs.

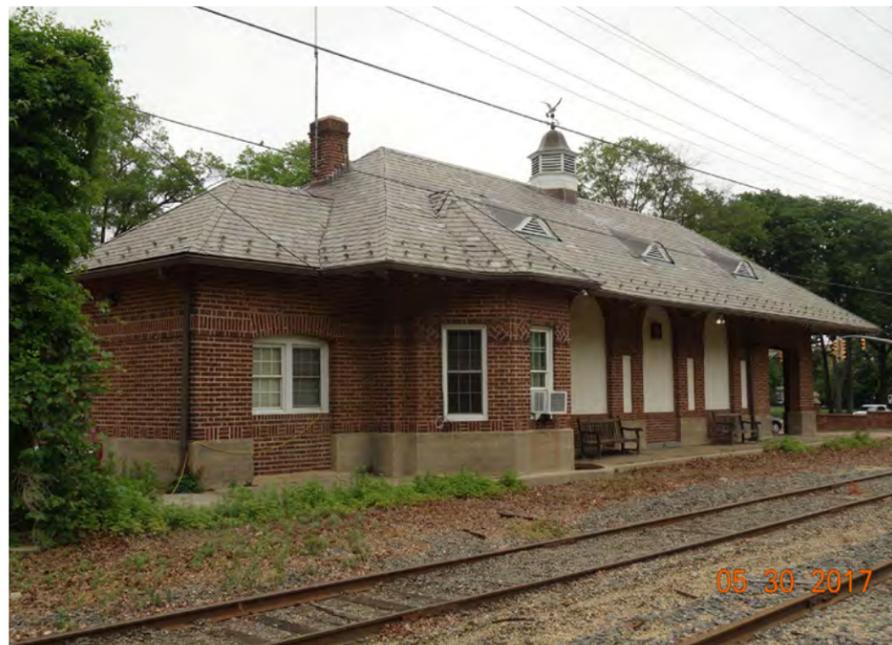
Figure 2.6_5 South Facade - Hip Slate Roof

1. Provide new ridge and hip slate tiles and secure properly.
2. Demolish deteriorated slate tiles and replace with new.

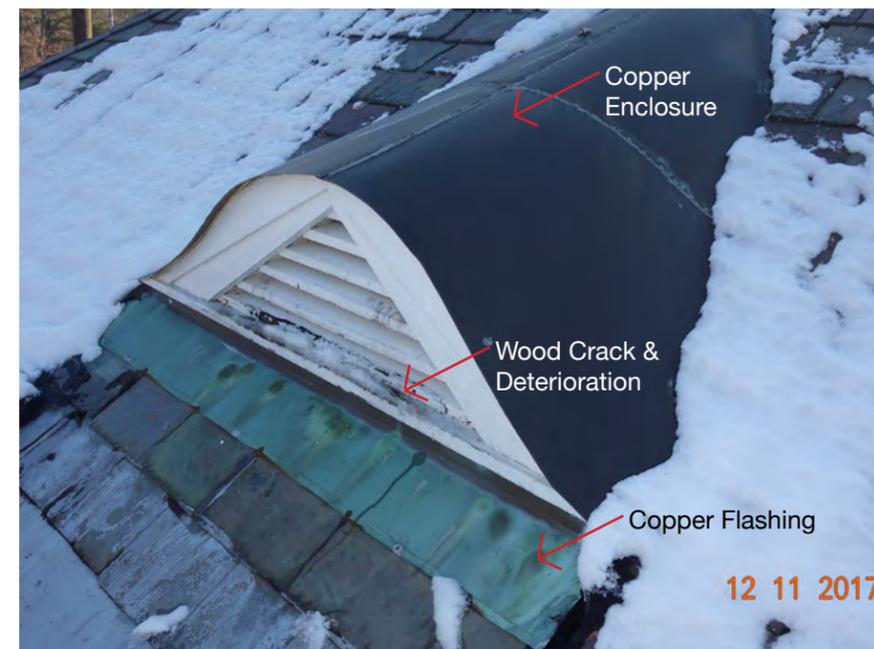
Figure 2.6_6 Copper & Wood Dormer

1. Repair or replace wood vent.

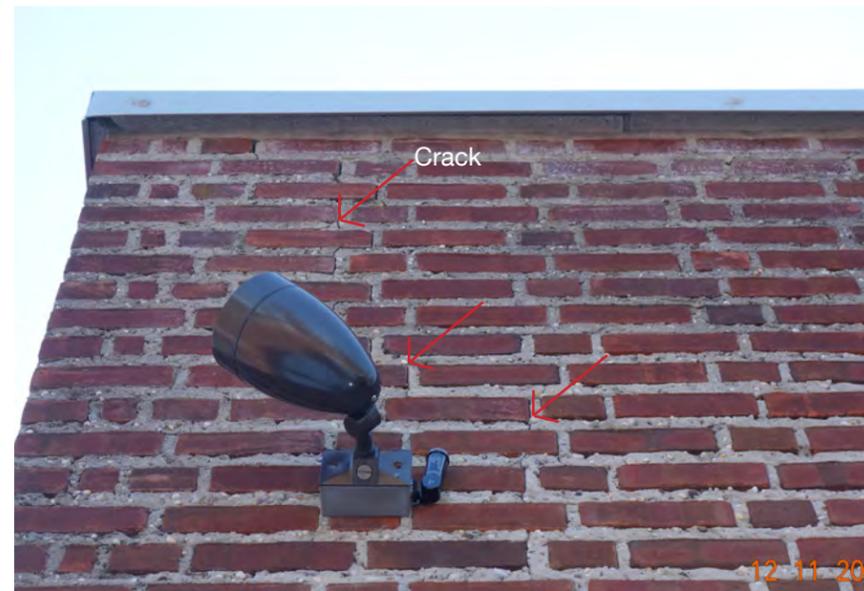
- **Stepped and vertical cracks** from corbeled brick band up to parapet stainless steel cap.
- **Horizontal crack** at Apparatus Garage Door brick arch.
- **Apparatus Garage Door** steel jamb and lintel paint flaking.
- **Course aggregate mortar** joints are worn above Apparatus Room door opening.
- **Thin red mortar joints** are worn and open on corners.
- **Vertical cracks** at concrete base. Biological growth and masonry staining in same area.
- **Parge coating** on horizontal surface of corbeled brick band missing.
- **Brick missing mortar** at underside of arch at Exterior Porch opening.

Figure 2.5_2 North Facade - Stepped & Vertical Crack

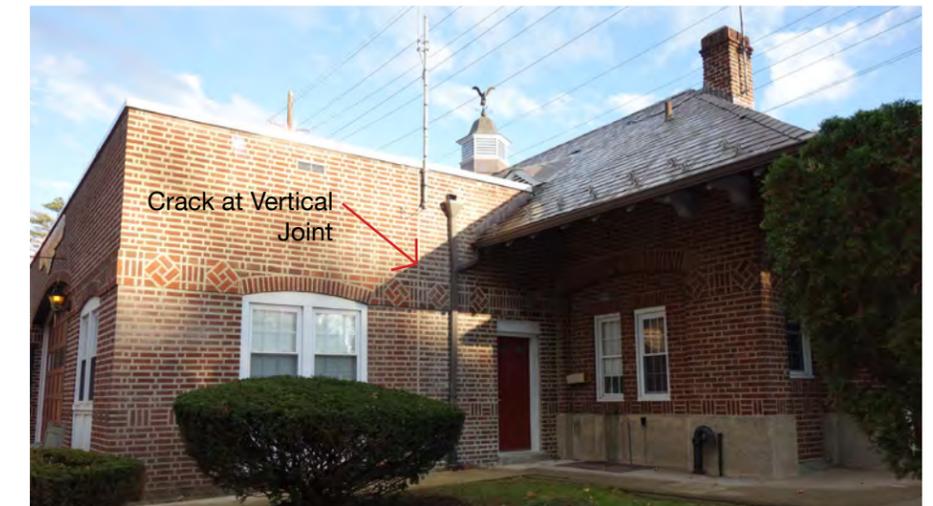
- **Thin red mortar joints** are worn, missing and cracked on Facade corners.
- **Mortar crack** at vertical joint between historic building and addition.
- **Ivy** growing on south portion of facade.

Figure 2.5_4 West Facade

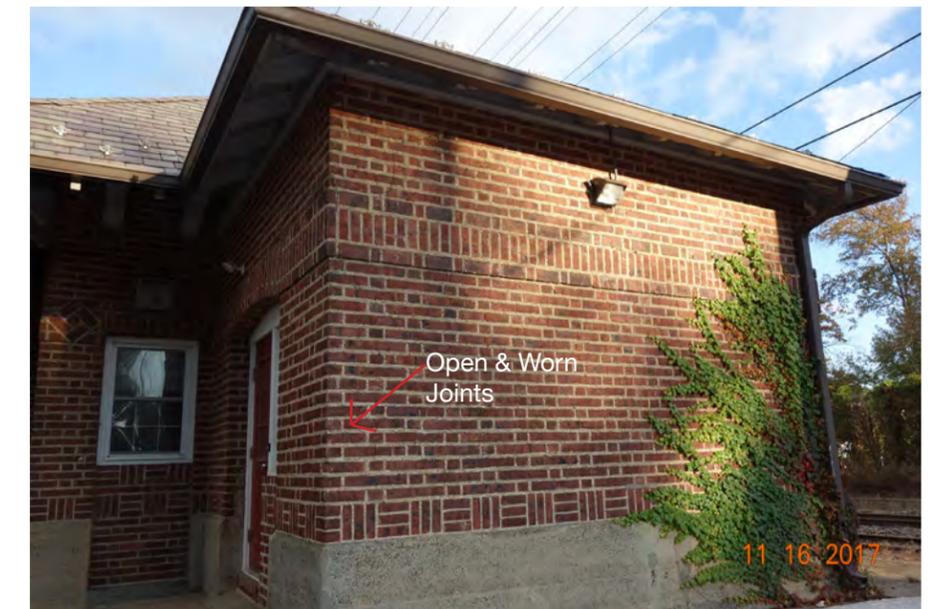
Figure 2.5_5 West Facade

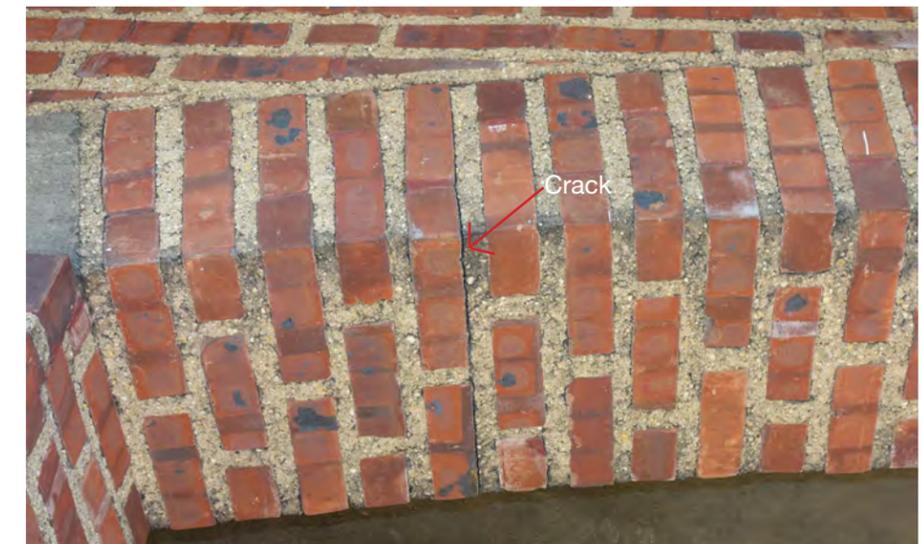
- **Brick crack and missing mortar** at brick head and underside of arch at Exterior Porch opening.
- **Course aggregate mortar joints** are worn at wood fascia at level of wood eave.
- **Vertical and horizontal cracks** at concrete base.
- **Exfoliation and cracks** at top side of parged or bluestone sill.
- **Parge coating** on horizontal surface of corbeled brick band missing.
- **Ivy** growing on west portion of facade.

Figure 2.5_9 South Facade - Exterior Portico Arch Crack

1. Repair all brick and concrete base cracks.
2. Repair Exterior Porch brick arch cracks and re-point worn mortar joints.
3. Provide new bluestone sills.
4. Re-point areas with worn and open mortar joints.
5. Provide new parge coating on top of corbeled brick band.
6. Remove ivy and repair masonry where required.
7. Scrape and paint existing Apparatus Door steel jamb and lintel.

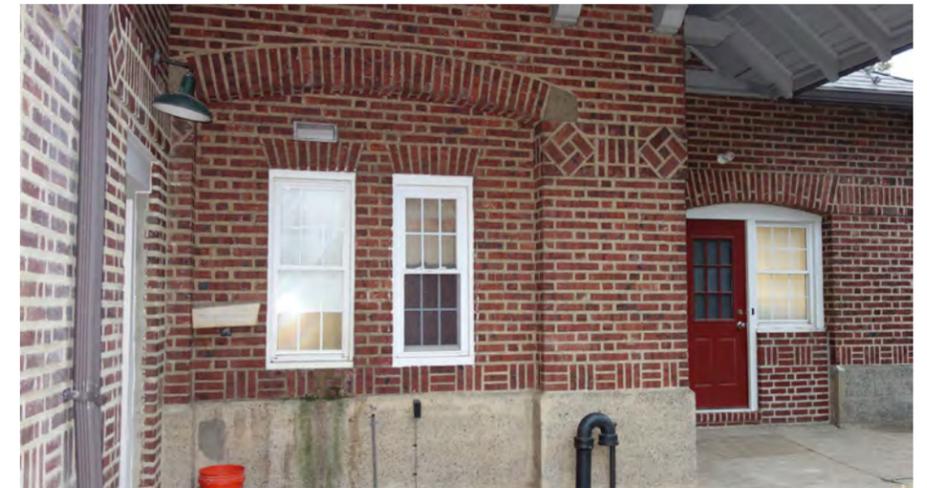
Figure 2.5_11 North Facade Windows

1. Replace the window lintel with a new hot dipped galvanized lintel. Provide proper flashing and weep holes.
2. Windows and doors should be replaced to meet the current NYS Energy Conservation Code.

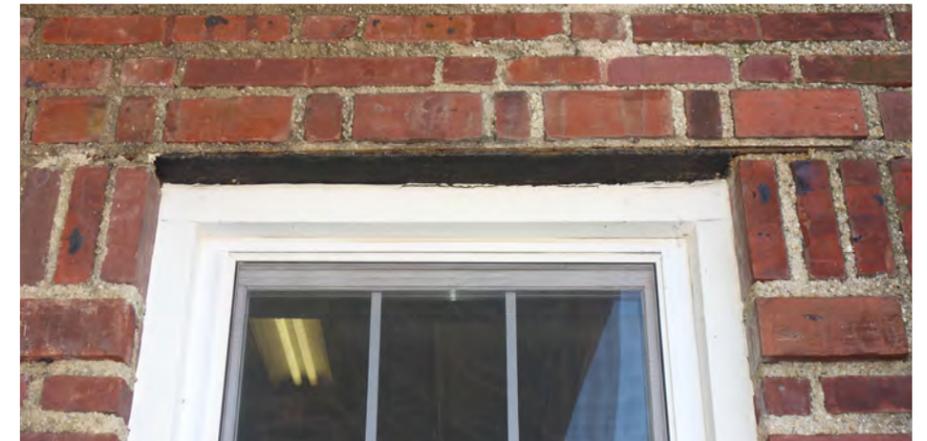
- **Window lintel** is rusted due to water infiltration. Moderate deterioration. (East Facade)
- **Sealant missing and failed** at aluminum sill pan and frame. Gaps and holes in aluminum sill.
- **Aluminum windows** near end of life. Most likely do not meet the current NYS Energy Conservation Code.

Figure 2.5_12 Rusted Window Lintel

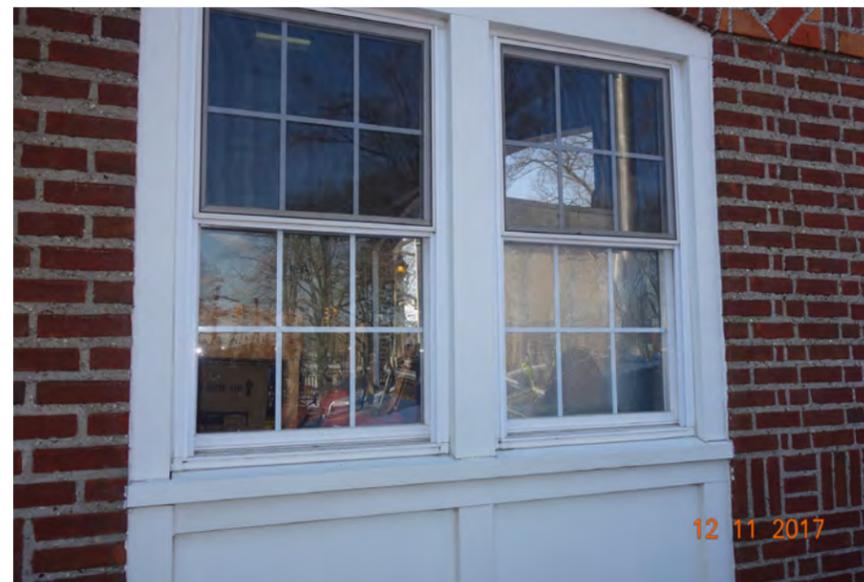
Figure 2.5_10 East Window

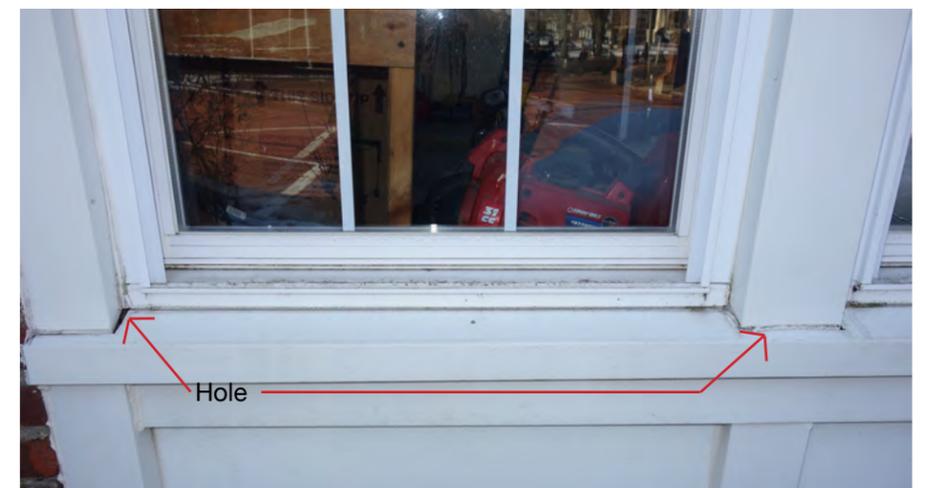
Figure 2.5_13 Aluminum Sill Holes

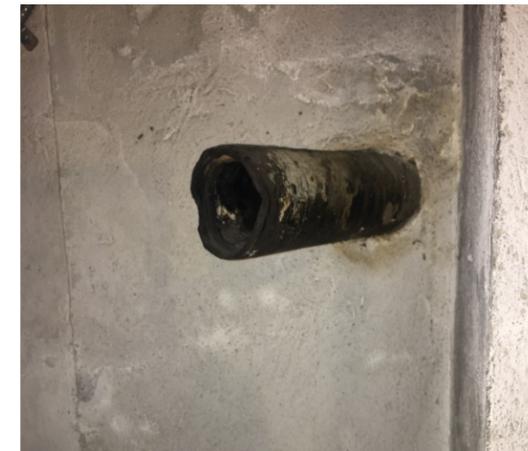
- i) Cellar
 - 1) Main sanitary service cracked & corroded (noted during observations, design team informed corrections made by Garden City in the interim)
 - 2) Remove and abandon existing pipe protrusion through basement wall:
