APPENDIX M
**Assessment of Repairs, Restoration,
and Mitigation Costs**

ASSESSMENT OF REPAIRS AND RESTORATION

OF ST. PAUL'S SCHOOL, GARDEN CITY, NEW YORK

Date: January 21, 2011

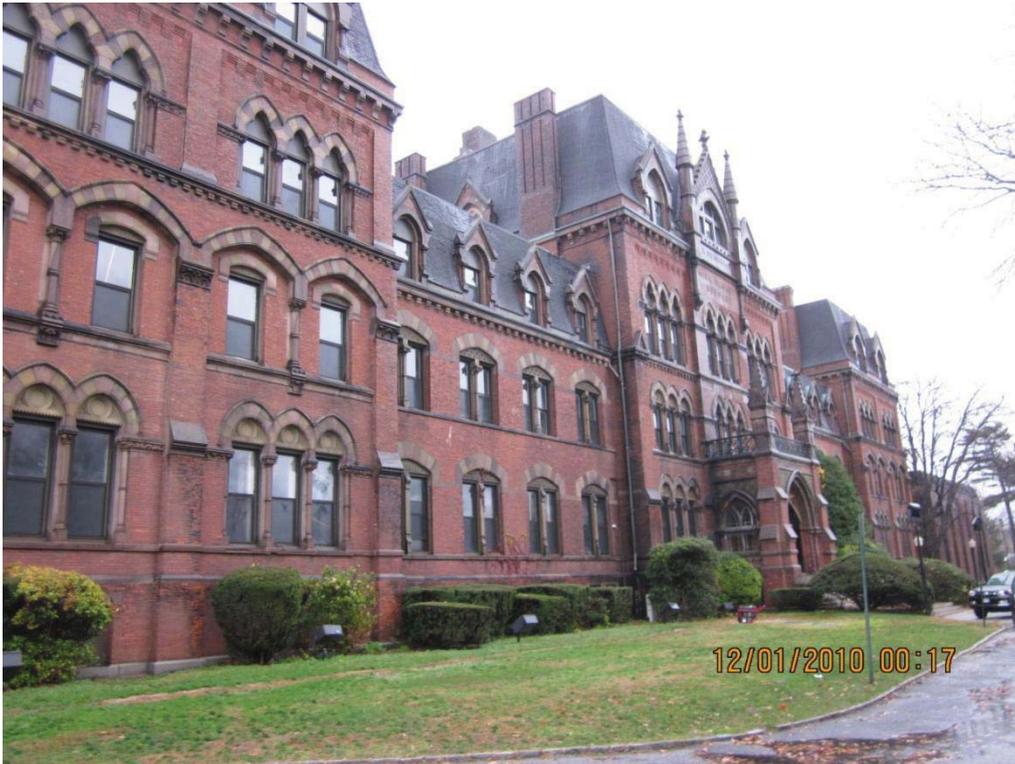
General view of front facade

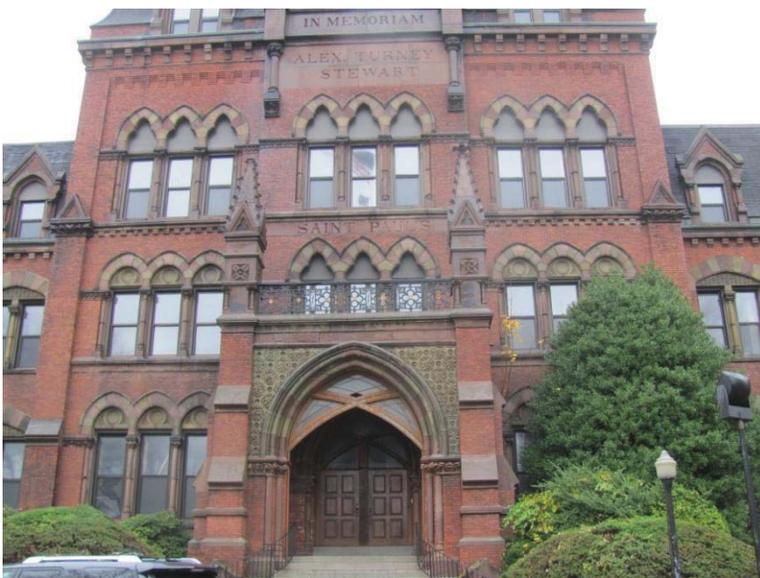
Detail of front entry

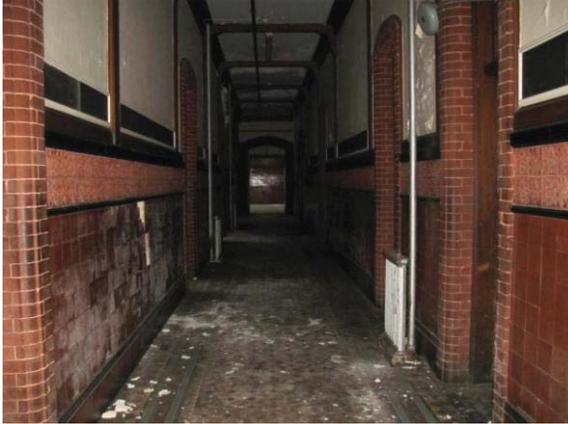
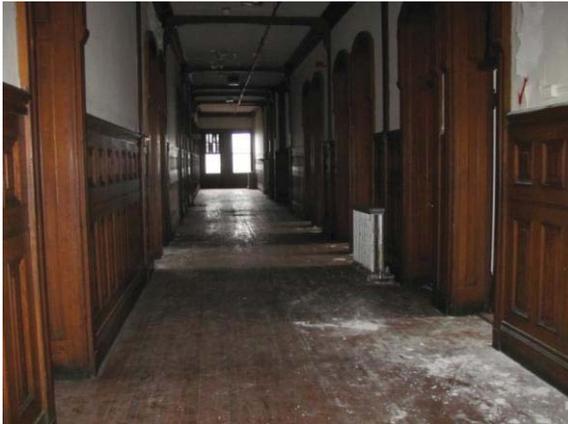
Typical Corridors. Corridor walls are structural and support the floor framing.

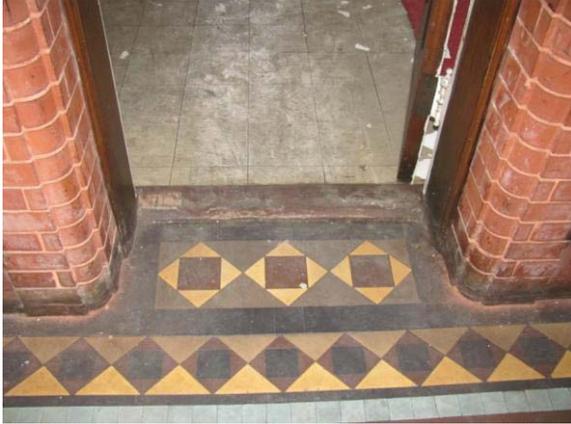
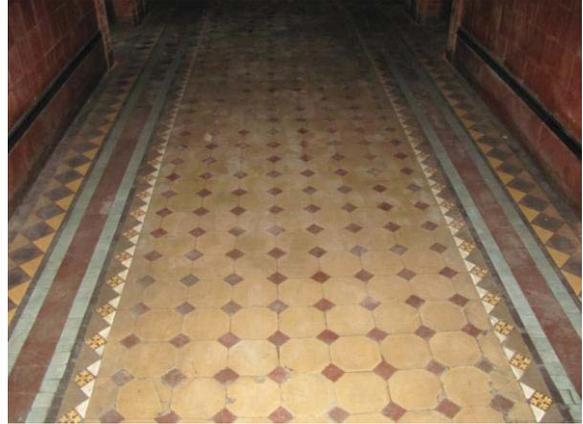
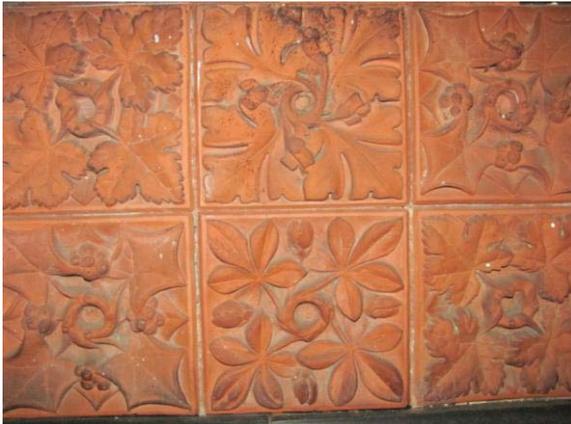
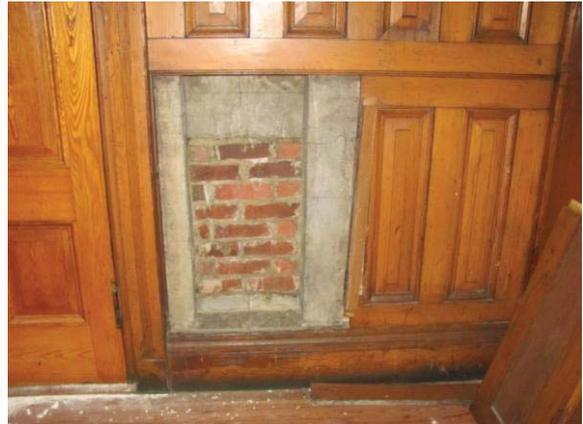
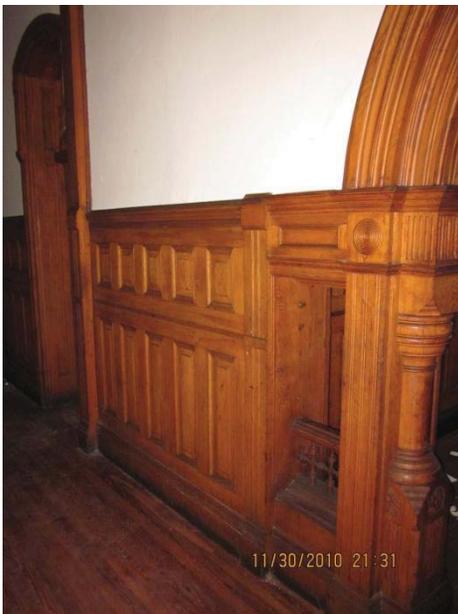
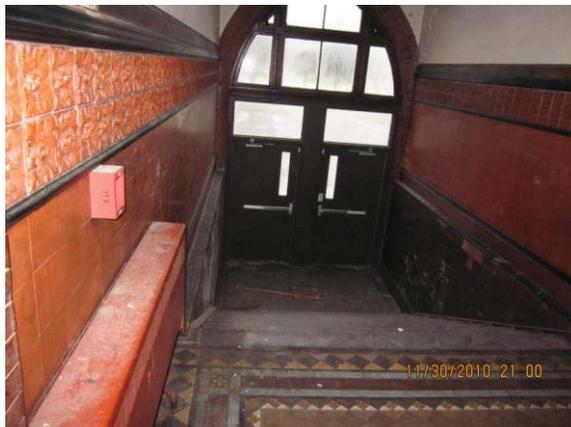
Corridor finish details

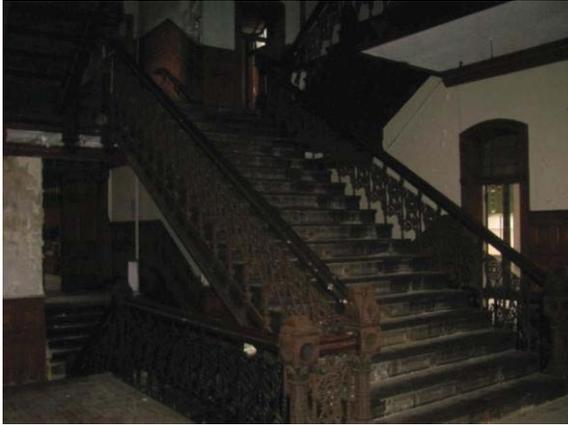
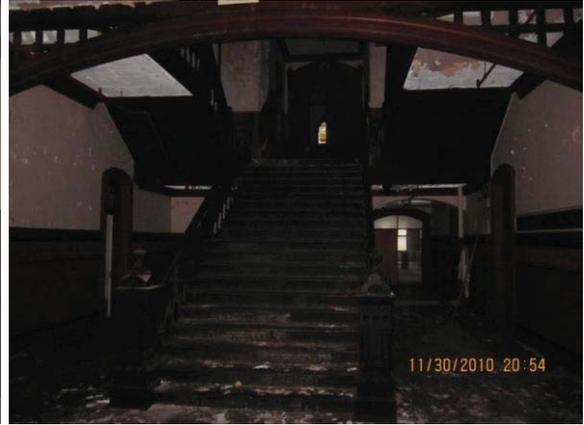
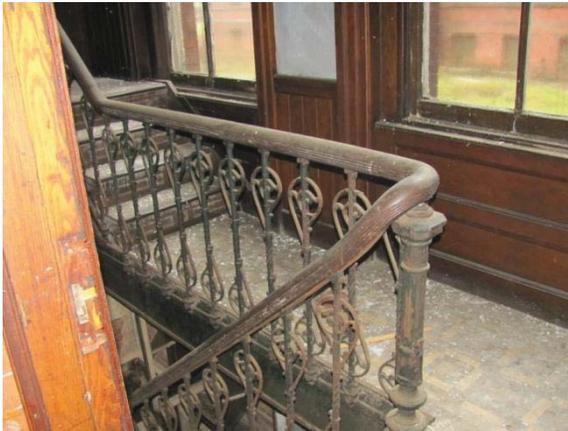
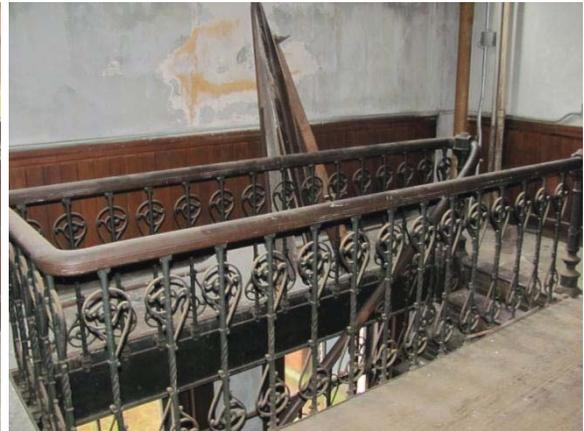
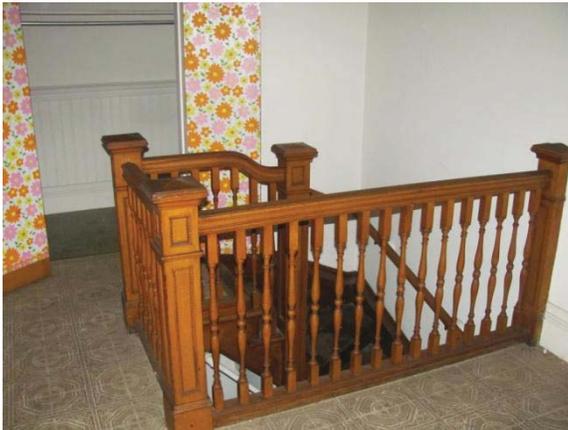
Typical stairs.

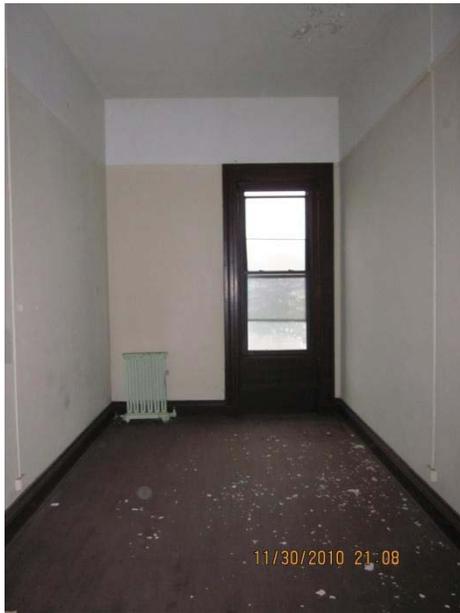
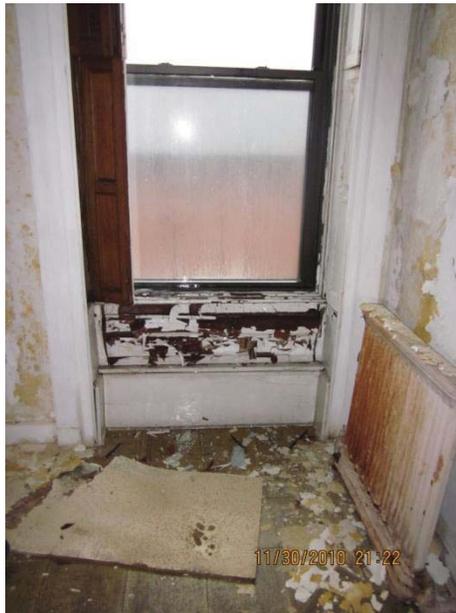
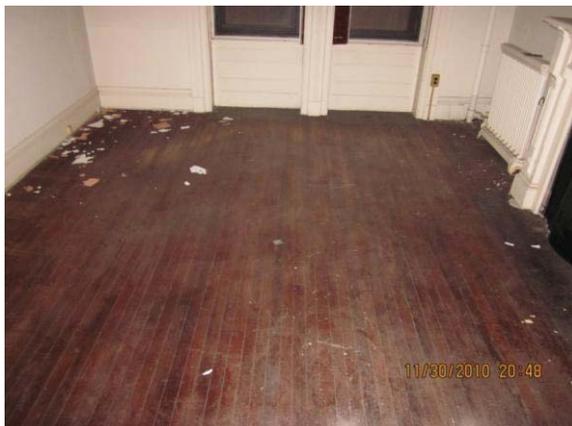
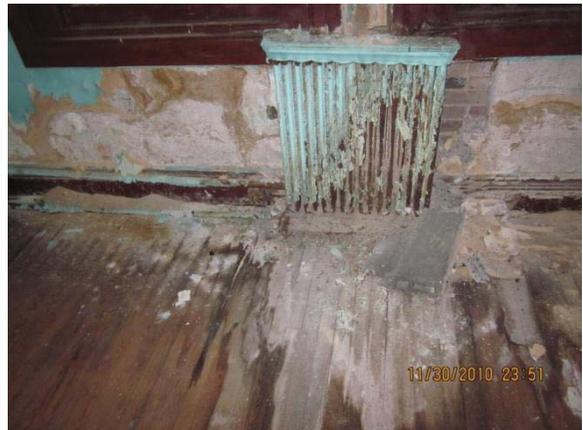
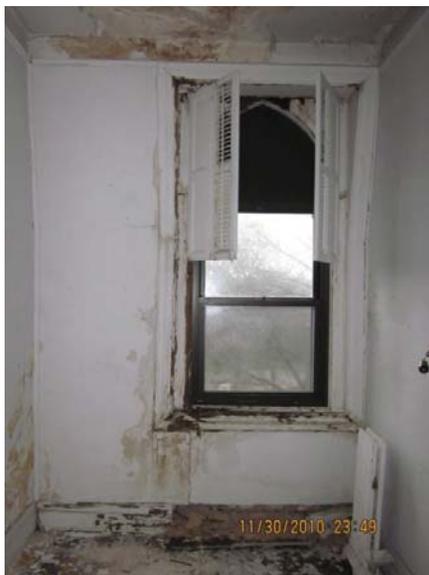
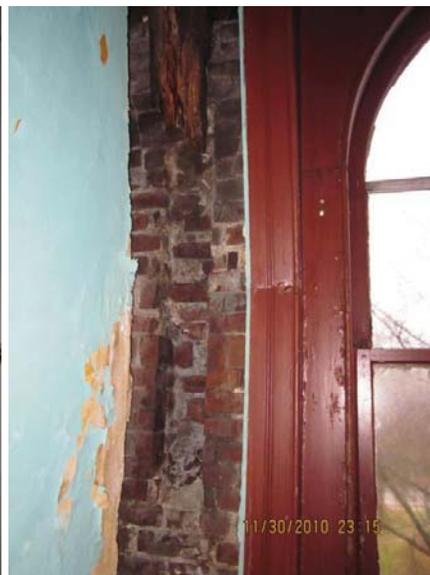
Typical room size and condition of finishes is evident in these photographs.
