St. Paul's School
Garden City, NY

Building Envelope and Structural Condition
Assessment Report

July 19, 2019

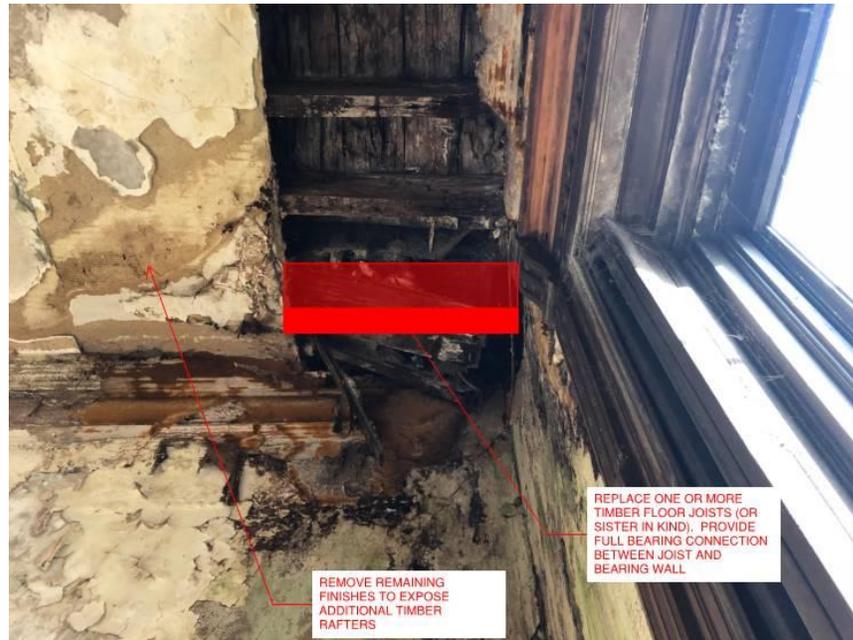
The floor joists in the west room adjacent to the main entry are exposed and severely deteriorated at their bearing connection point to the masonry wall. Refer to Appendix D for overall location of condition. Refer to Figures 1 and 2 for interior condition.

Figure 2: Joist to Bearing Wall Connection

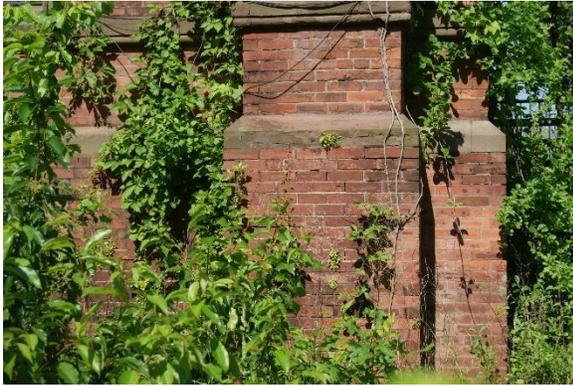
Photo 1. East façade: Open mortar joints in brick masonry. Stone surface delamination.

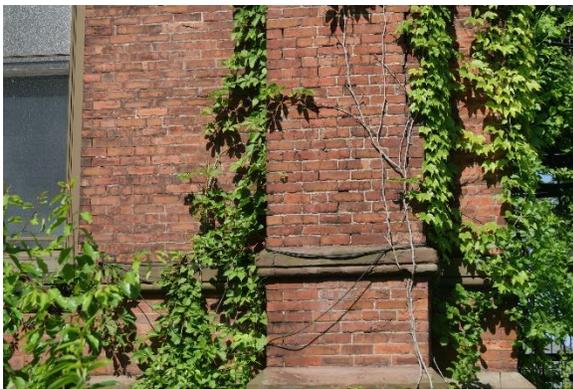
Photo 2. East façade: Open mortar joints in brick masonry. Stone surface delamination.

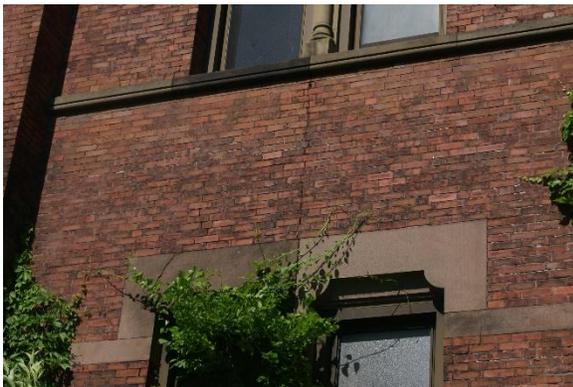
Photo 3. East façade: Vertical crack in brick masonry. Cracked stone.

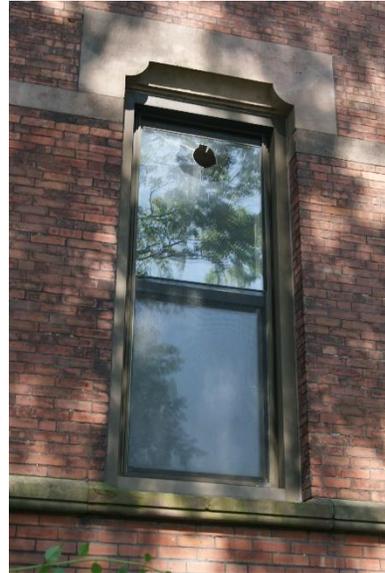
Photo 4. East façade: Cracked glass. Stone surface delamination.

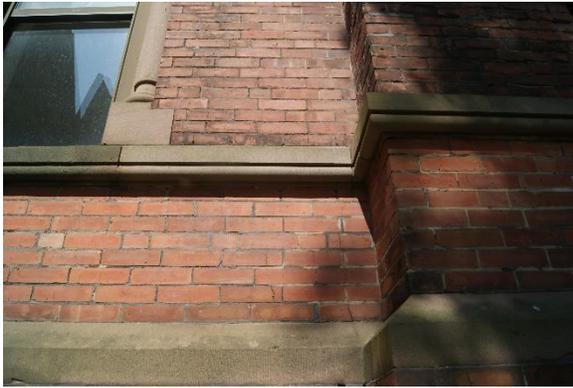
Photo 7. East façade: Open mortar joints in brick masonry. Vertical crack in brick masonry.

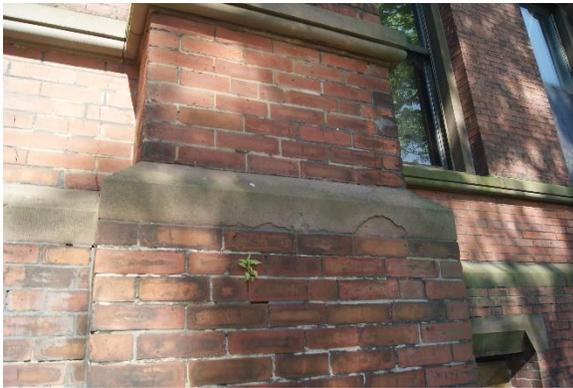
Photo 8. East façade: Open mortar joints in brick masonry. Stone surface delamination.

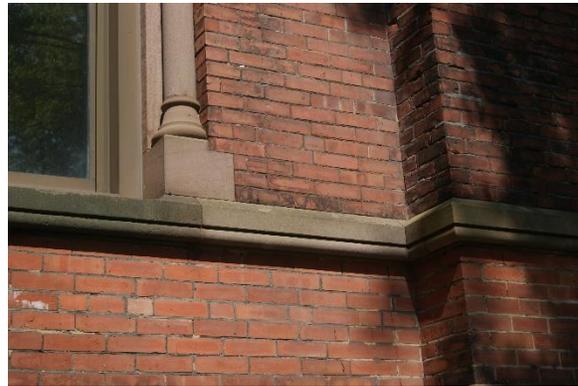
Photo 11. East façade: Open mortar joints in brick masonry.

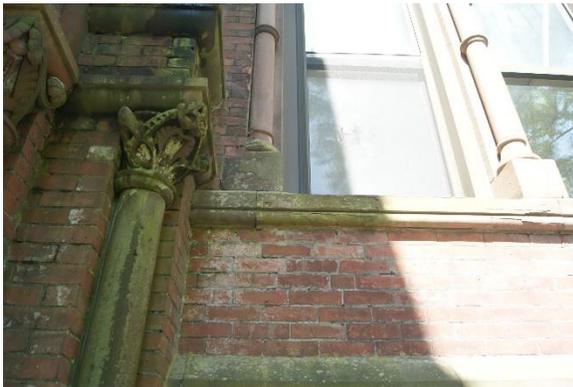
Photo 9. East façade: Open mortar joints in brick masonry. Stone surface delamination. Efflorescence.

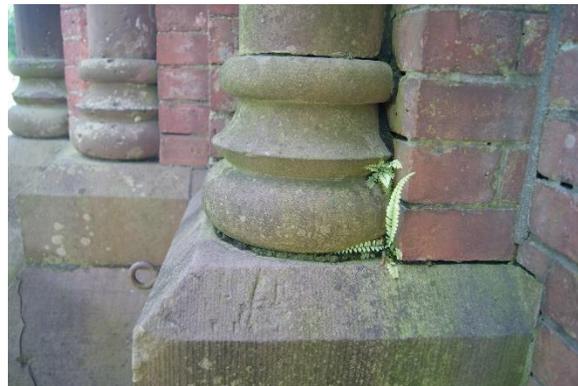
Photo 12. East façade: Open mortar joints in brick masonry. Biological growth.

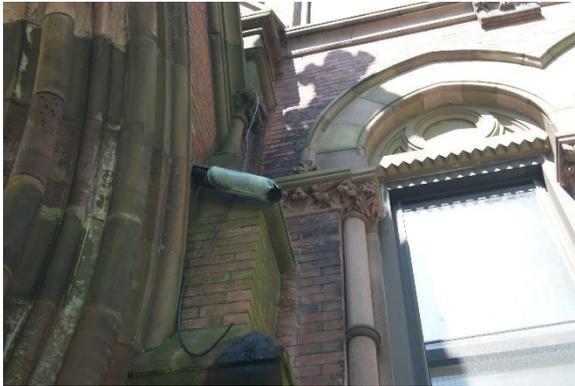
Photo 13. East façade: Open mortar joints in brick masonry. Stone surface delamination. Efflorescence. Deformed scupper.

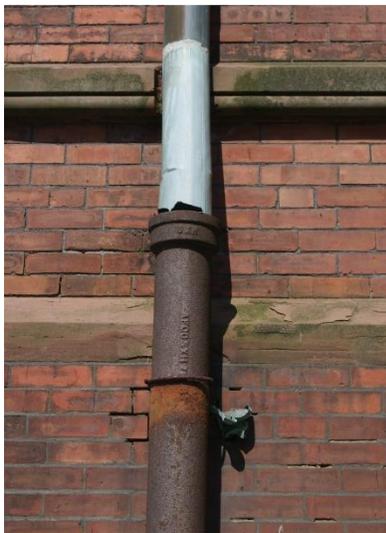
Photo 14. East façade: Open mortar joints in brick masonry. Stone surface delamination. Rusted and damaged downspout.

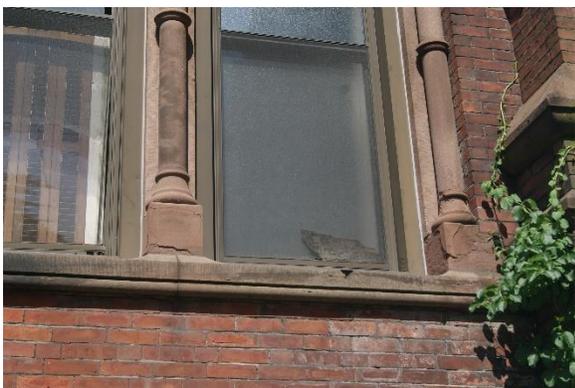
Photo 15. East façade: Open mortar joints in brick masonry. Stone surface delamination. Efflorescence.

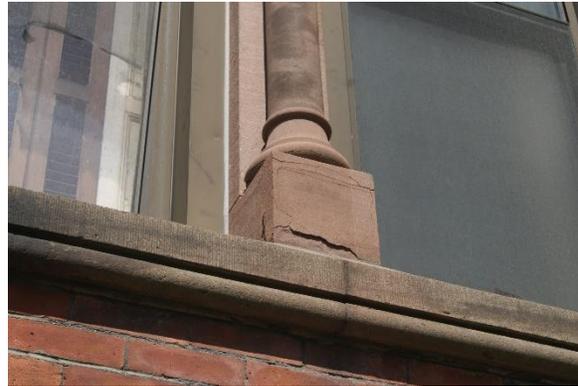
Photo 16. East façade: Stone surface delamination.

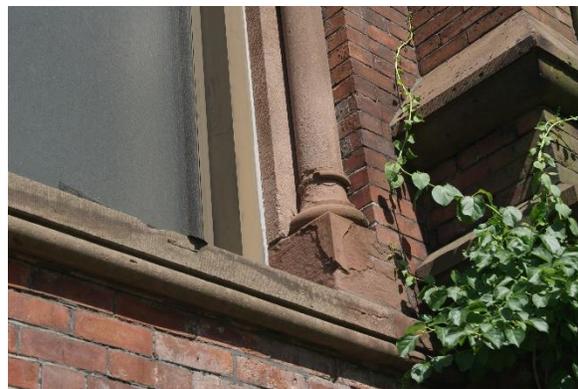
Photo 17. East façade: Efflorescence. Stone surface delamination.

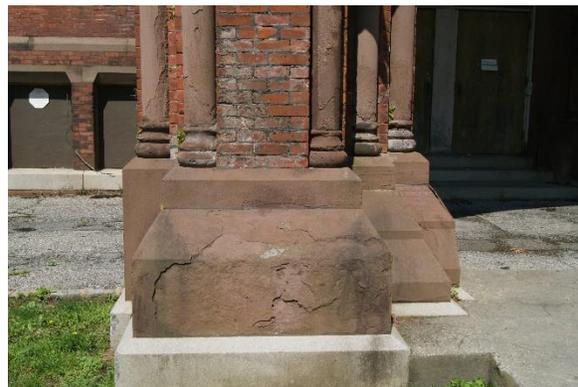
Photo 18. East façade: Efflorescence. Stone surface delamination. Weathered joints in brick masonry.

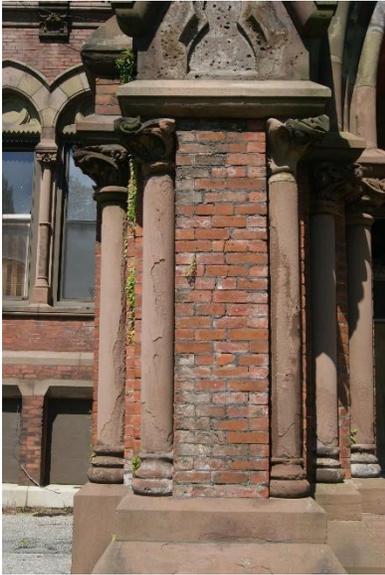
Photo 19. East façade: Efflorescence. Stone surface delamination. Weathered joints in brick masonry.

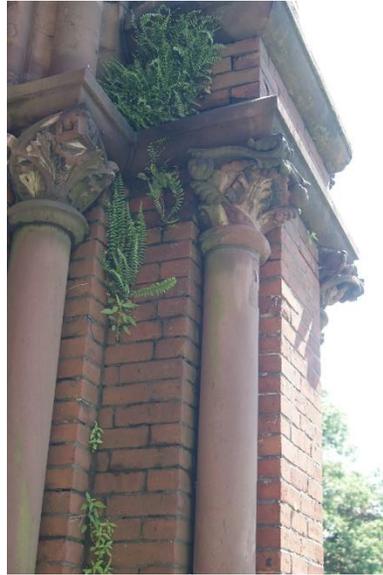
Photo 21. East façade: Biological growth. Weathered joints in brick masonry.

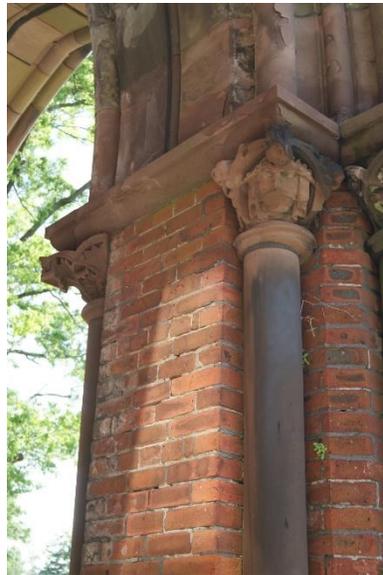
Photo 22. East façade: Efflorescence. Stone surface delamination. Weathered joints in brick masonry.

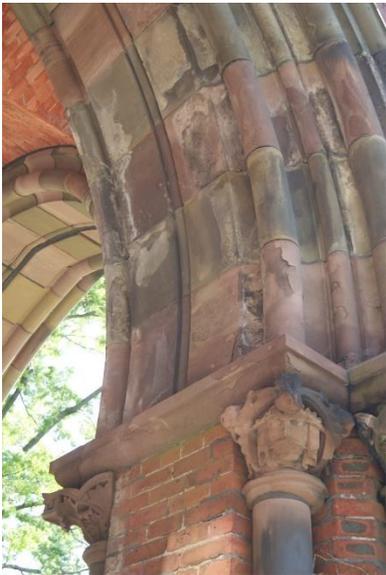
Photo 23. East façade: Efflorescence. Stone surface delamination. Weathered joints in brick masonry.

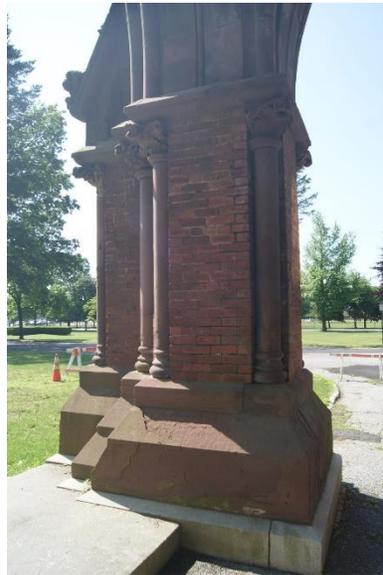
Photo 25. East façade: Efflorescence. Stone surface delamination. Weathered joints in brick masonry.

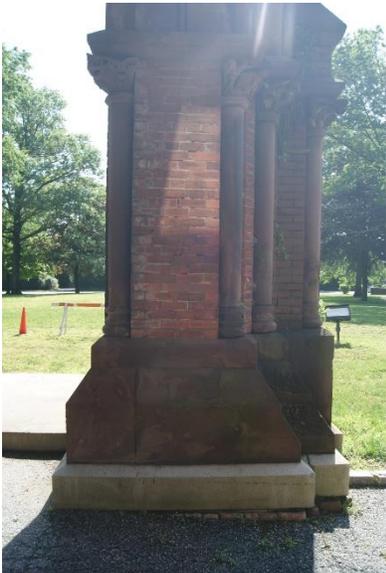
Photo 24. East façade: Efflorescence. Stone surface delamination. Weathered joints in brick masonry.

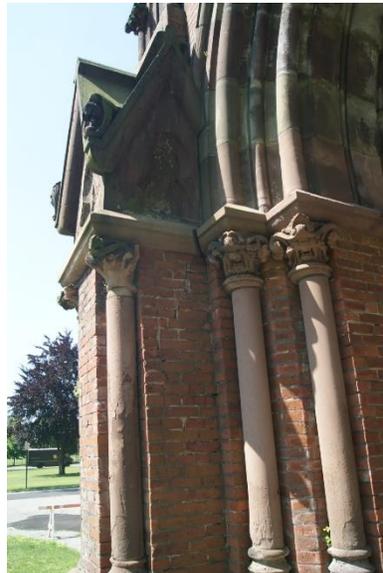
Photo 26. East façade: Efflorescence. Stone surface delamination. Weathered joints in brick masonry. Step cracks in brick masonry.

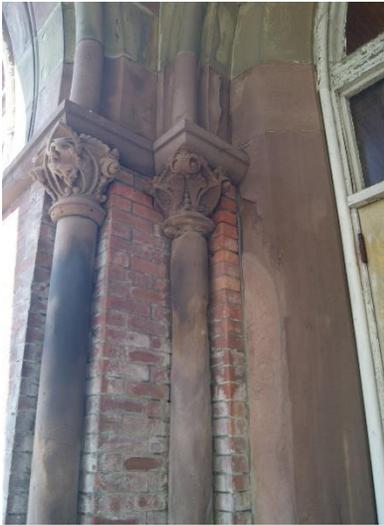
Photo 27. East façade: Efflorescence. Stone surface delamination. Weathered joints in brick masonry.

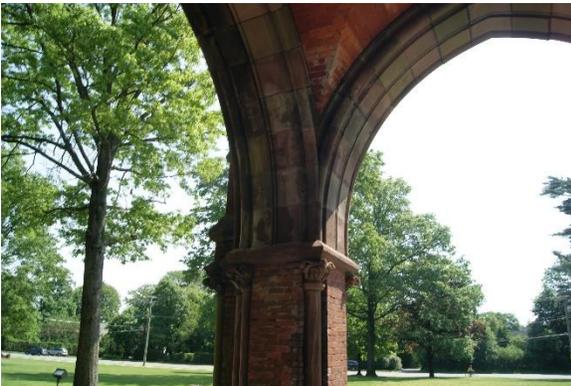
Photo 28. East façade: Efflorescence. Stone surface delamination. Weathered joints in brick masonry.

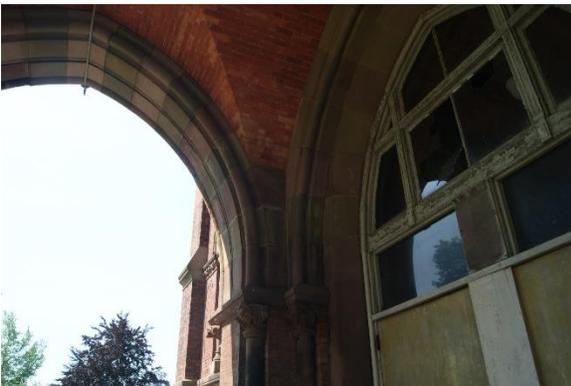
Photo 29. East façade: Stone surface delamination. Weathered joints in brick masonry. Deteriorated wood door frame.

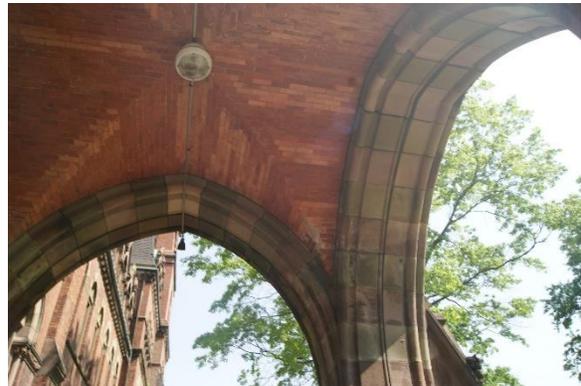
Photo 31. East façade: Stone surface delamination. Weathered joints in brick masonry.

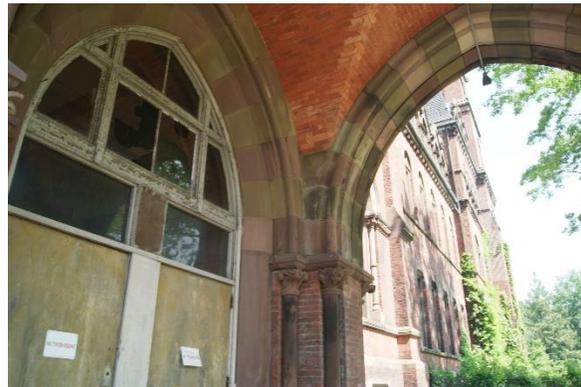
Photo 32. East façade: Stone surface delamination. Weathered joints in brick masonry.

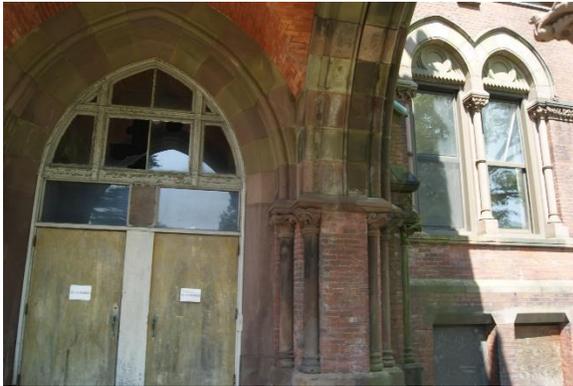
Photo 33. East façade: Stone surface delamination. Weathered joints in brick masonry. Efflorescence.

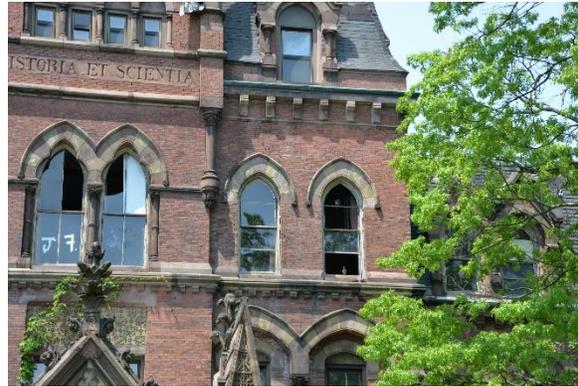
Photo 36. North façade: Missing and cracked window glass. Soiled masonry.

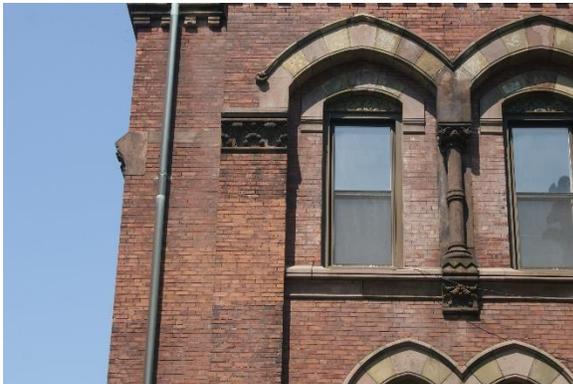
Photo 34. North façade: Soiled masonry. Stone delamination. Efflorescence. Weathered mortar joints.

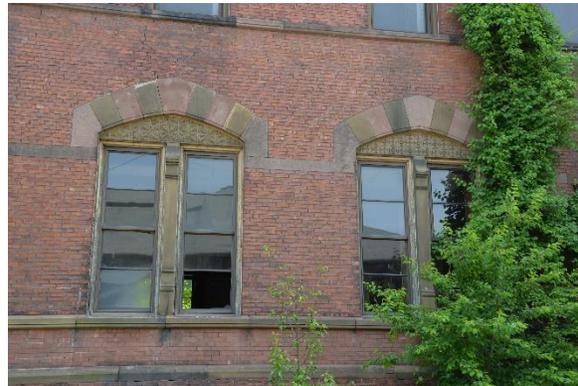
Photo 37. North façade: Missing window glass. Cracked masonry. Stone delamination.

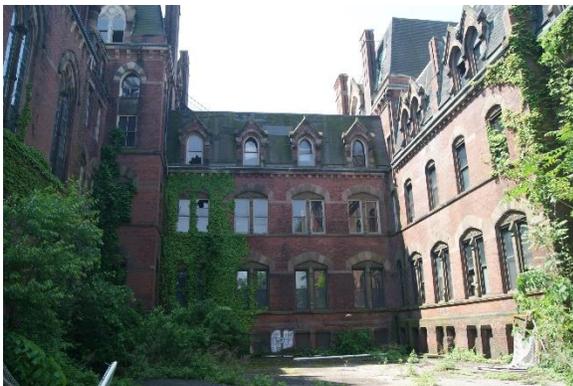
Photo 35. North façade: Cracked window glass. Soiled masonry. Missing downspouts.

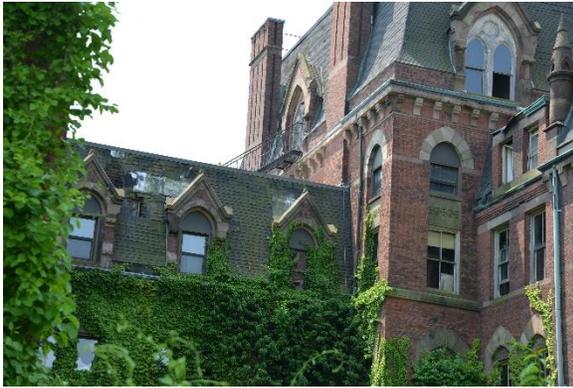
Photo 39. North façade: Roof patches. Missing window glass. Soiled masonry. Deteriorated wood window frames.

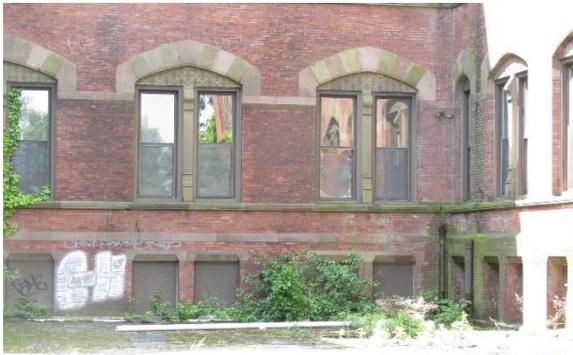
Photo 40. North façade: Soiled masonry.

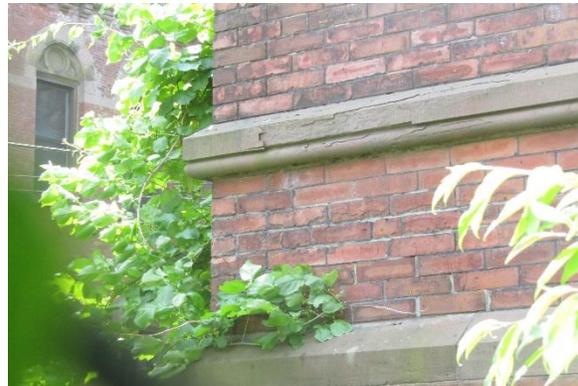
Photo 43. North façade: Soiled masonry. Stone delamination.

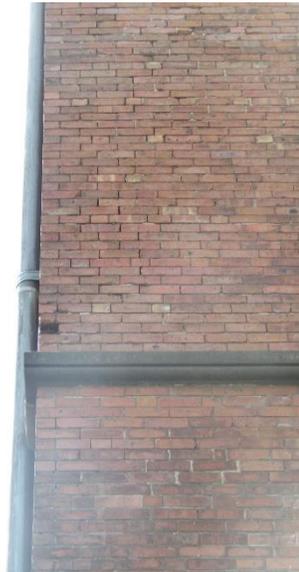
Photo 44. North façade: Open mortar joints. Loose brick masonry. Missing brick.

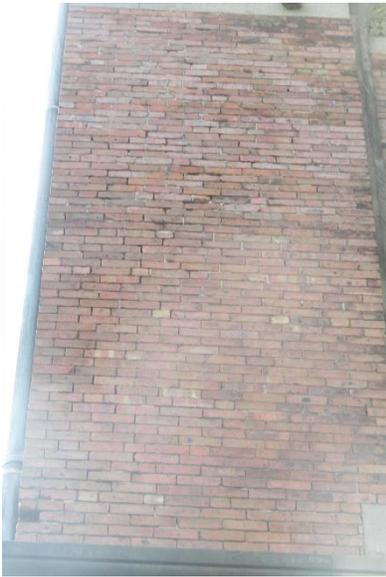
Photo 45. North façade: Open mortar joints. Loose brick masonry. Missing brick.

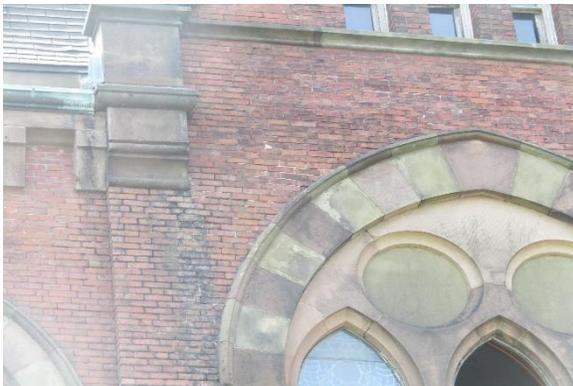
Photo 46. North façade: Open mortar joints. Loose brick masonry. Efflorescence. Stone delamination.

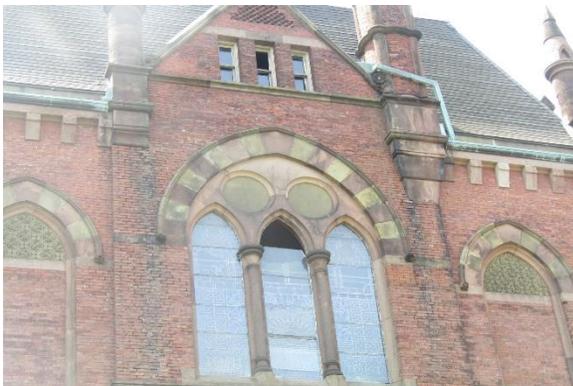
Photo 47. North façade: Missing window glass. Soiled masonry. Stone delamination.

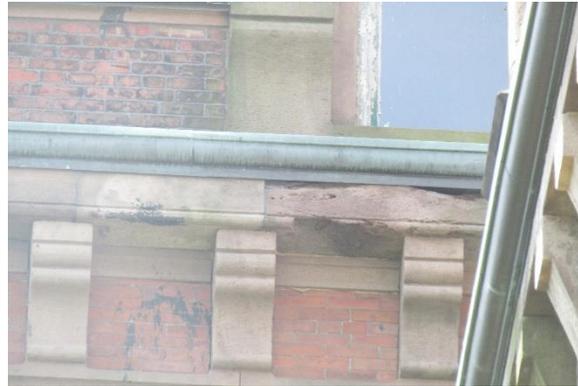
Photo 48. North façade: Soiled masonry. Stone delamination. Stone spall.

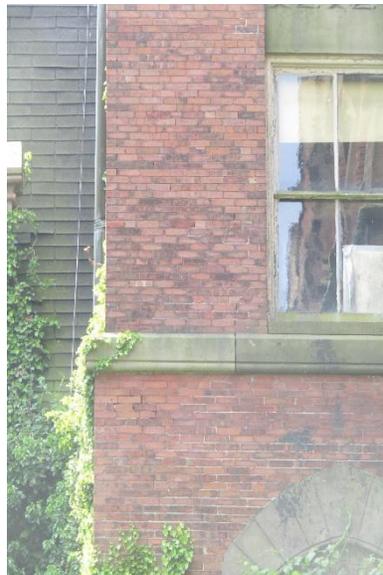
Photo 49. North façade: Soiled masonry. Open mortar joints. Deteriorated wood window frame.

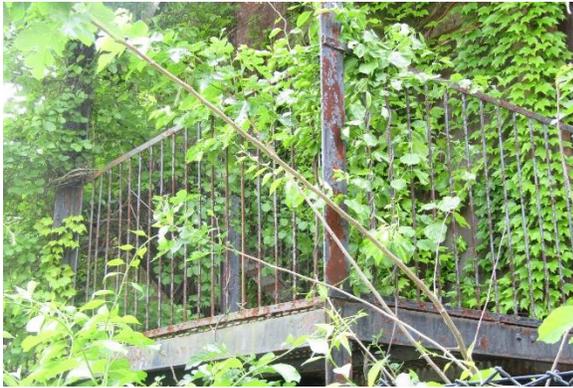
Photo 51. North façade: Corroded fire escape.

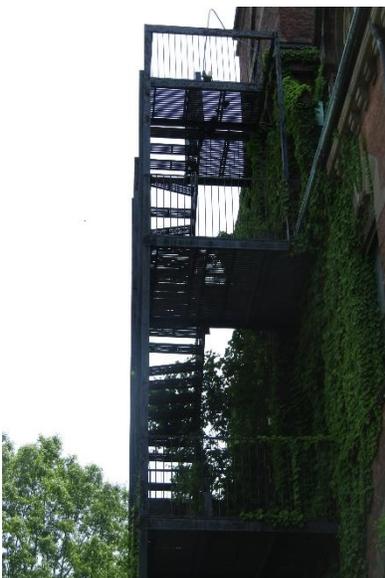
Photo 53. North façade: Displaced fire escape steps.

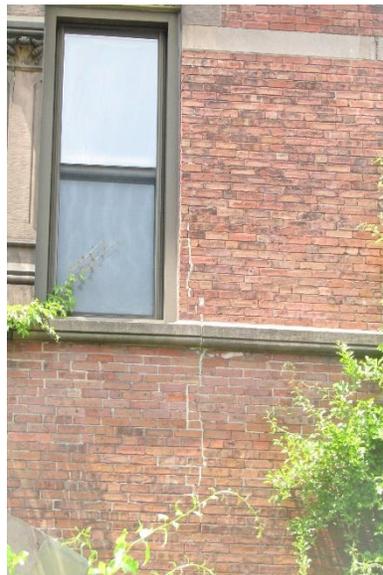
Photo 56. North façade: Re-opened previous crack repair. Soiled masonry.

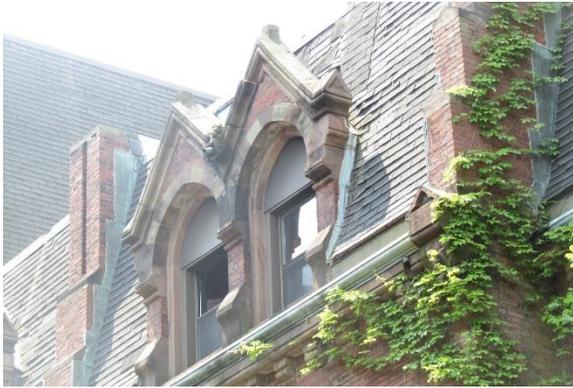
Photo 57. North façade: Missing window glass. Replacement metal arch panel and aluminum window.

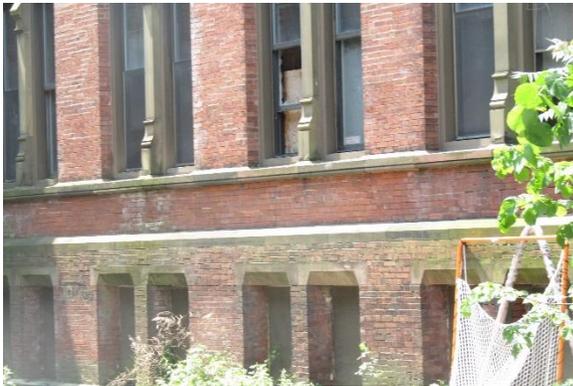
Photo 58. North façade: Efflorescence. Open and weathered mortar joints. Soiled masonry.

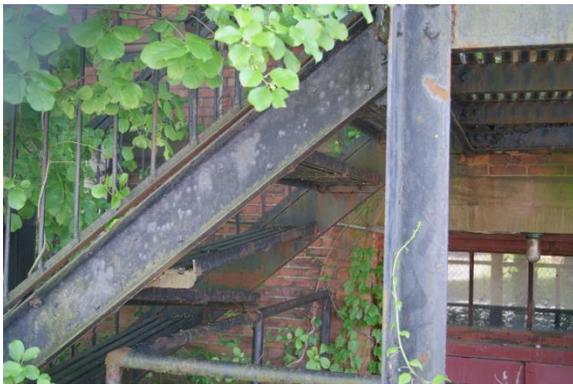
Photo 59. North façade: Failed paint and corrosion at fire escape. Displaced fire escape steps.

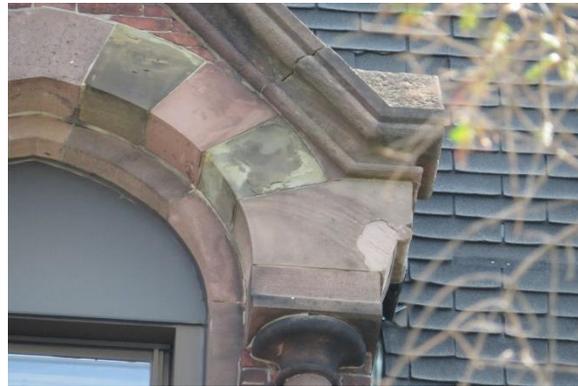
Photo 61. West façade: Soiled and delaminated stone. Replacement metal arch panel and aluminum window.

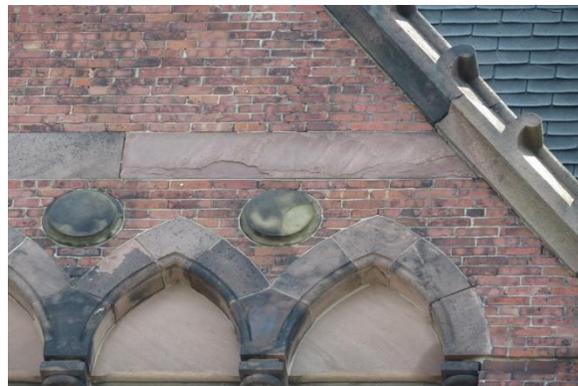
Photo 62. West façade: Stone delamination. Soiled masonry. Open mortar joints.

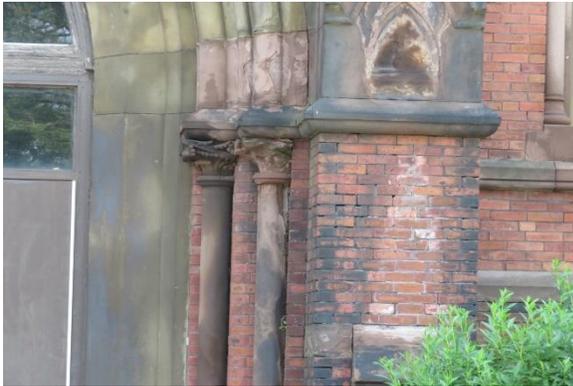
Photo 63. West façade: Stone delamination. Soiled masonry. Open mortar joints.

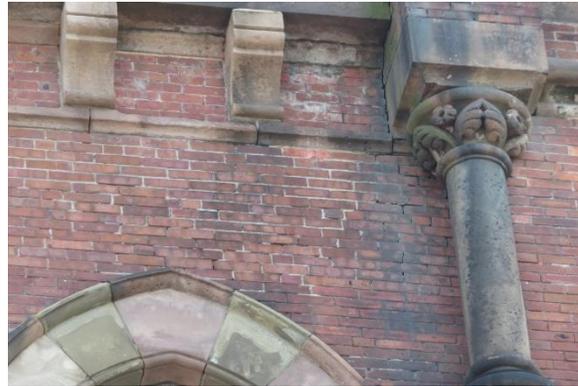
Photo 66. West façade: Stone delamination. Soiled masonry. Open mortar joints.

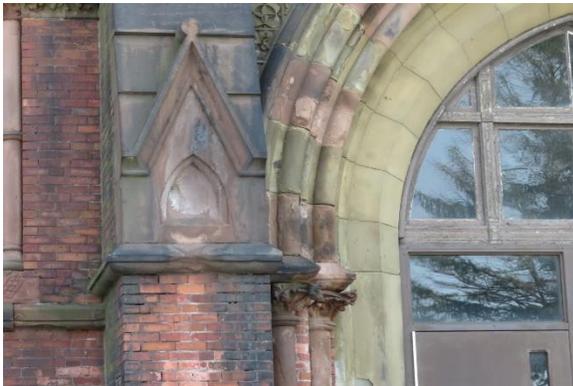
Photo 64. West façade: Stone delamination. Soiled masonry. Open mortar joints.

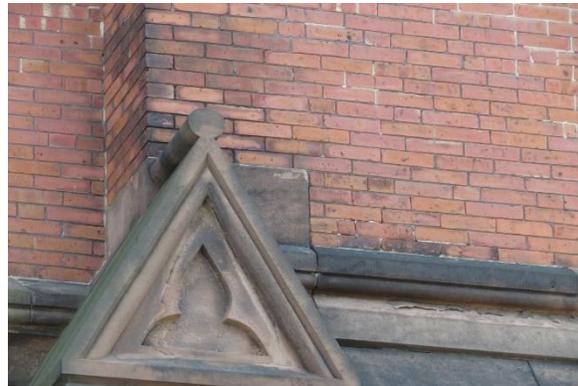
Photo 67. West façade: Stone delamination. Soiled masonry. Open mortar joints.

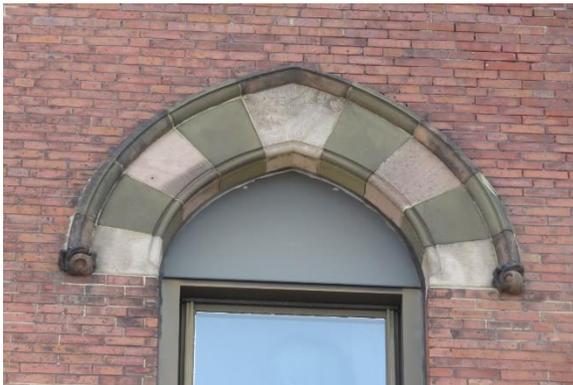
Photo 65. West façade: Stone delamination. Soiled masonry. Open mortar joints. Replacement metal arch panel and aluminum window.

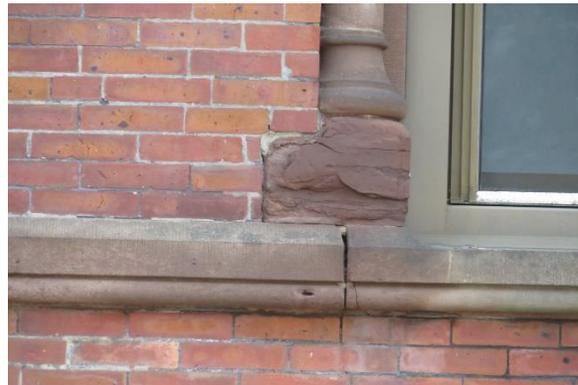
Photo 68. West façade: Stone delamination. Soiled masonry. Open mortar joints. Chipped stone.

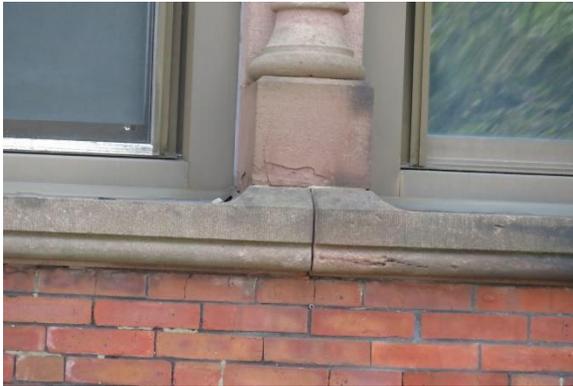
Photo 69. West façade: Stone delamination. Soiled masonry. Open mortar joints.

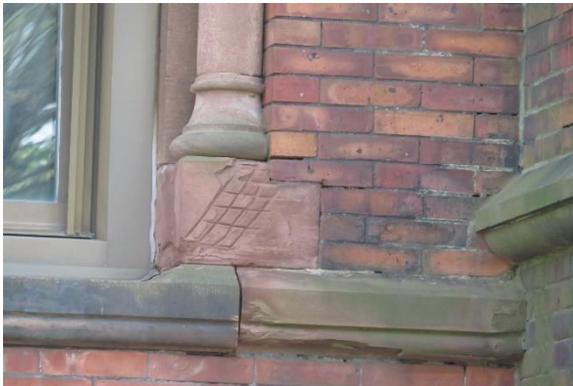
Photo 70. West façade: Stone delamination. Soiled masonry. Open mortar joints. Spalled stone.

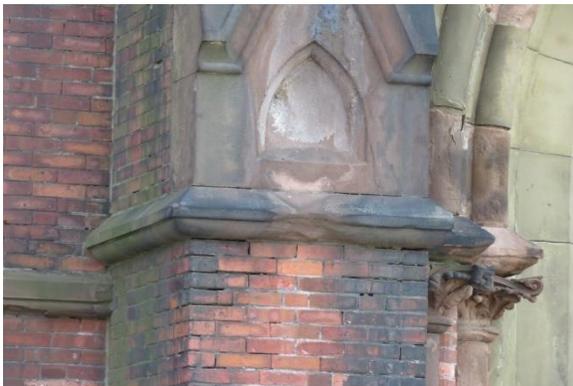
Photo 71. West façade: Stone delamination. Soiled masonry. Open mortar joints. Loose masonry. Efflorescence.

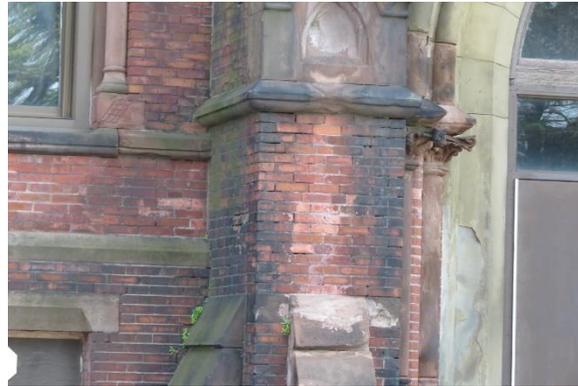
Photo 72. West façade: Stone delamination. Soiled masonry. Open mortar joints. Efflorescence. Biological growth.

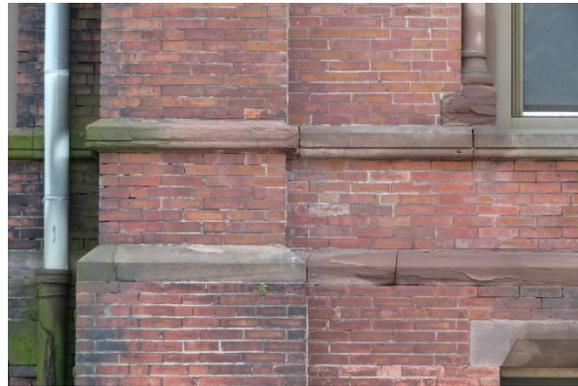
Photo 73. West façade: Stone delamination. Soiled masonry. Open and weathered mortar joints. Efflorescence.

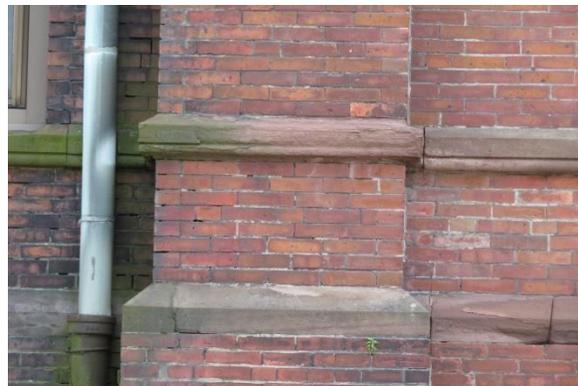
Photo 74. West façade: Stone delamination. Soiled masonry. Open and weathered mortar joints. Cracked stone. Bio-growth.

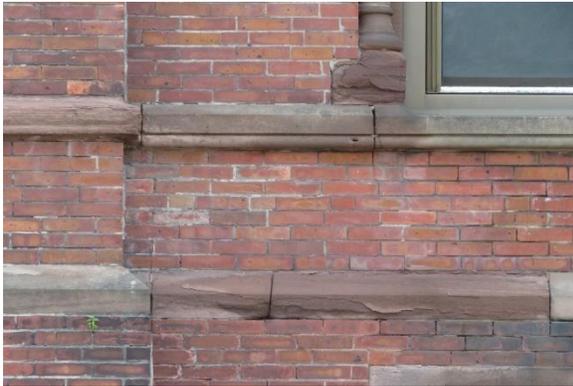
Photo 75. West façade: Stone delamination. Soiled masonry. Open and weathered mortar joints. Cracked stone.

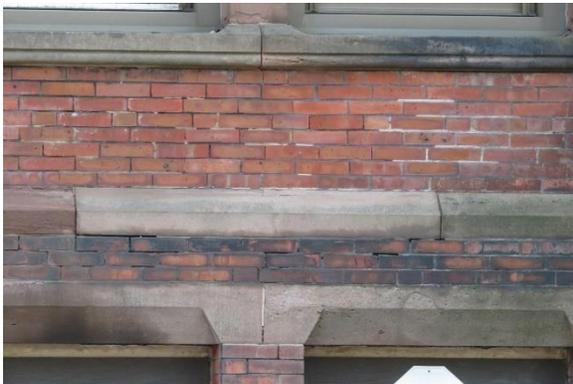
Photo 76. West façade: Stone delamination. Soiled masonry. Open and weathered mortar joints.

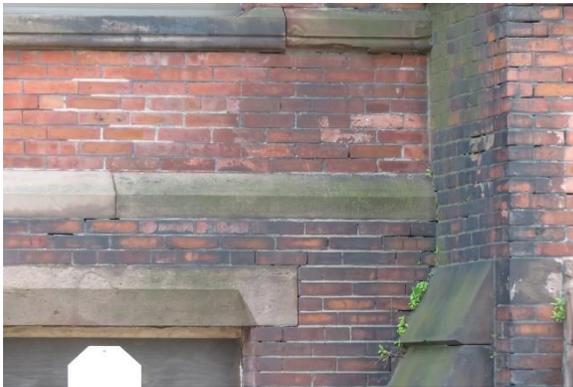
Photo 77. West façade: Stone delamination. Soiled masonry. Open and weathered mortar joints. Bio-growth.

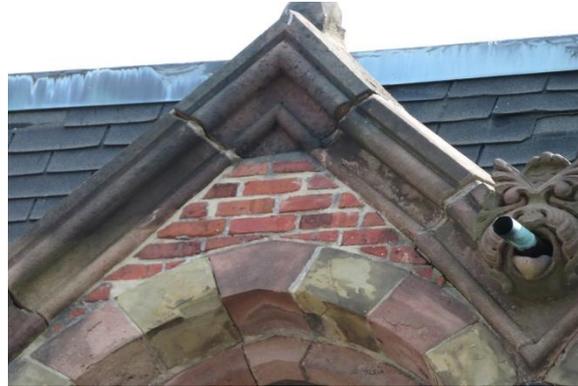
Photo 78. West façade: Stone delamination. Soiled masonry. Cracked stone.

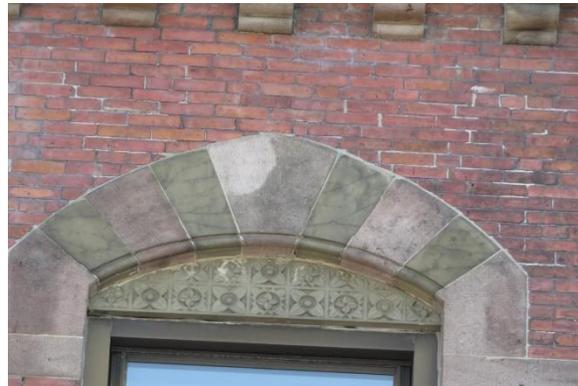
Photo 79. West façade: Stone delamination. Cracked stone.

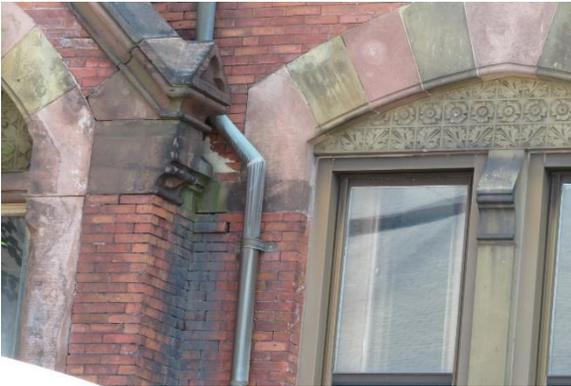
Photo 81. West façade: Stone delamination. Soiled masonry. Cracked stone. Loose brick masonry. Open mortar joints.

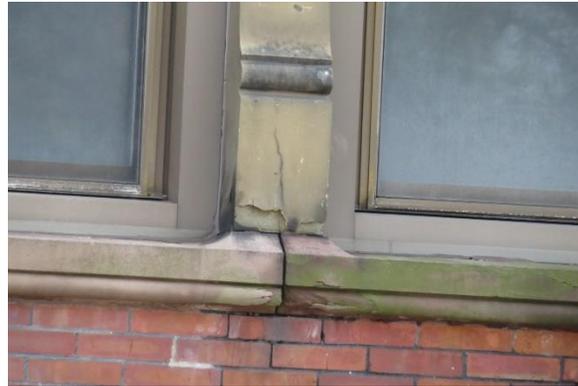
Photo 84. West façade: Stone delamination. Cracked stone. Open mortar joints.

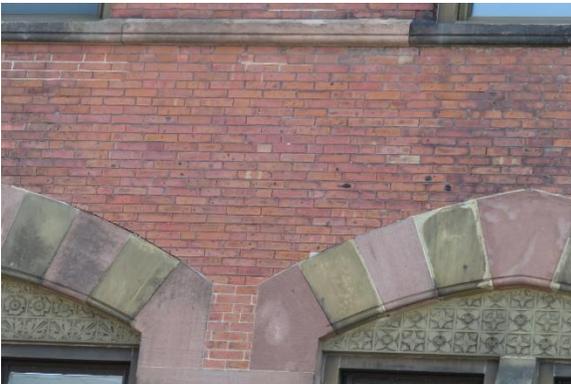
Photo 82. West façade: Stone delamination. Weathered mortar joints.

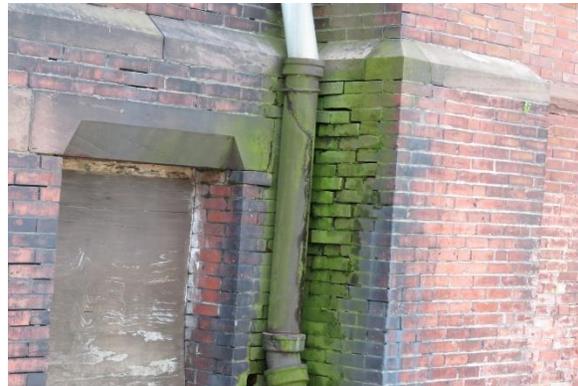
Photo 85. West façade: Stone delamination. Soiled masonry. Cracked downspout. Open and weathered mortar joints. Loose brick masonry. Biological growth.

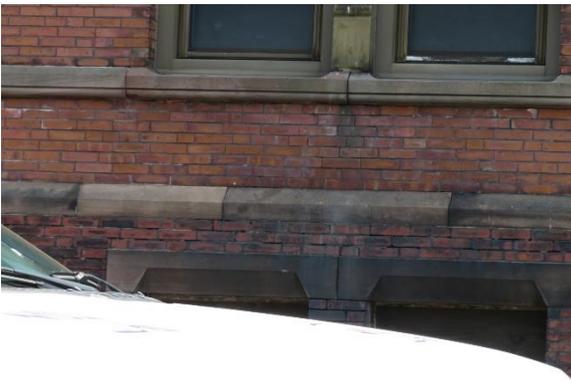
Photo 83. West façade: Stone delamination. Soiled masonry. Efflorescence. Open mortar joints.

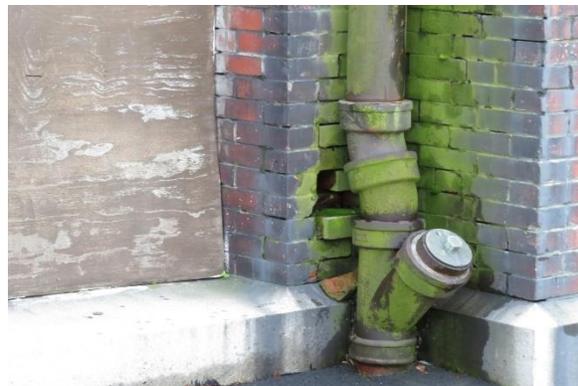
Photo 86. West façade: Soiled masonry. Open and weathered mortar joints. Loose brick masonry. Biological growth.

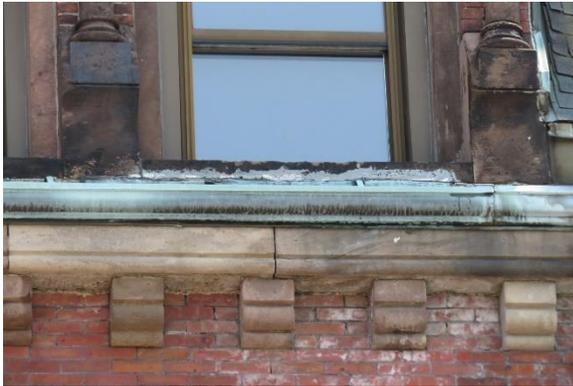
Photo 87. West façade: Stone delamination. Soiled masonry. Efflorescence. Weathered mortar joints.

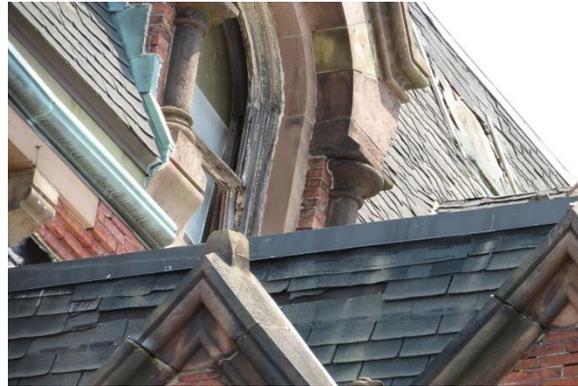
Photo 90. West façade: Deteriorated wood window frame.

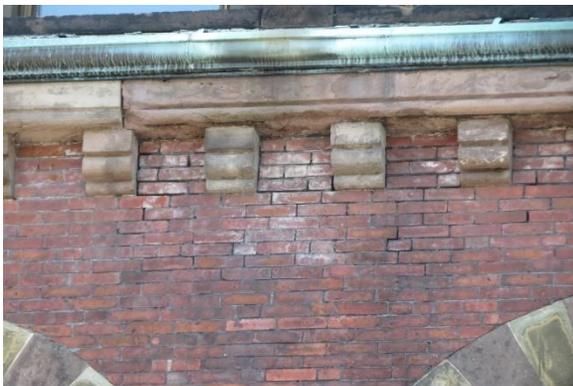
Photo 88. West façade: Stone delamination. Soiled masonry. Open and weathered mortar joints. Loose brick masonry. Efflorescence.

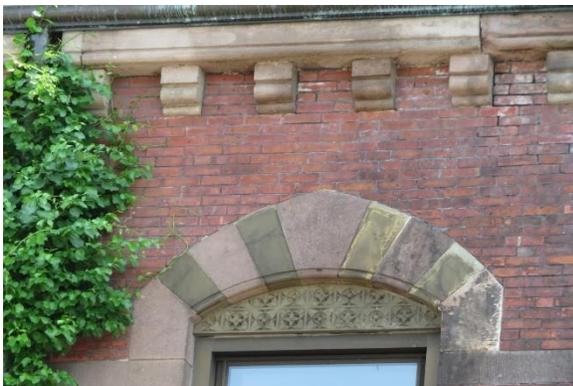
Photo 89. West façade: Stone delamination. Cracked stone. Soiled masonry. Open and weathered mortar joints. Loose brick masonry. Efflorescence.

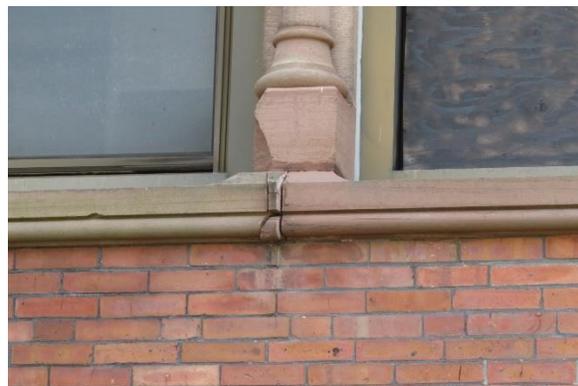
Photo 92. West façade: Cracked and spalled stone.

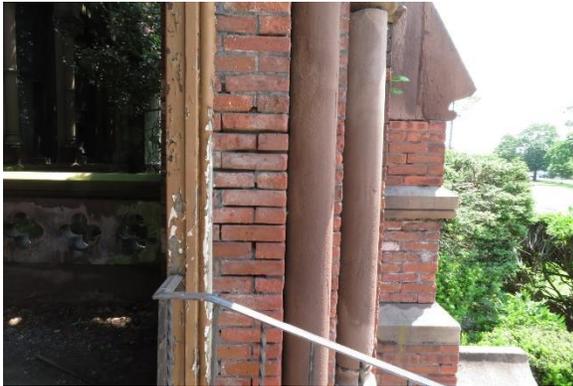
Photo 93. West façade: Open and weathered mortar joints. Loose brick masonry. Efflorescence. Missing wood window.

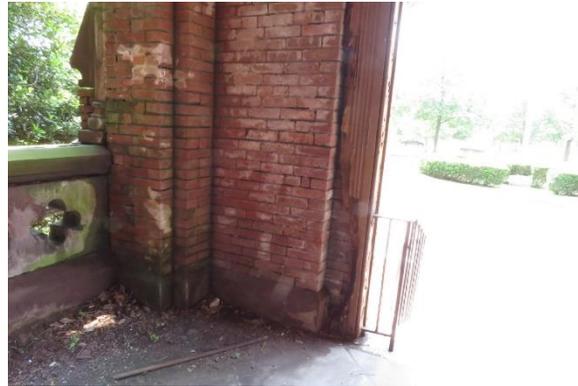
Photo 96. South portico: Open and weathered mortar joints. Efflorescence. Missing wood window.

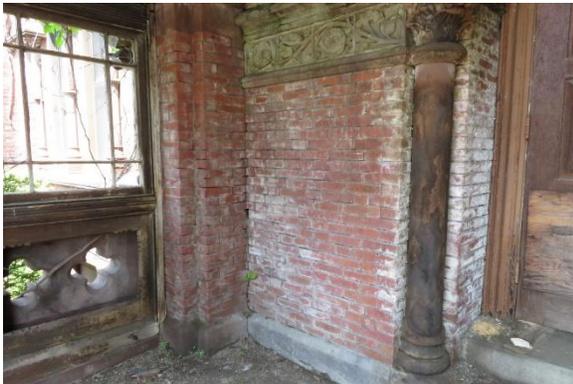
Photo 94. West façade: Open and weathered mortar joints. Efflorescence. Deteriorated woodwork. Stone delamination.

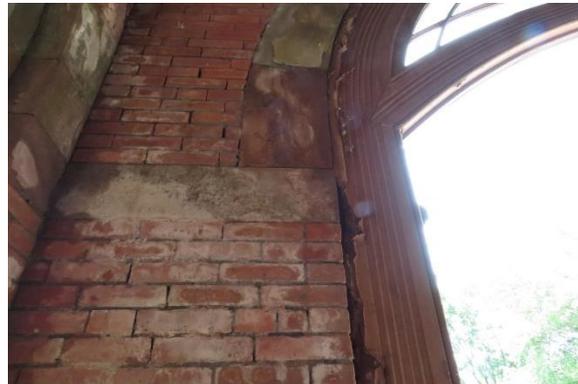
Photo 97. South portico: Open and weathered mortar joints. Efflorescence. Deteriorated woodwork. Stone delamination.

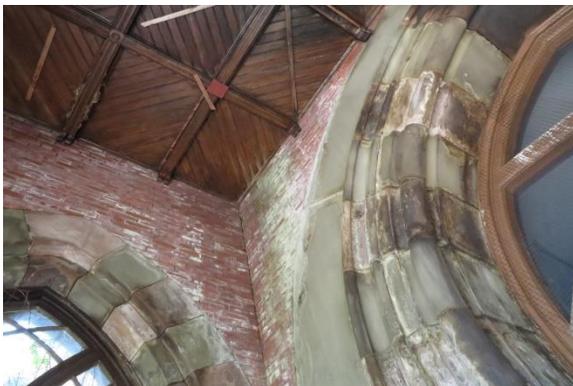
Photo 95. South portico: Efflorescence. Soiled masonry. Deteriorated woodwork. Stone delamination. Deteriorated wood ceiling.

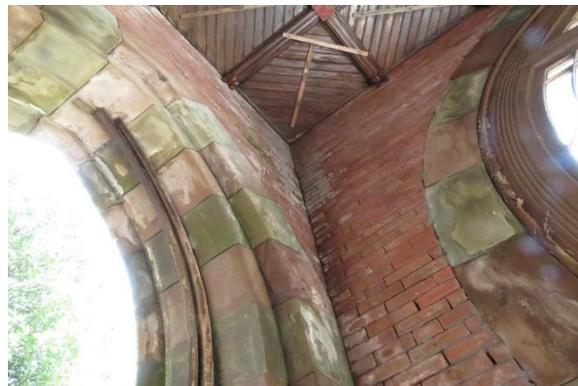
Photo 98. South portico: Open and weathered mortar joints. Loose brick masonry. Efflorescence. Deteriorated woodwork. Stone delamination.

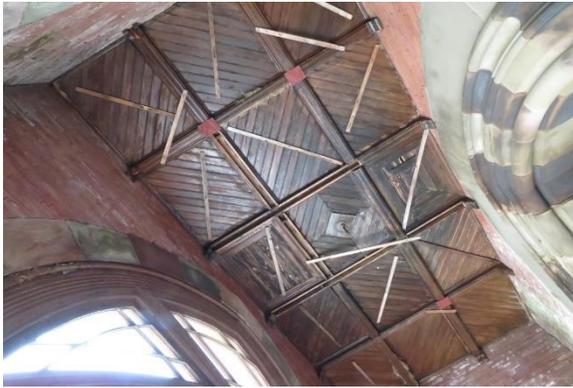
Photo 99. South portico: Open and weathered mortar joints. Efflorescence. Stone delamination. Deteriorated wood ceiling.

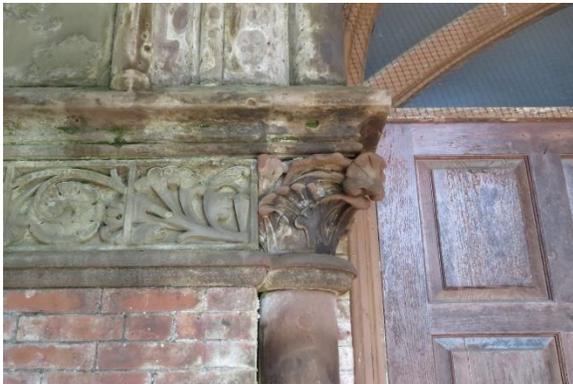
Photo 100. South portico: Weathered mortar joints. Efflorescence. Stone delamination.

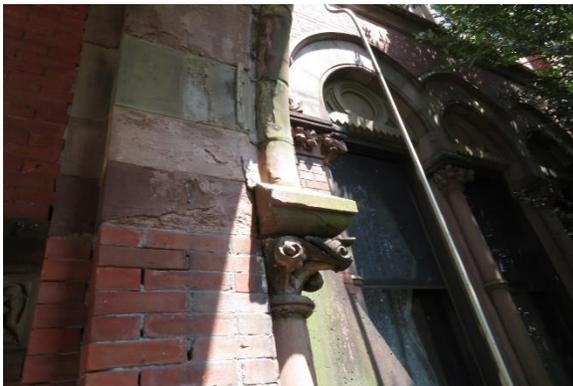
Photo 101. South portico: Open and weathered mortar joints. Stone delamination.

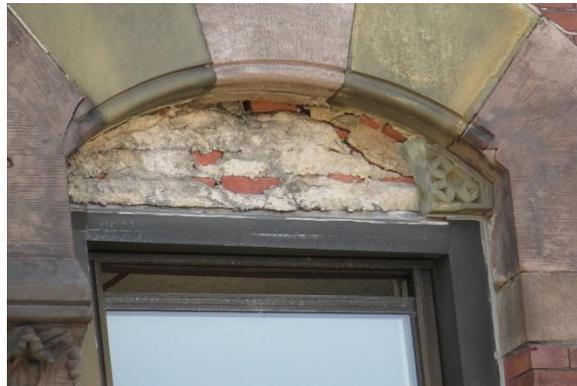
Photo 103. West façade: Cracked stone. Spalled stone. Missing decorative terra cotta panel. Cracked mortar.

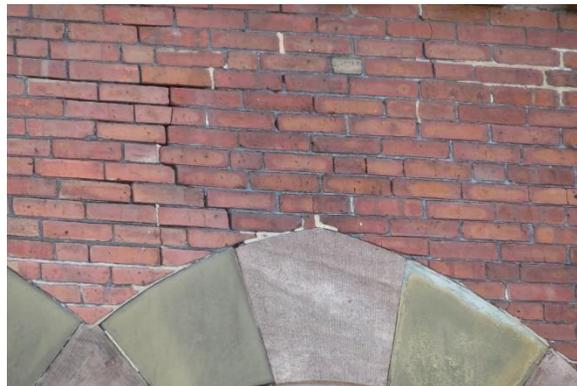
Photo 104. West façade: Brick masonry crack. Open and weathered mortar joints.

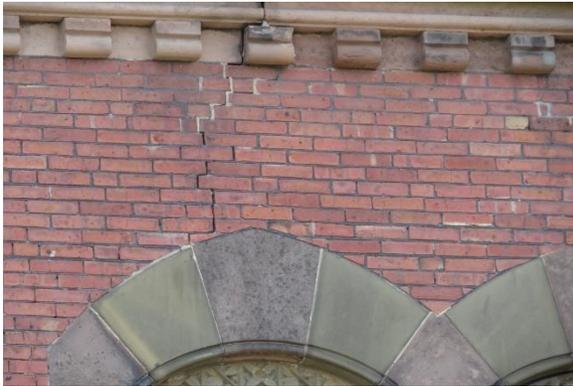
Photo 105. West façade: Brick masonry crack. Open and weathered mortar joints. Stone surface delamination.

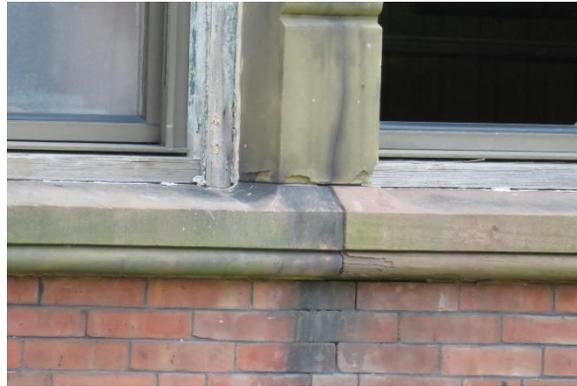
Photo 108. West façade: Stone surface delamination. Open and weathered mortar joints. Soiled masonry. Deteriorated wood window frames. Missing window glass.

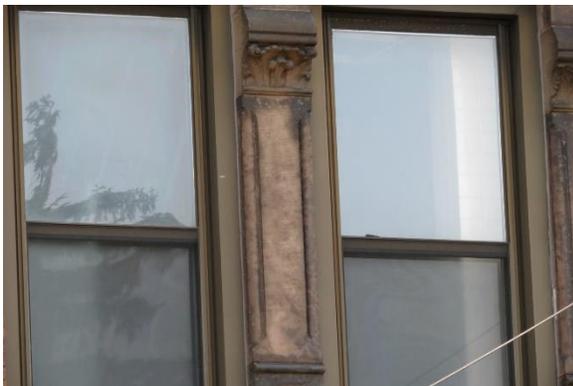
Photo 106. West façade: Stone surface delamination.
