St. Paul's School
Garden City, NY

Building Envelope and Structural Condition
Assessment Report

July 19, 2019

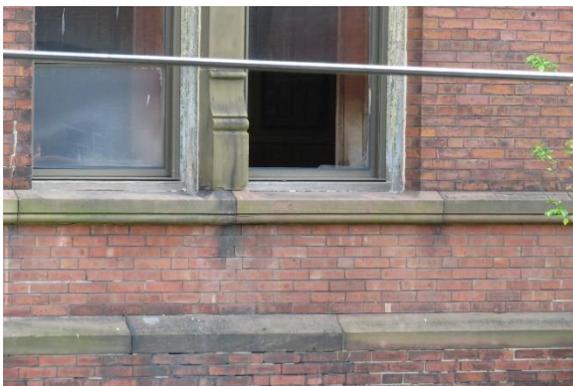
Photo 107. West façade: Stone surface delamination. Open and weathered mortar joints. Soiled masonry. Deteriorated wood window frames. Missing window glass.

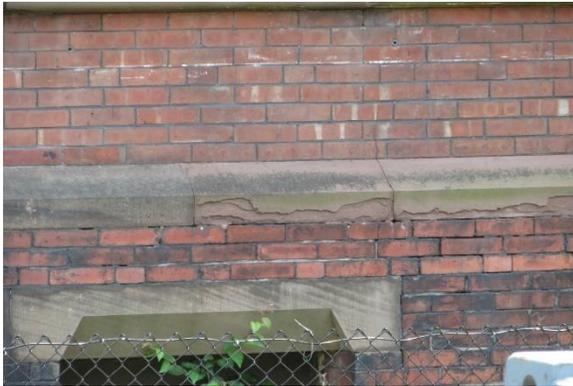
Photo 111. West façade: Stone surface delamination. Open and weathered mortar joints. Soiled masonry. Cracked stone. Cracked brick masonry. Miscellaneous weep.

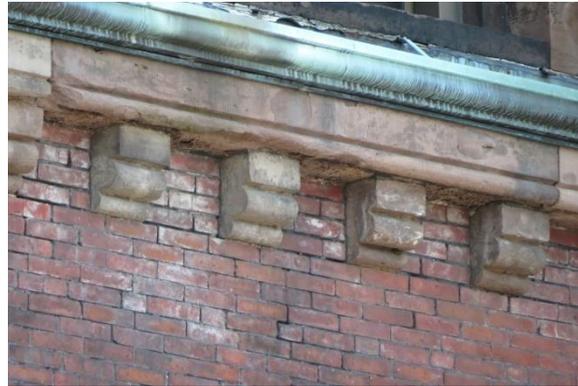
Photo 113. West façade: Stone surface delamination. Open and weathered mortar joints. Soiled masonry. Efflorescence.

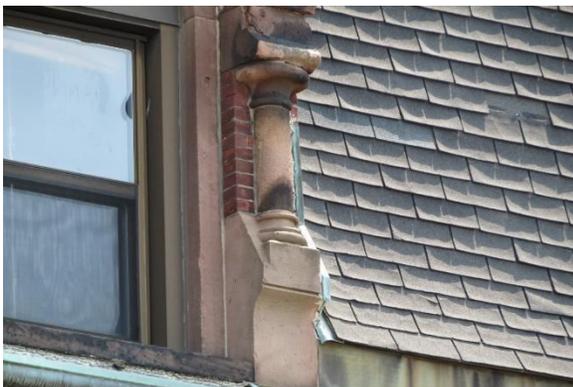
Photo 112. West façade: Stone surface delamination. Soiled masonry.

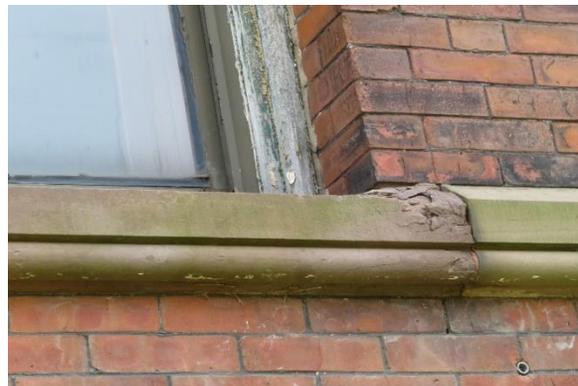
Photo 114. West façade: Stone surface delamination. Weathered mortar joints. Soiled masonry. Deteriorated wood window frames. Cracked brick masonry. Miscellaneous weep.

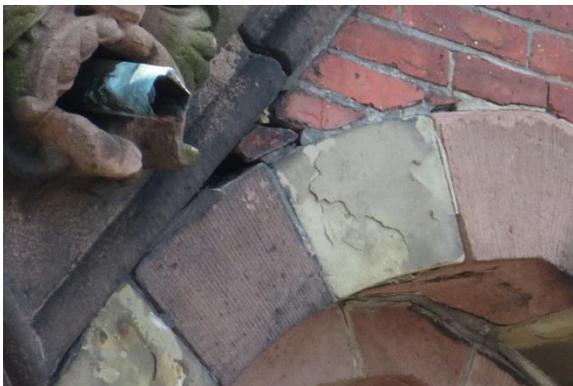
Photo 115. West façade: Stone surface delamination. Open and weathered mortar joints. Deformed scupper.

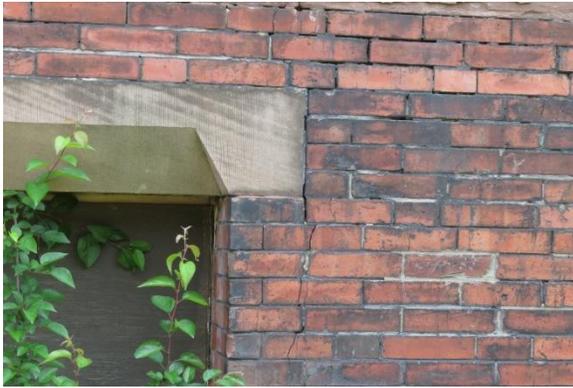
Photo 117. West façade: Open and weathered mortar joints. Soiled masonry. Cracked stone. Cracked brick masonry.

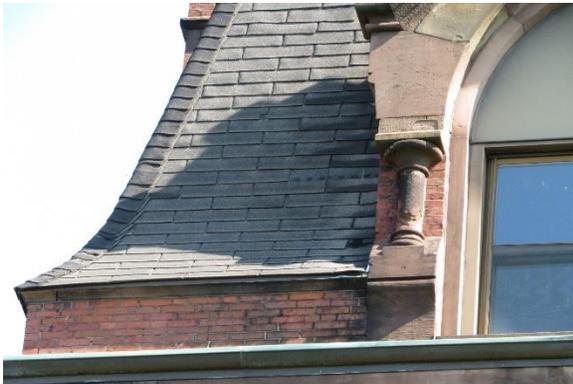
Photo 118. South façade: Stone surface delamination. Open and weathered mortar joints. Soiled masonry.

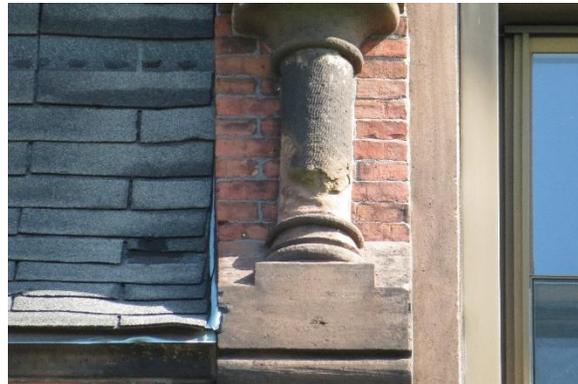
Photo 121. South façade: Stone surface delamination. Weathered mortar joints.

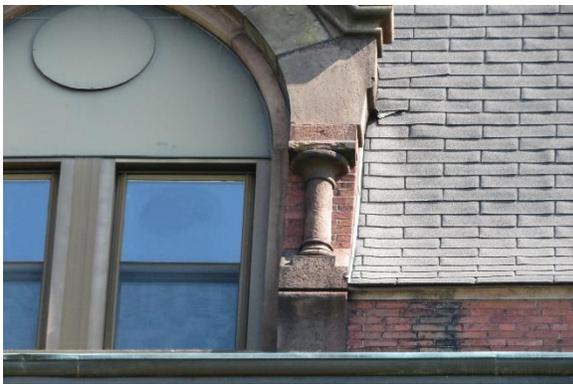
Photo 119. South façade: Stone surface delamination. Open and weathered mortar joints. Soiled masonry. Replacement metal arch panel.

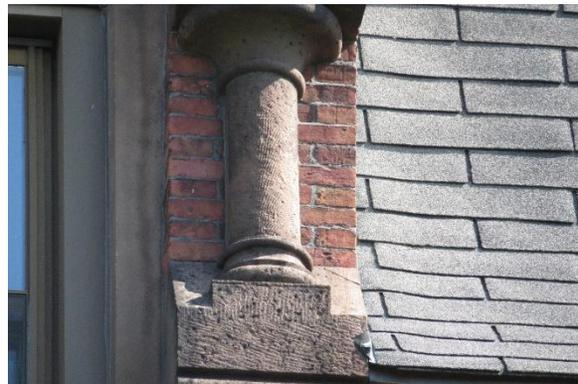
Photo 122. South façade: Stone surface delamination. Cracked stone.

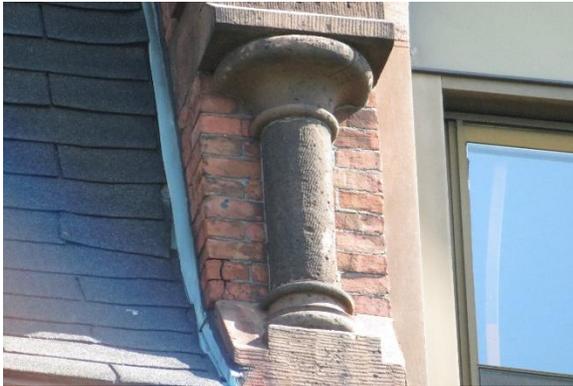
Photo 123. South façade: Cracked brick.

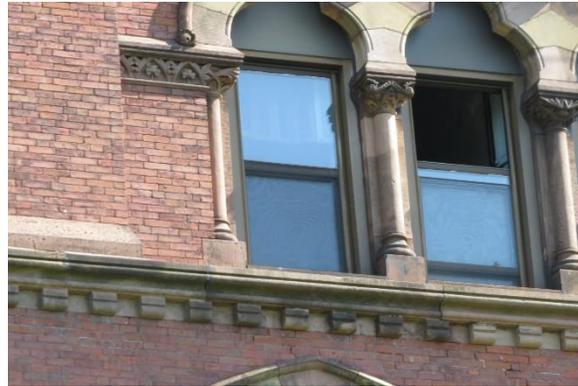
Photo 126. South façade: Open and weathered mortar joints. Soiled masonry. Missing window glass. Brick masonry crack.

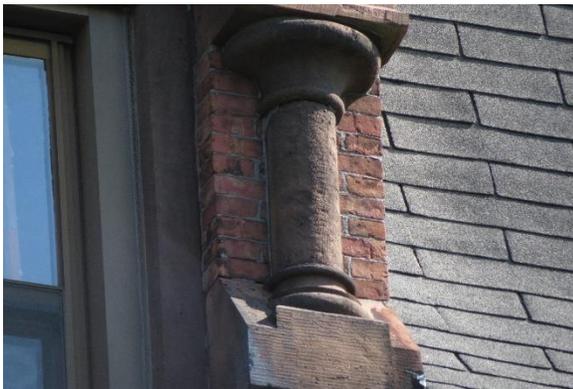
Photo 124. South façade: Stone surface delamination. Weathered mortar joints. Soiled masonry.

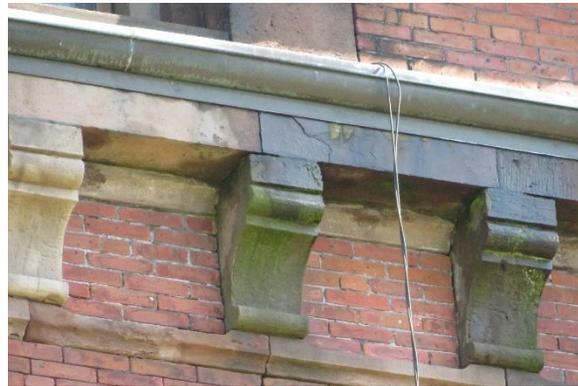
Photo 127. South façade: Stone surface delamination. Weathered mortar joints. Soiled masonry.

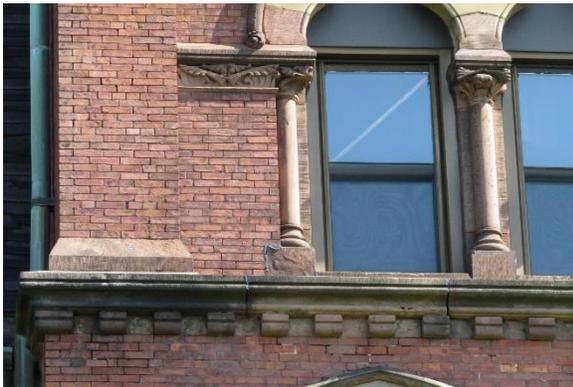
Photo 125. South façade: Stone surface delamination. Open and weathered mortar joints. Loose brick masonry.

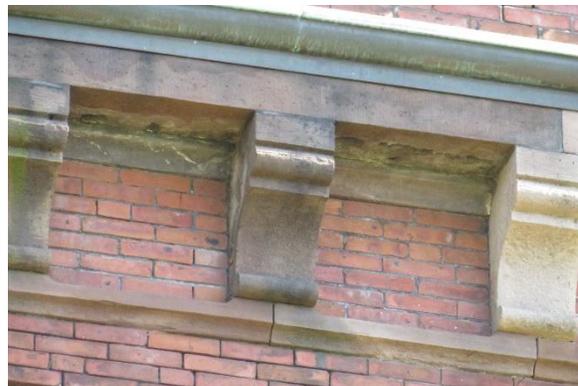
Photo 128. South façade: Stone surface delamination. Weathered mortar joints. Soiled masonry.

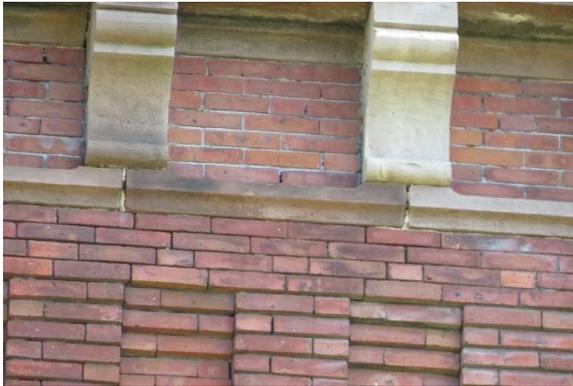
Photo 129. South façade: Stone surface delamination. Weathered mortar joints. Soiled masonry. Loose brick masonry.

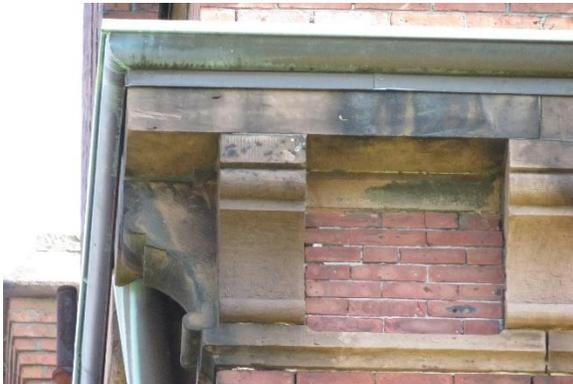
Photo 130. South façade: Stone surface delamination. Open and weathered mortar joints. Soiled masonry. Efflorescence. Cracked brick.

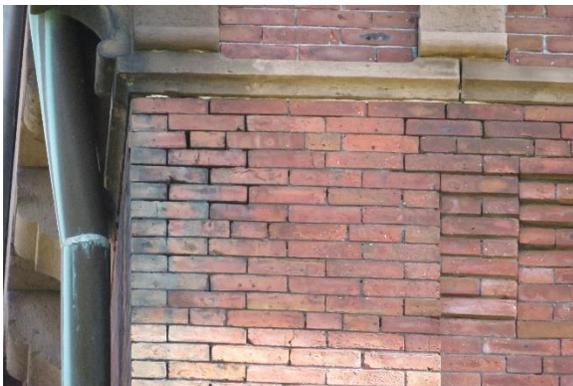
Photo 131. South façade: Open mortar joints. Loose brick masonry. Soiled masonry. Damaged downspout.

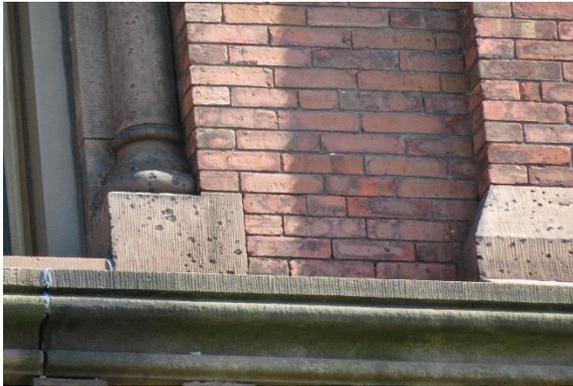
Photo 135. South façade: Stone surface delamination. Open and weathered mortar joints.

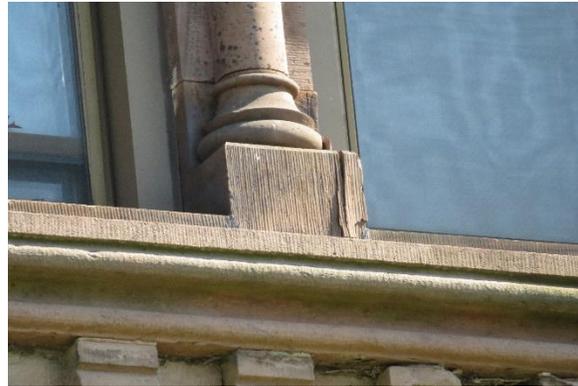
Photo 138. South façade: Stone surface delamination. Cracked stone.

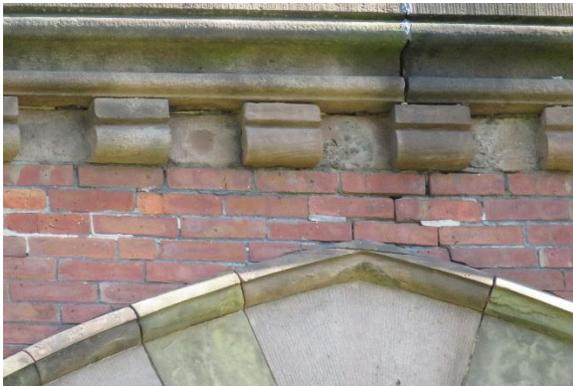
Photo 136. South façade: Stone surface delamination. Cracked stone. Cracked brick masonry. Open and weathered mortar joints.

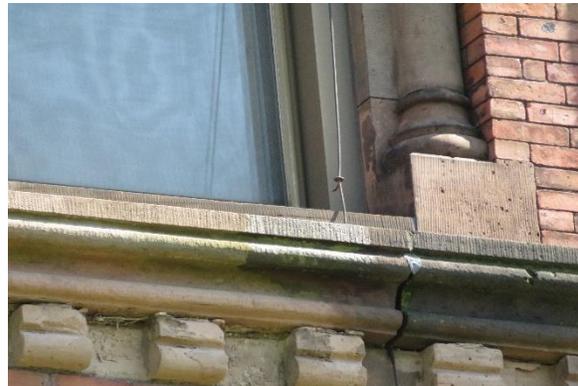
Photo 139. South façade: Stone surface delamination. Open mortar joints.

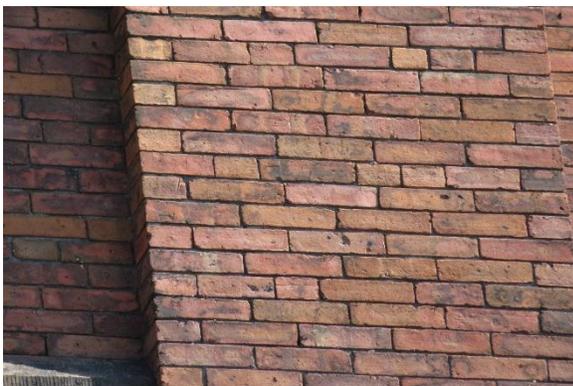
Photo 137. South façade: Open and weathered mortar joints.

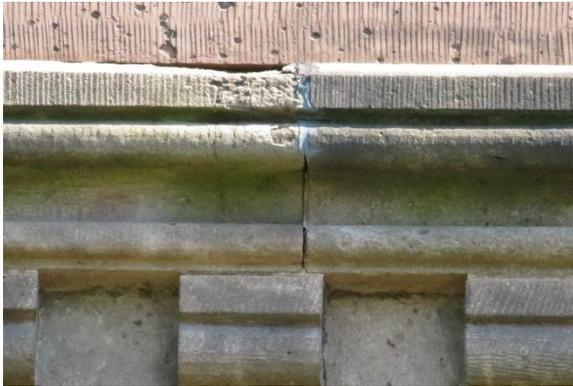
Photo 141. South façade: Stone surface delamination. Spalled stone. Open mortar joints.

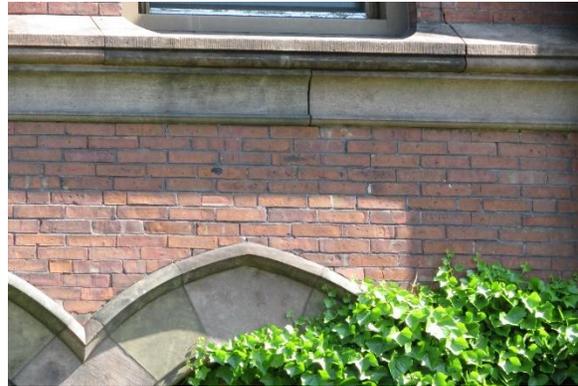
Photo 144. South façade: Open and weathered mortar joints.

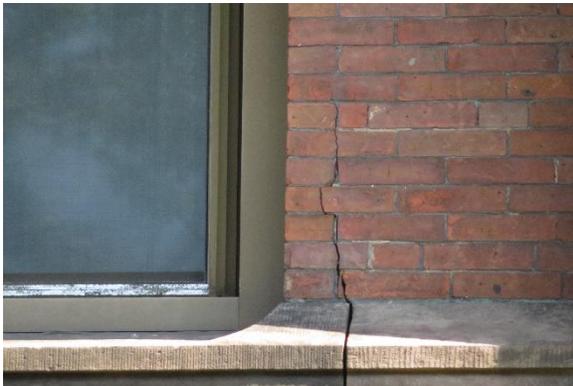
Photo 142. South façade: Open mortar joints. Cracked brick masonry.

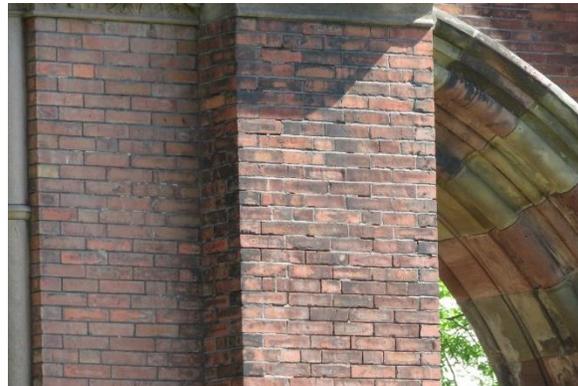
Photo 145. South façade: Open and weathered mortar joints. Stone surface delamination.

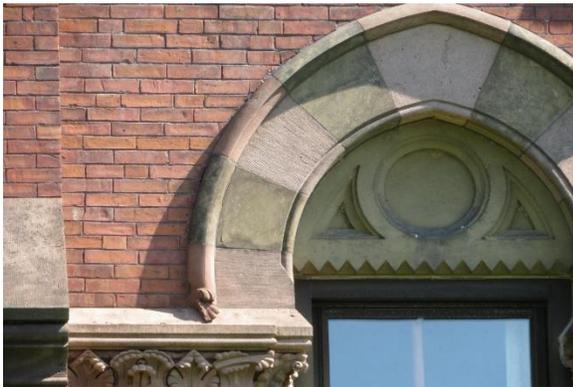
Photo 143. South façade: Cracked brick masonry. Weathered mortar joints.

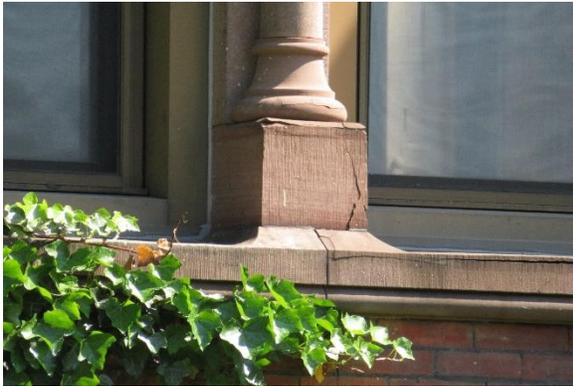
Photo 147. South façade: Cracked stone. Stone surface delamination.

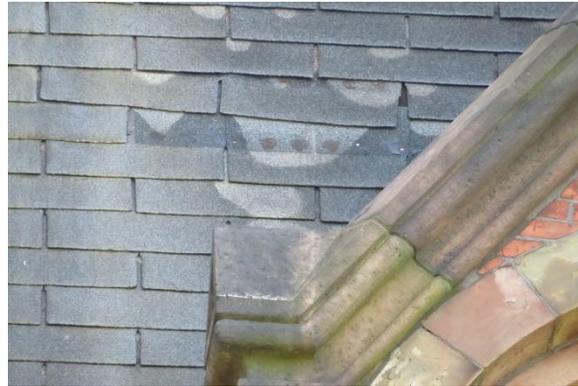
Photo 150. South façade: Stone surface delamination.

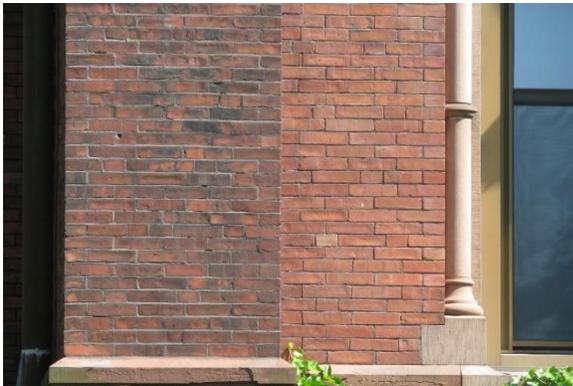
Photo 148. South façade: Open and weathered mortar joints. Stone surface delamination.

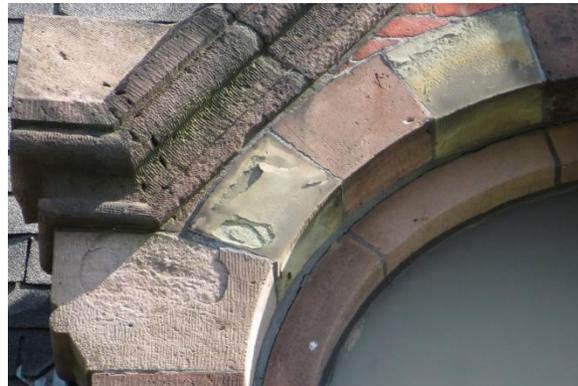
Photo 151. South façade: Stone surface delamination.

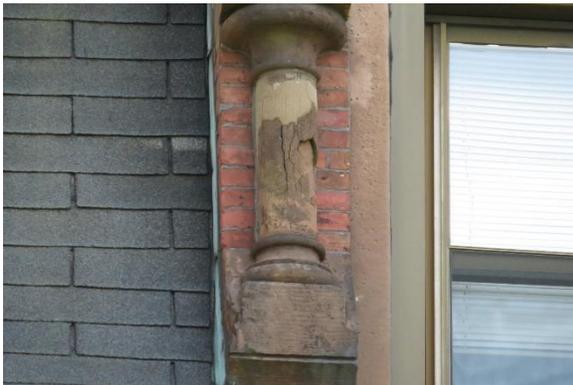
Photo 149. South façade: Stone surface delamination.

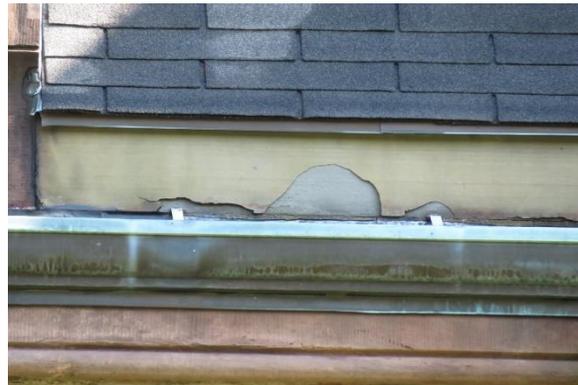
Photo 152. South façade: Stone surface delamination.

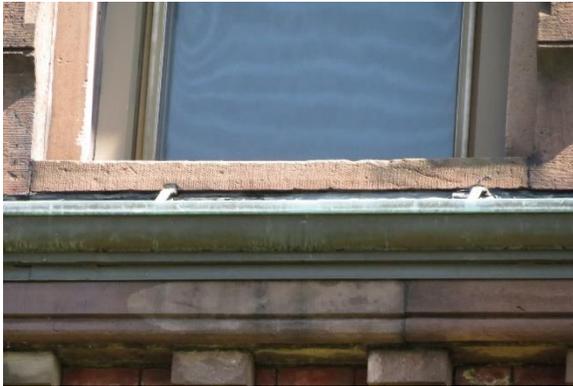
Photo 153. South façade: Stone surface delamination.

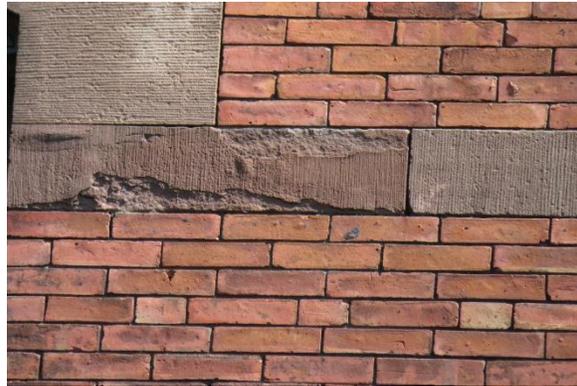
Photo 156. South façade: Stone surface delamination.

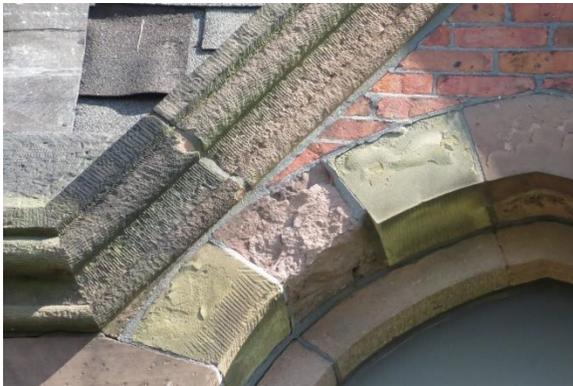
Photo 154. South façade: Stone surface delamination.

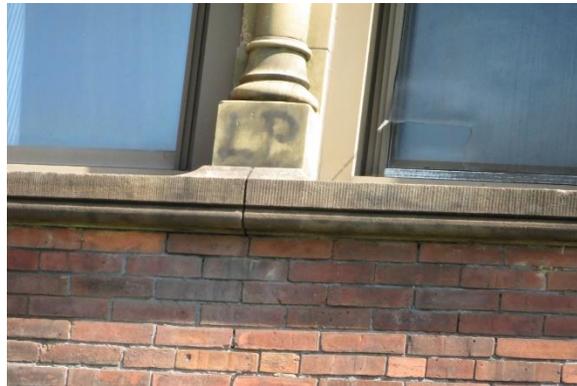
Photo 157. South façade: Open and weathered mortar joints. Stone surface delamination.

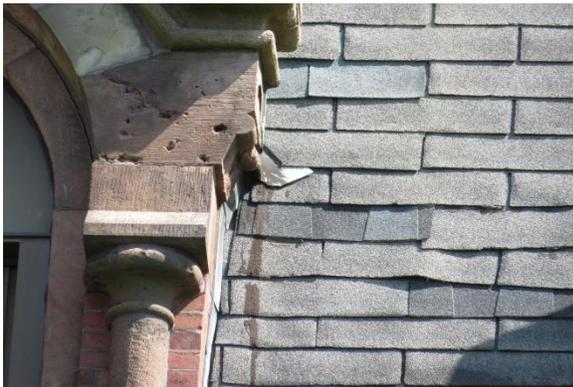
Photo 155. South façade: Stone surface delamination.

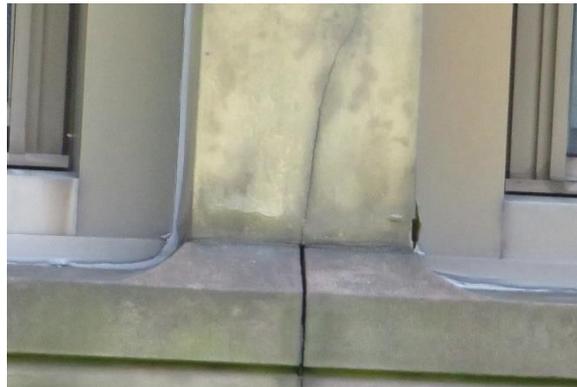
Photo 158. South façade: Open mortar joint. Stone crack. Stone surface delamination.

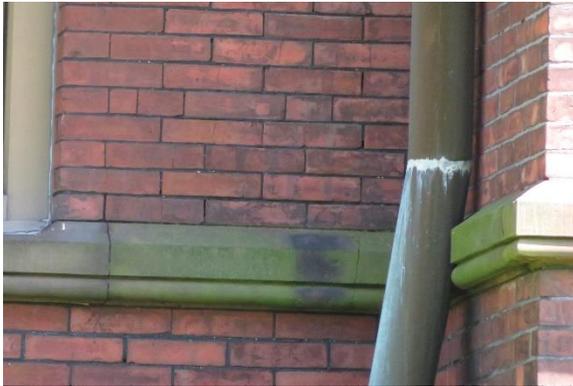
Photo 159. South façade: Open and weathered mortar joints. Soiled brick masonry.

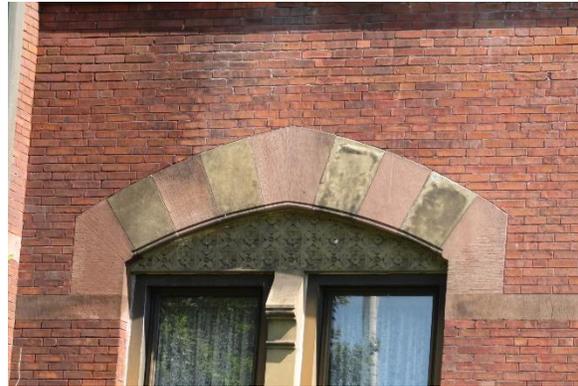
Photo 162. South façade: Weathered mortar joints. Stone delamination.

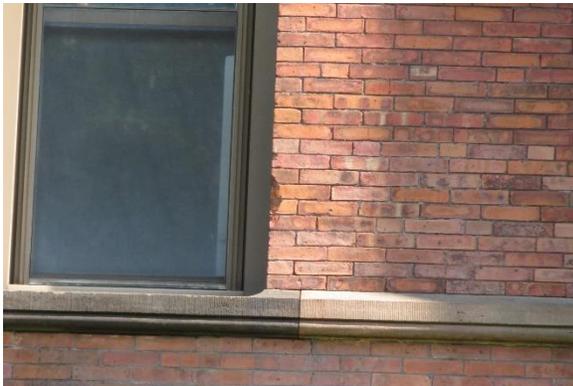
Photo 160. South façade: Spalled brick. Weathered mortar joints.

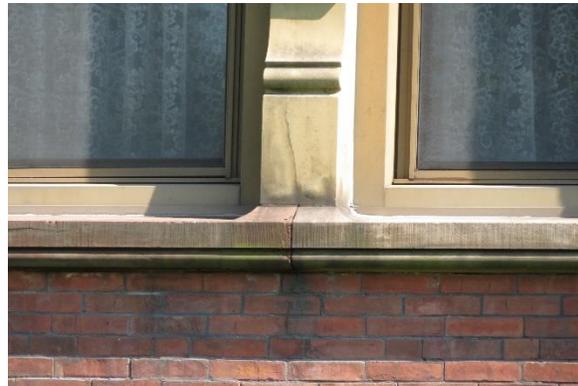
Photo 163. South façade: Weathered mortar joints. Cracked stone.

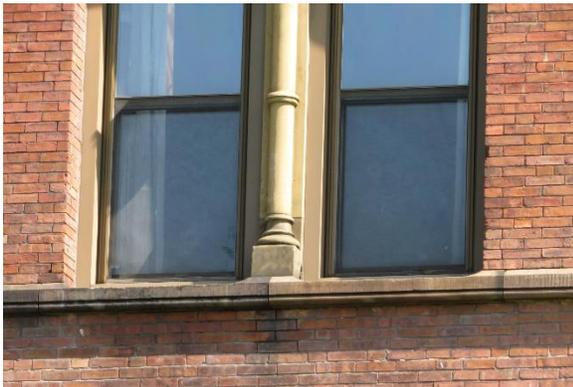
Photo 161. South façade: Weathered mortar joints. Soiled masonry.

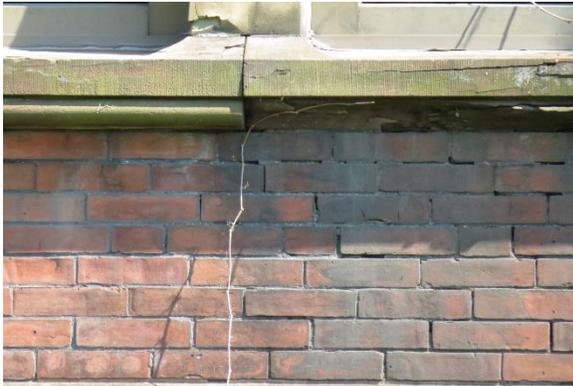
Photo 165. South façade: Stone surface delamination. Cracked stone. Open and weathered mortar joints.

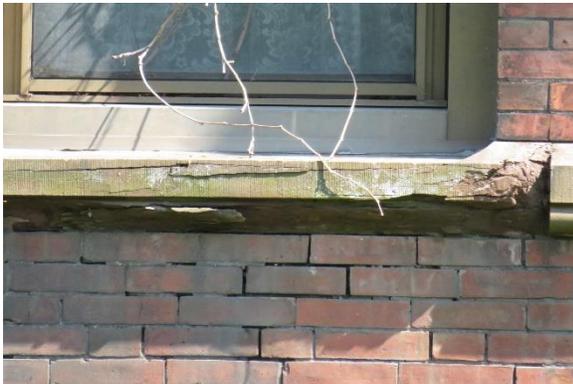
Photo 166. South façade: Stone surface delamination. Cracked stone. Open and weathered mortar joints.

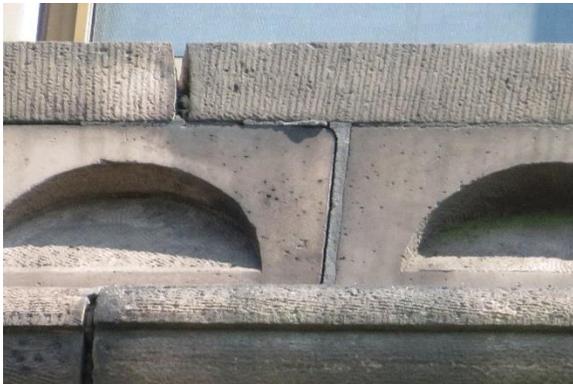
Photo 167. South façade: Stone surface delamination. Cracked and open mortar joints.

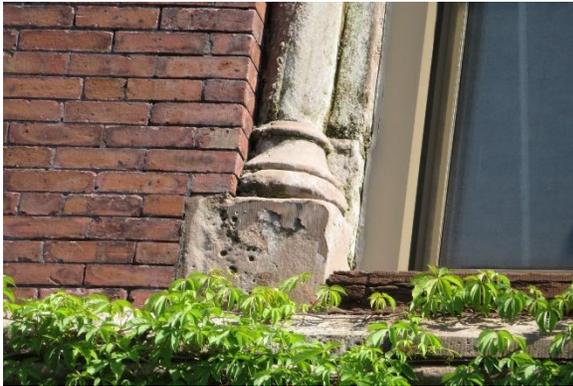
Photo 171. South façade: Stone surface delamination. Cracked stone. Cracked and open mortar joints.

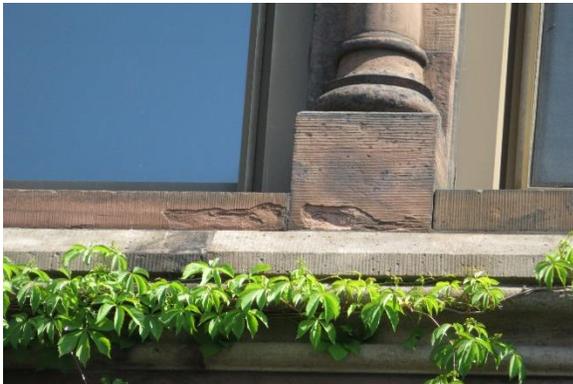
Photo 172. South façade: Stone surface delamination. Open mortar joints.

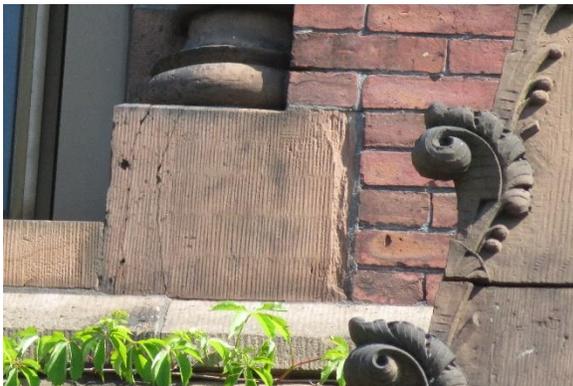
Photo 173. South façade: Stone surface delamination. Cracked stone. Cracked and open mortar joints.

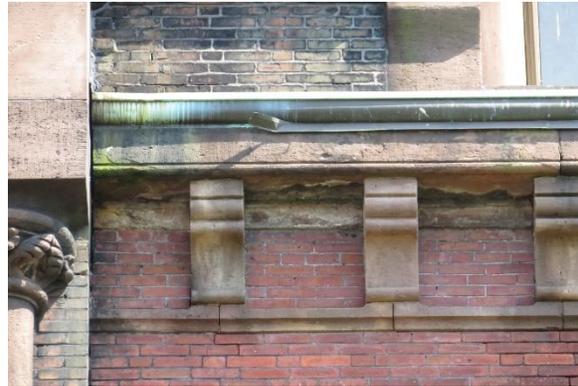
Photo 174. South façade: Stone surface delamination. Weathered and open mortar joints. Soiled masonry.

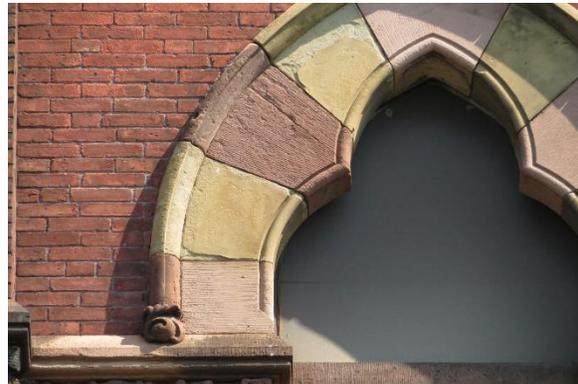
Photo 175. South façade: Stone surface delamination.

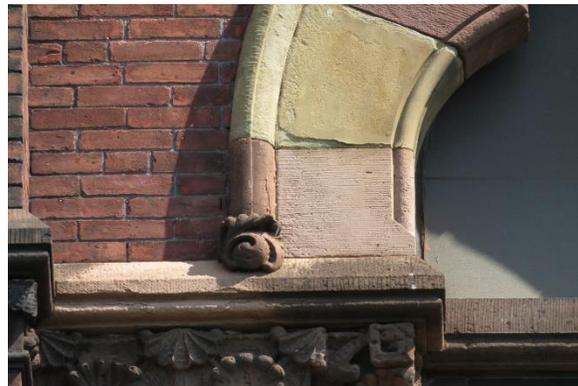
Photo 176. South façade: Stone surface delamination.

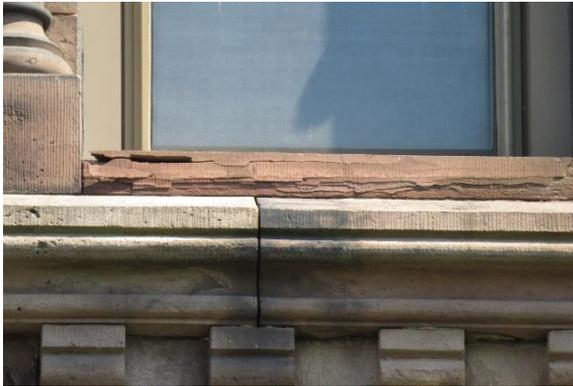
Photo 177. South façade: Stone surface delamination.

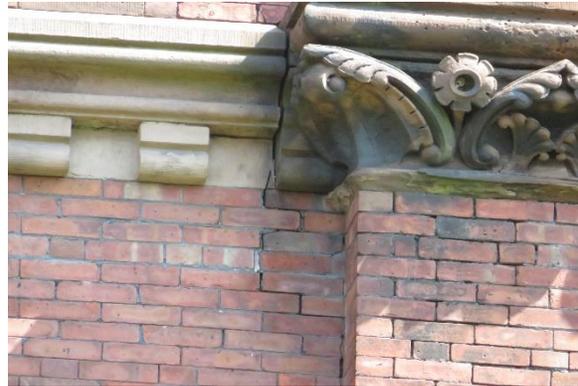
Photo 180. South façade: Stone surface delamination. Cracked and open mortar joints. Step crack in brick masonry.

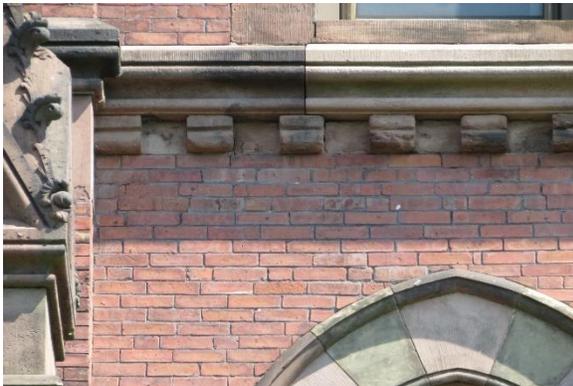
Photo 178. South façade: Stone surface delamination. Weathered mortar joints.

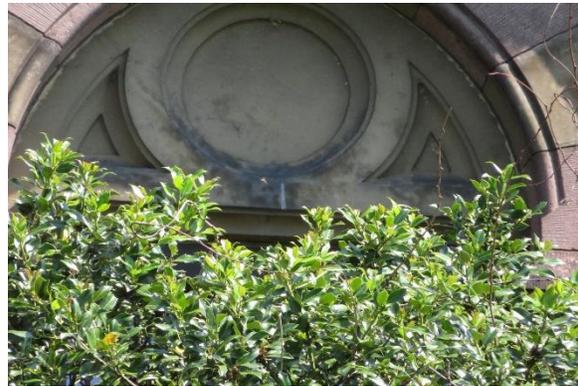
Photo 181. South façade: Stone surface delamination.

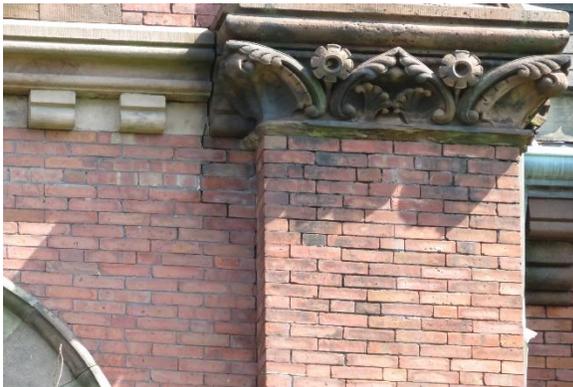
Photo 179. South façade: Stone surface delamination. Cracked and open mortar joints.

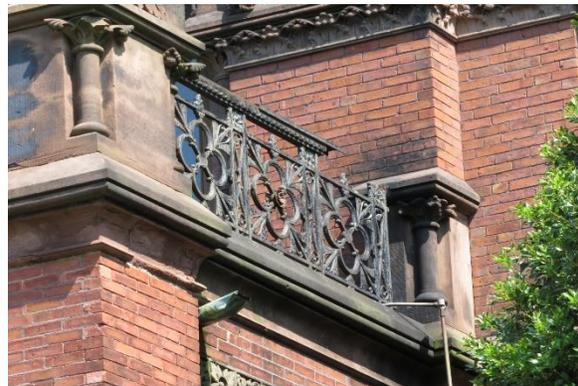
Photo 182. South façade: Missing railing section. Deformed downspout. Soiled masonry.

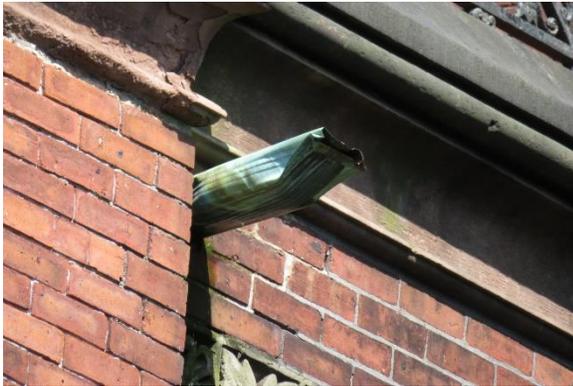
Photo 183. South façade: Weathered and open mortar joints. Deformed downspout. Stone delamination.

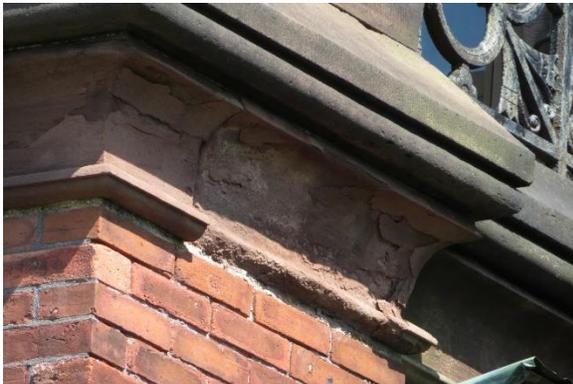
Photo 186. South façade: Biological growth. Open mortar joints.

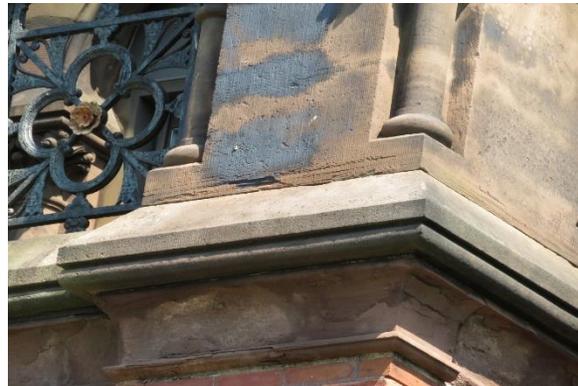
Photo 184. South façade: Weathered and open mortar joints. Stone delamination.

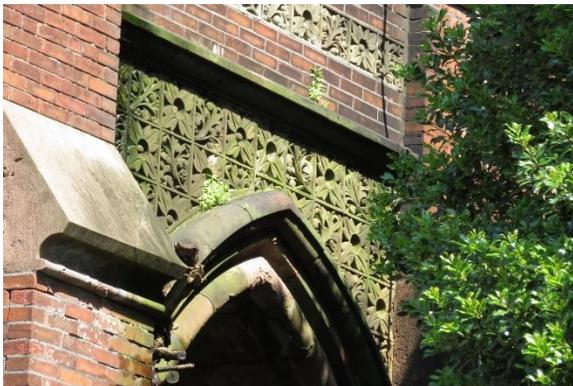
Photo 187. South façade: Stone delamination.

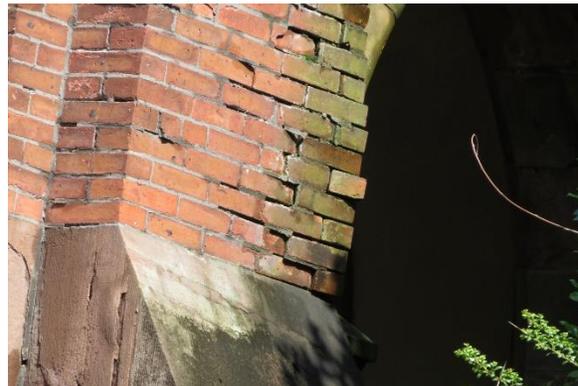
Photo 185. South façade: Weathered and open mortar joints. Stone delamination. Efflorescence. Biological growth.

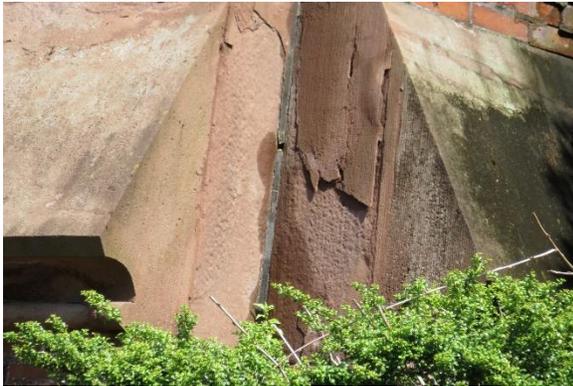
Photo 188. South façade: Weathered and open mortar joints. Stone delamination. Loose brick masonry.

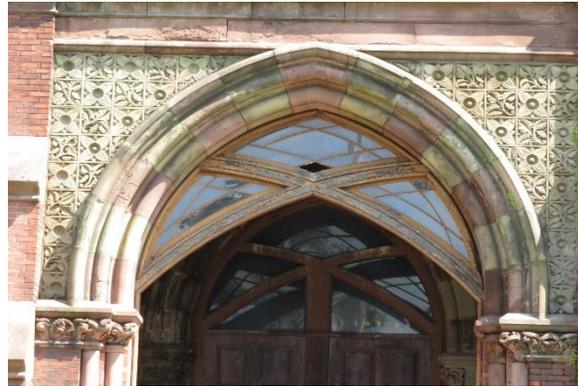
Photo 189. South façade: Stone delamination. Open and weathered mortar joints.

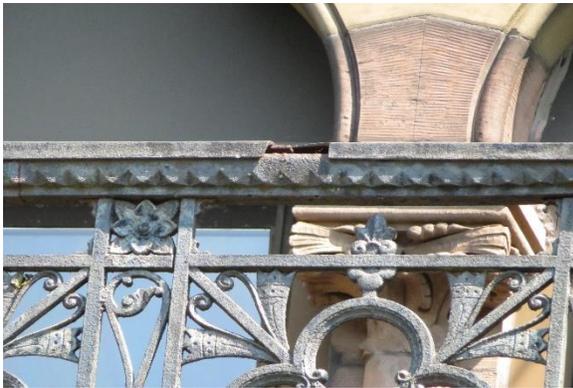
Photo 192. South façade: Missing glass. Stone delamination.

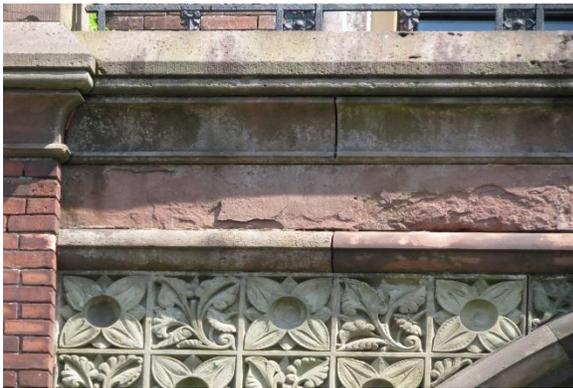
Photo 193. South façade: Weathered and open mortar joints. Efflorescence. Biological growth.

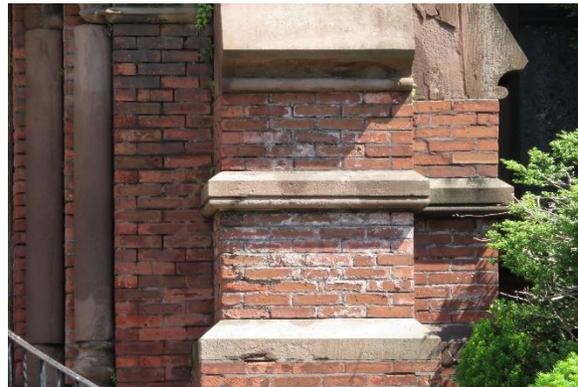
Photo 191. South façade: Stone delamination.

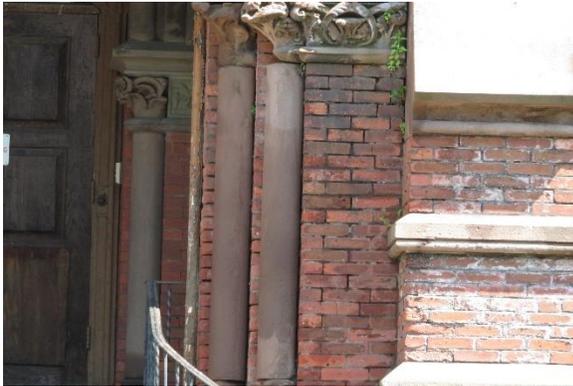
Photo 194. South façade: Efflorescence. Weathered and open mortar joints. Stone delamination.

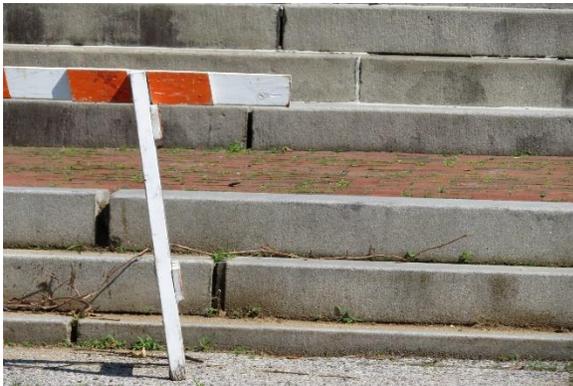
Photo 195. South façade: Open mortar joints. Efflorescence. Biological growth.

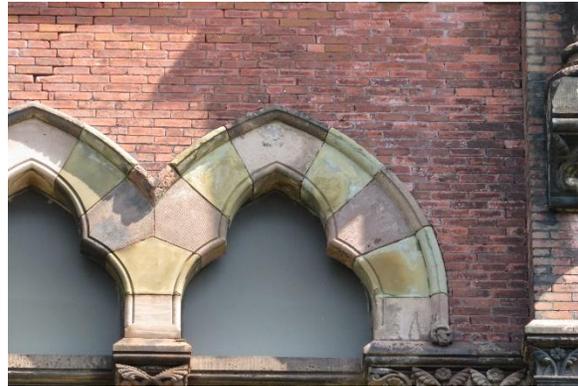
Photo 197. South façade: Stone delamination. Open mortar joints. Efflorescence. Loose brick masonry. Soiled masonry.

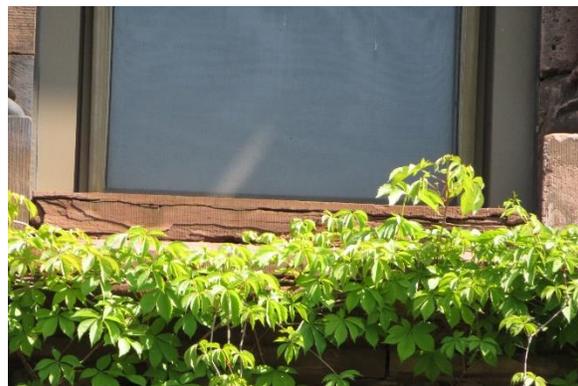
Photo 199. South façade: Spalled stone.

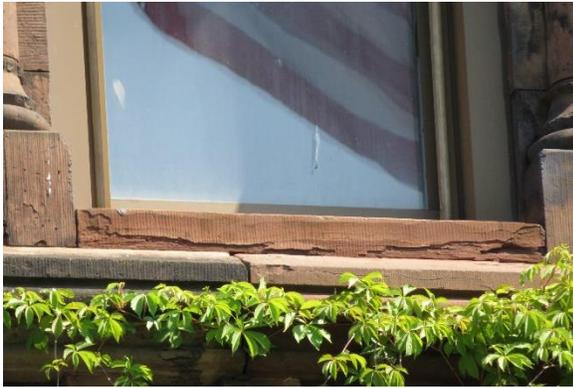
Photo 200. South façade: Stone delamination. Stone spall.

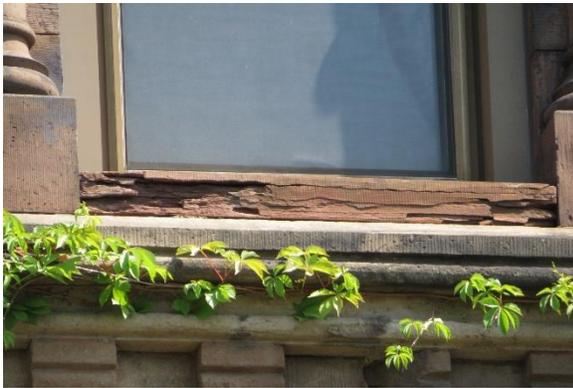
Photo 204. South façade: Stone delamination. Stone spall.

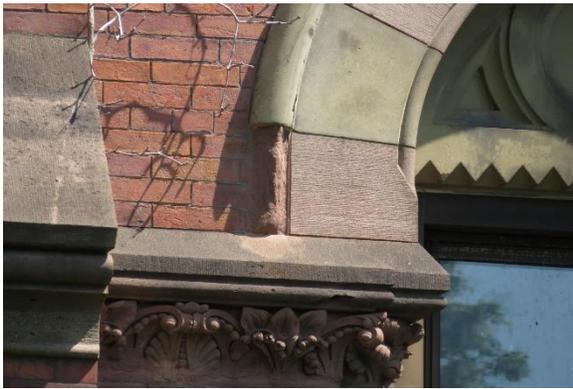
Photo 205. South façade: Efflorescence. Stone delamination. Soiled masonry.

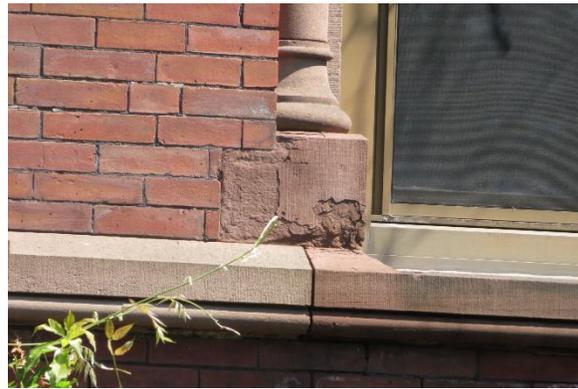
Photo 203. South façade: Stone delamination.

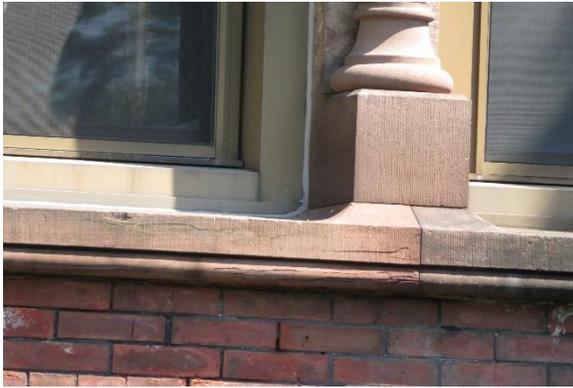
Photo 206. South façade: Stone delamination. Open mortar joints.

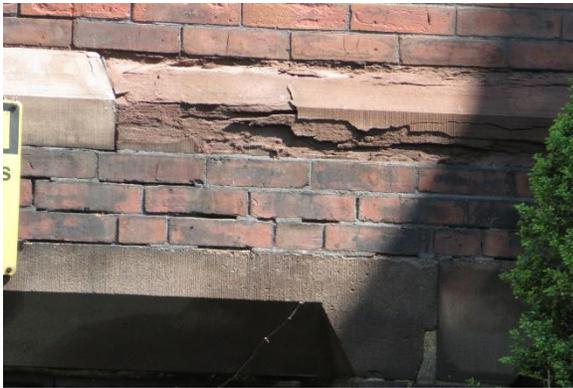
Photo 210. South façade: Stone delamination.

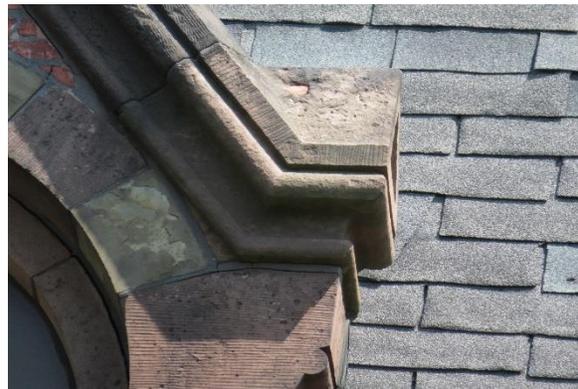
Photo 208. South façade: Stone delamination. Open mortar joints.

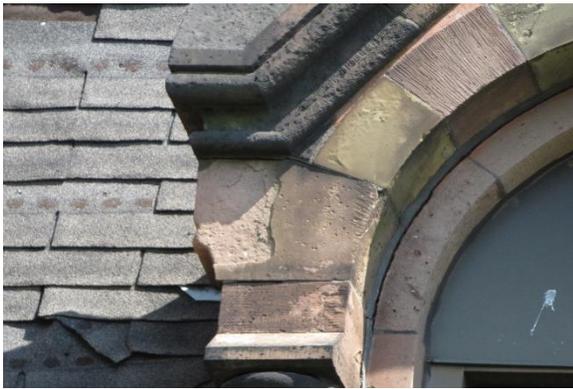
Photo 211. South façade: Stone delamination.

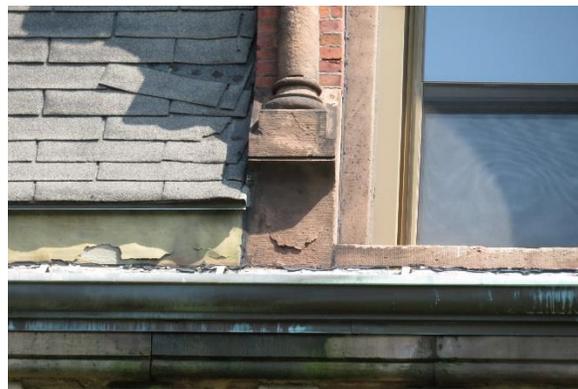
Photo 209. South façade: Stone delamination. Open mortar joints.

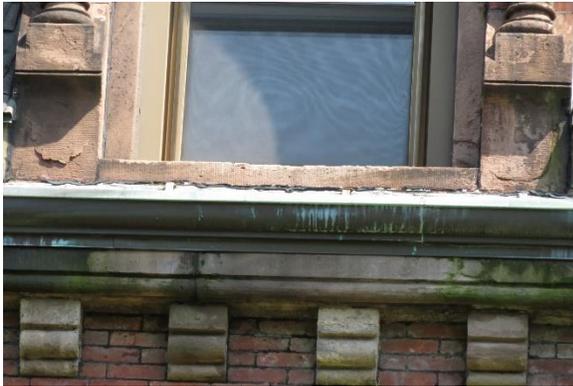
Photo 212. South façade: Stone delamination. Open mortar joints.

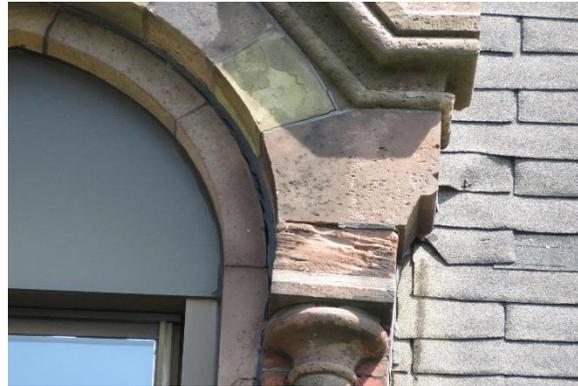
Photo 213. South façade: Stone delamination. Open mortar joints.

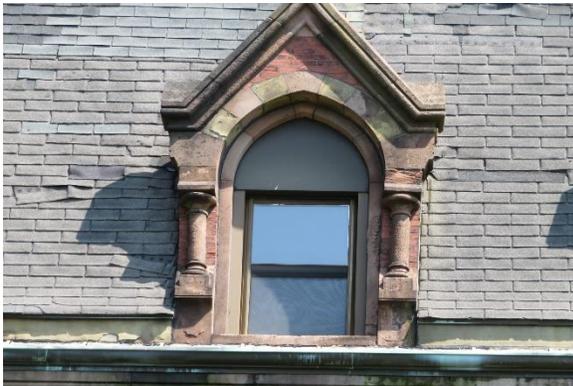
Photo 216. South façade: Stone delamination. Open mortar joints.

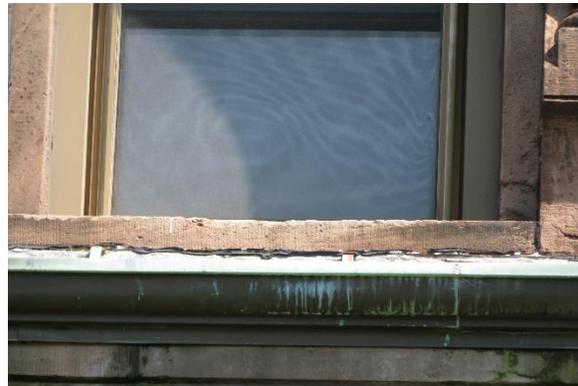
Photo 214. South façade: Stone delamination.

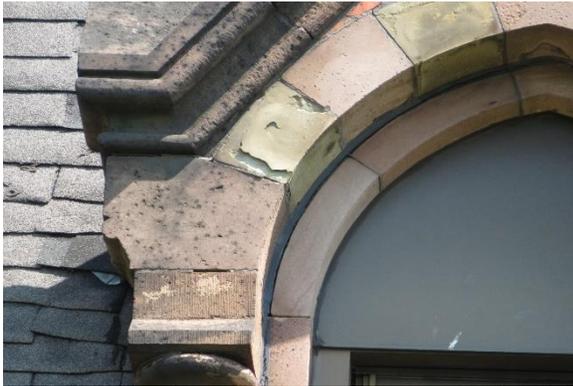
Photo 217. South façade: Stone delamination. Stone crack. Deteriorated mortar joints.

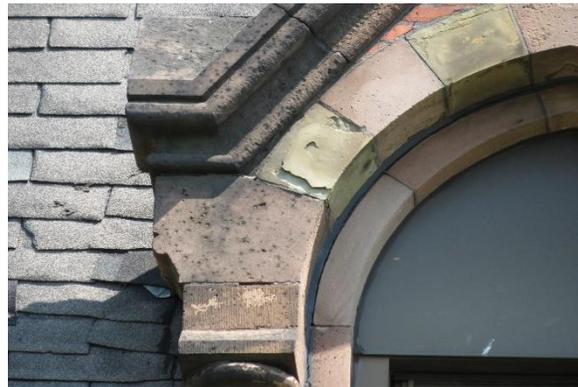
Photo 215. South façade: Stone delamination. Open mortar joints.

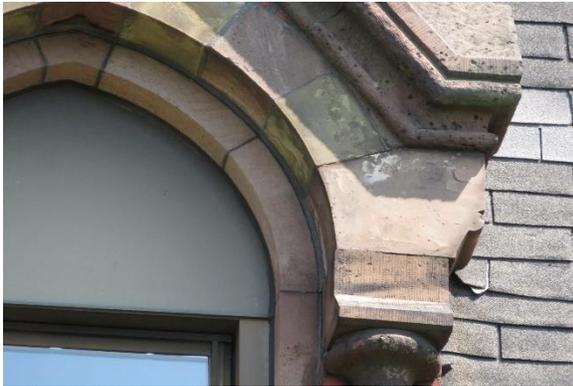
Photo 218. South façade: Stone delamination. Open mortar joints.

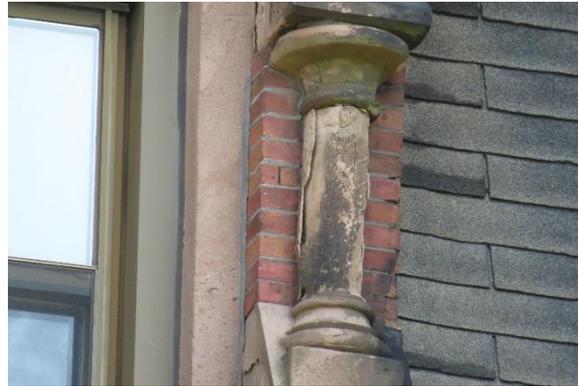
Photo 219. South façade: Stone delamination. Open mortar joints. Replacement metal arch panel.

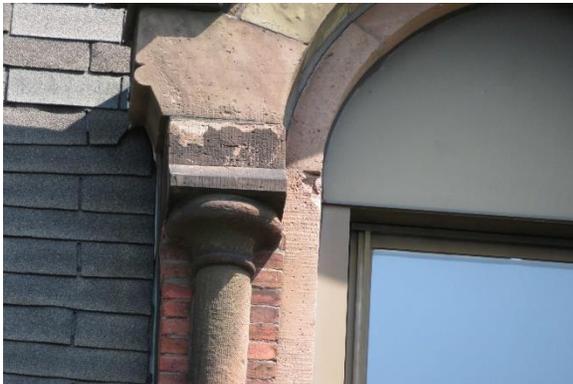
Photo 222. South façade: Stone delamination. Open mortar joints.
