St. Paul's School
Garden City, NY

Building Envelope and Structural Condition
Assessment Report

July 19, 2019

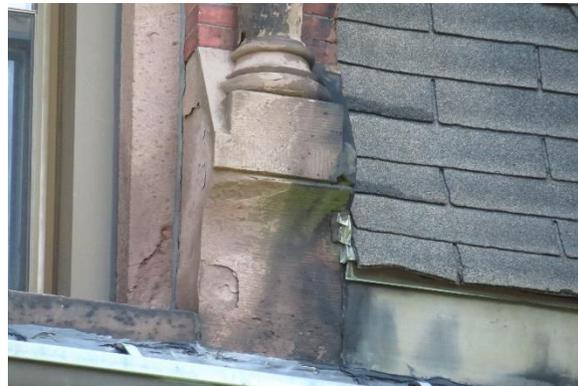
Photo 220. South façade: Stone delamination. Open mortar joints.

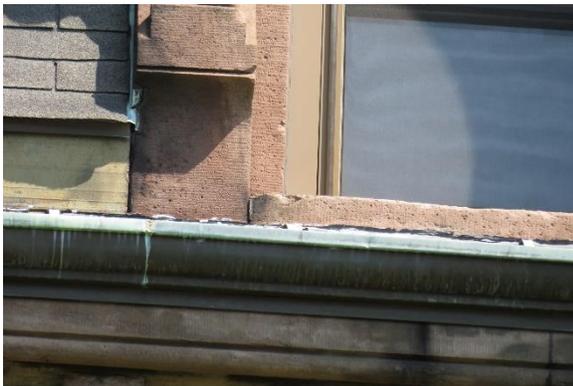
Photo 223. South façade: Stone delamination. Spalled stone. Open mortar joints. Cracked brick.

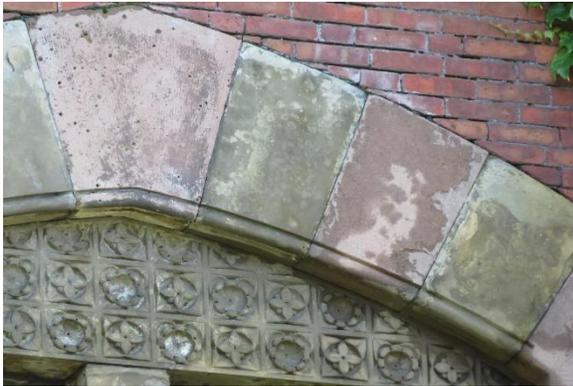
Photo 224. South façade: Missing flashing. Soiled masonry. Spalled brick.

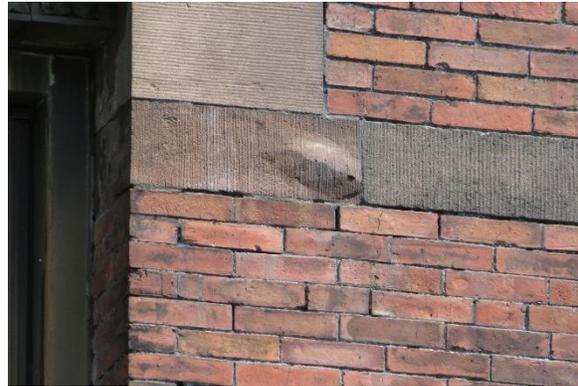
Photo 225. South façade: Soiled masonry. Weathered mortar joints. Stone delamination.

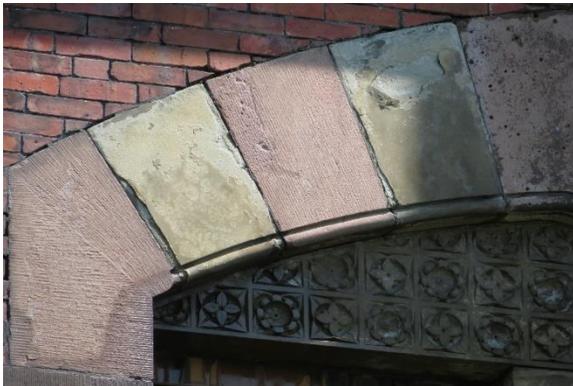
Photo 228. South façade: Stone delamination. Open mortar joints.

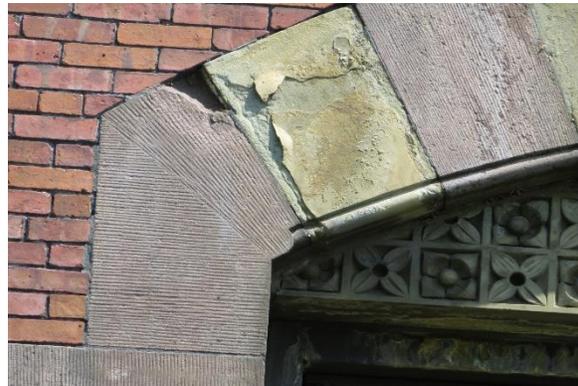
Photo 226. South façade: Stone delamination. Open and weathered mortar joints.

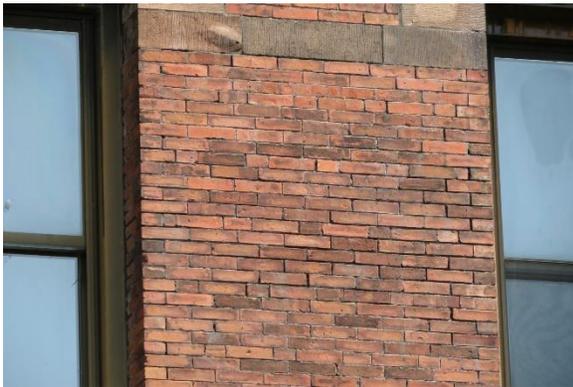
Photo 229. South façade: Stone delamination. Spalled stone. Open mortar joints.

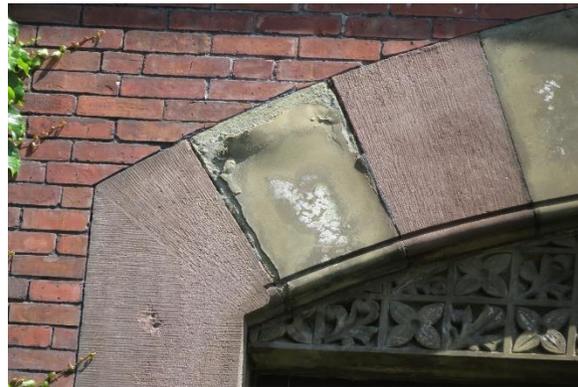
Photo 230. South façade: Stone delamination. Open mortar joints.

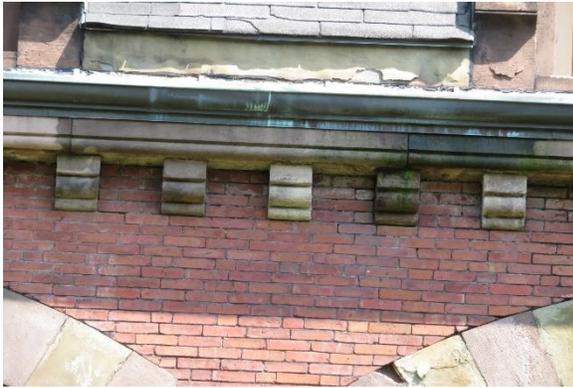
Photo 231. South façade: Stone delamination. Open mortar joints.

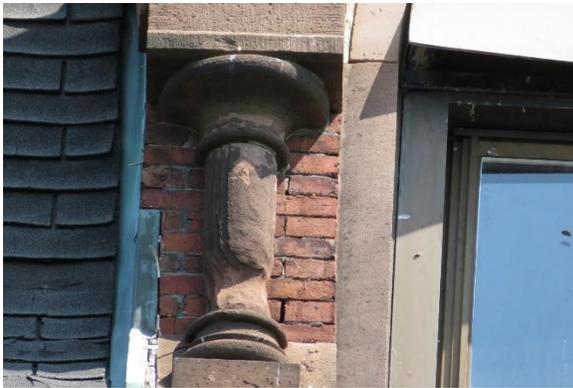
Photo 232. South façade: Stone delamination. Spalled stone. Open mortar joints.

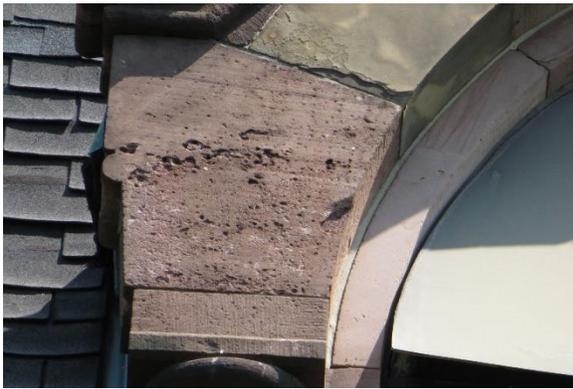
Photo 233. South façade: Stone delamination. Open mortar joints.

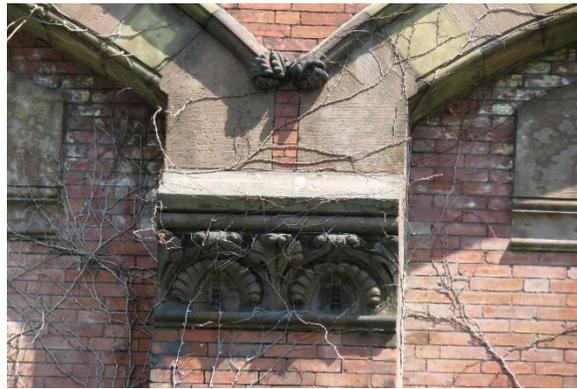
Photo 236. South façade: Efflorescence. Open and weathered mortar joints.

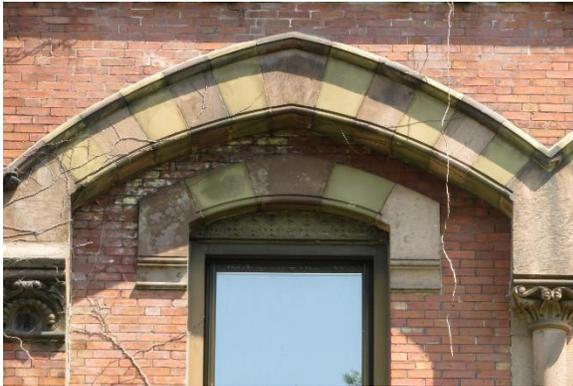
Photo 237. South façade: Efflorescence. Open mortar joints.

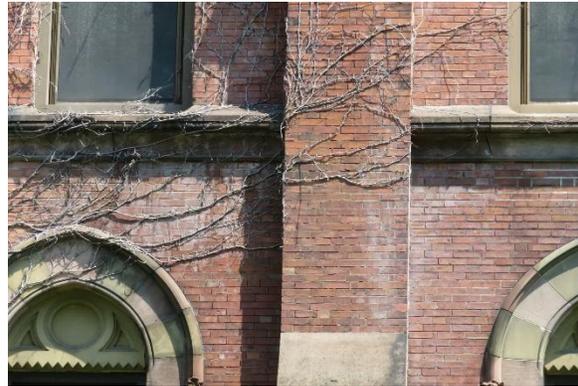
Photo 240. South façade: Open and weathered mortar joints. Efflorescence.

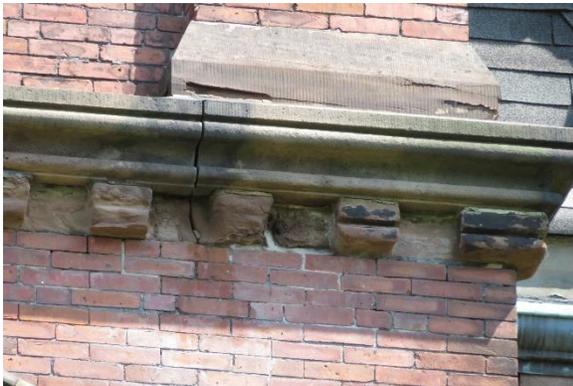
Photo 238. South façade: Stone delamination. Spalled stone. Open mortar joints. Efflorescence.

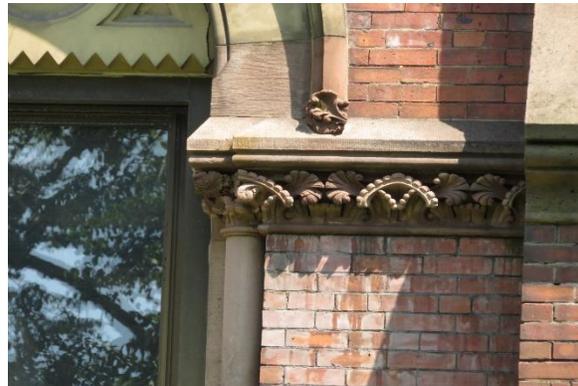
Photo 241. South façade: Open mortar joints. Efflorescence.

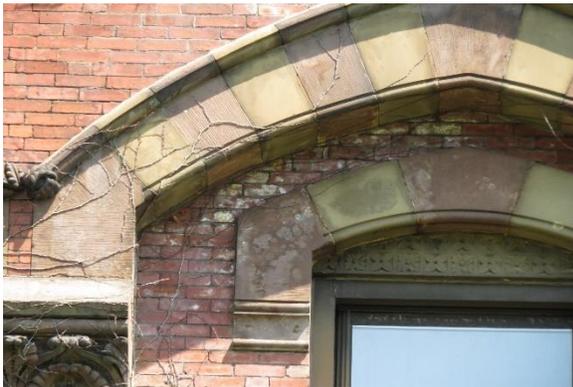
Photo 239. South façade: Stone delamination. Cracked stone. Open mortar joints. Efflorescence.

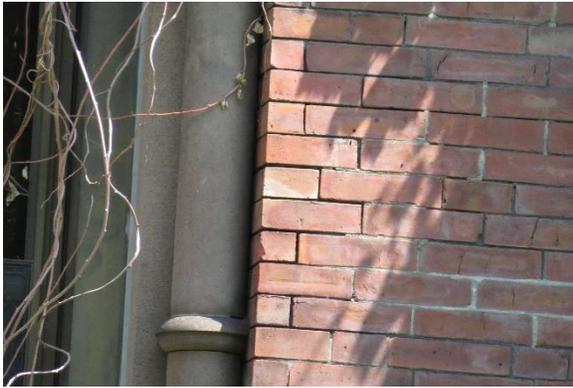
Photo 243. South façade: Open and weathered mortar joints.

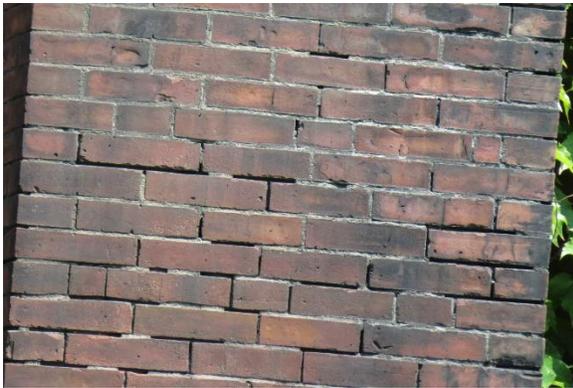
Photo 244. South façade: Open and weathered mortar joints.

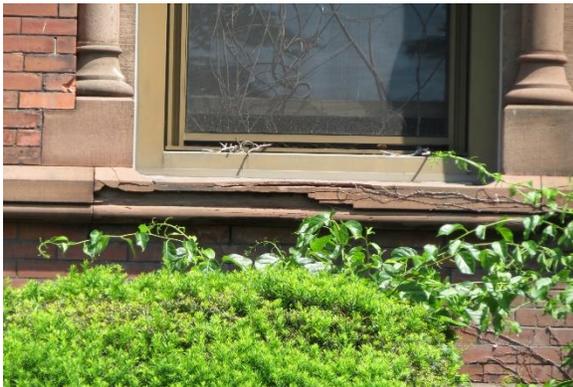
Photo 245. South façade: Spalled stone.

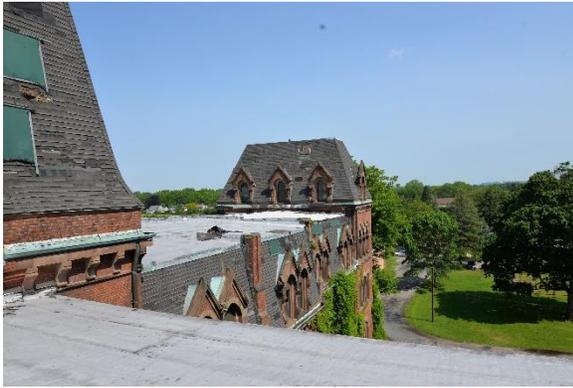
Photo 249. Roof: Deteriorated flat roof membrane. Failed previous patches on mansard roof. Deteriorated shingles.

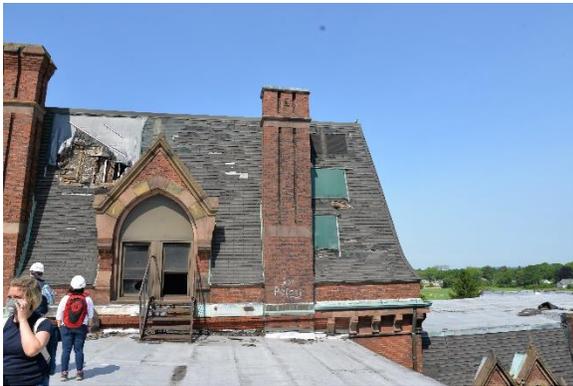
Photo 250. Roof: Failed previous patches. Deteriorated shingles. Damaged and open roofing.

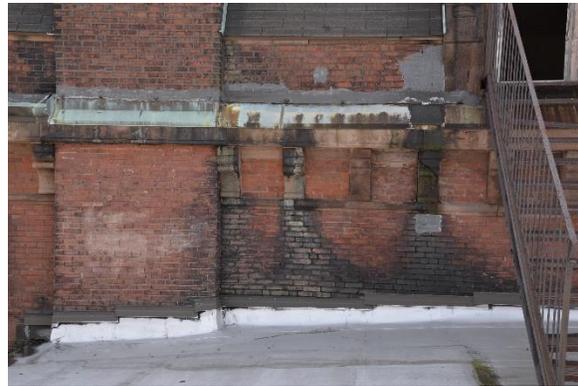
Photo 253. Roof: Open and weathered mortar joints at the roof. Soiled masonry. Failed previous patches.

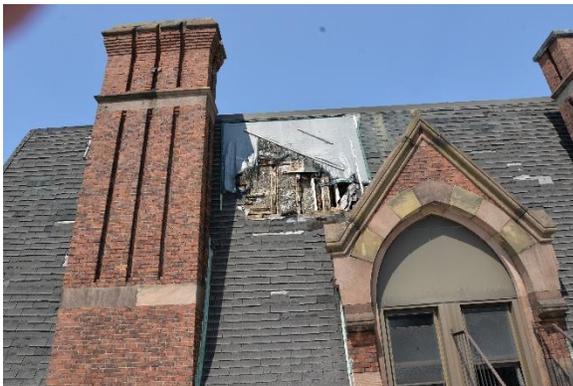
Photo 251. Roof: Damaged and open roofing.

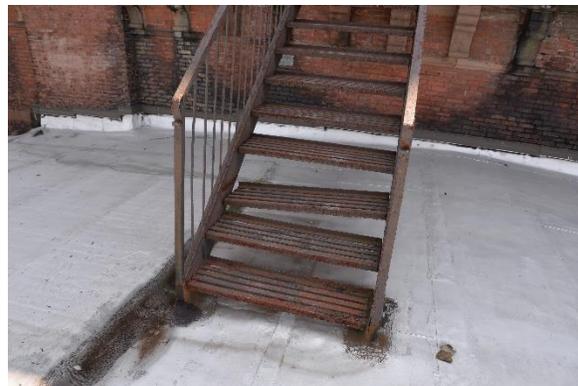
Photo 254. Roof: Displaced steps at the egress stairs. Corroded egress stairs.

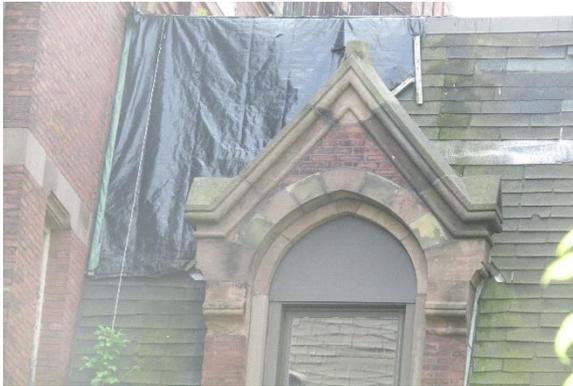
Photo 255. Roof: Temporary tarp installed at roofing.

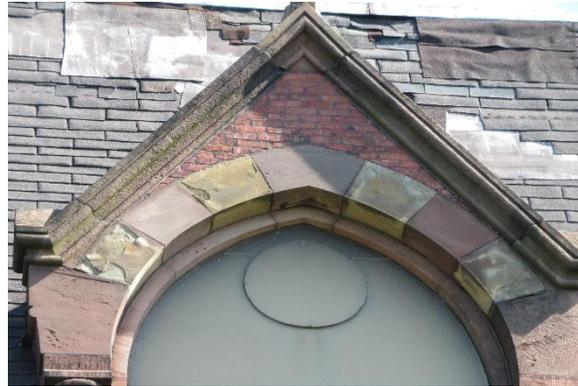
Photo 258. Roof: Damaged roofing. Failed previous roof patches.

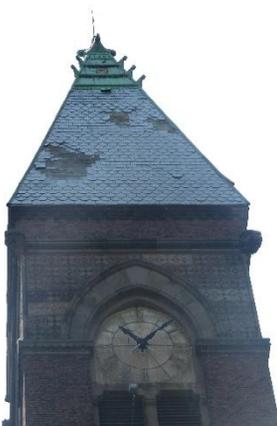
Photo 256. Roof: Missing slate shingles at the clock tower roof.

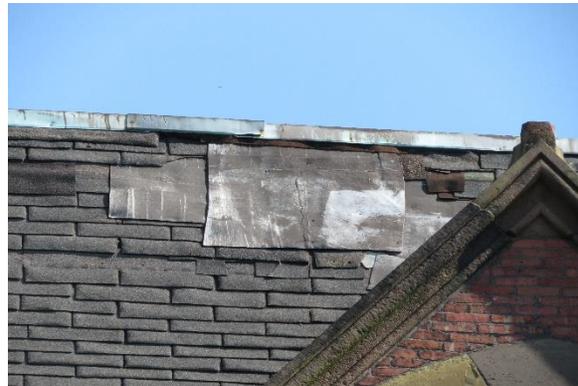
Photo 259. Roof: Damaged roofing. Failed previous roof patches.

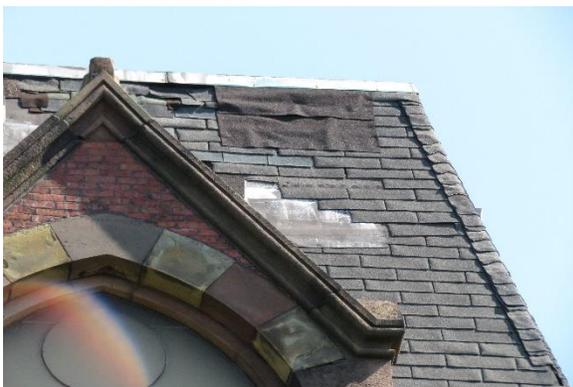
Photo 257. Roof: Damaged roofing. Failed previous roof patches.

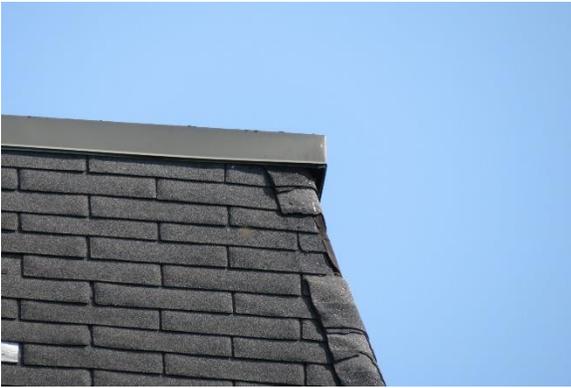
Photo 261. Roof: Damaged roofing. Missing ridge elements.

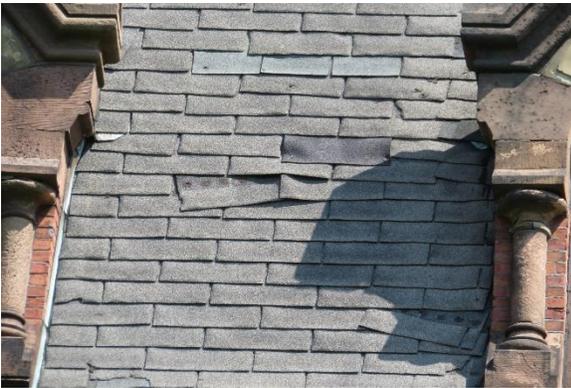
Photo 262. Roof: Loose shingles.

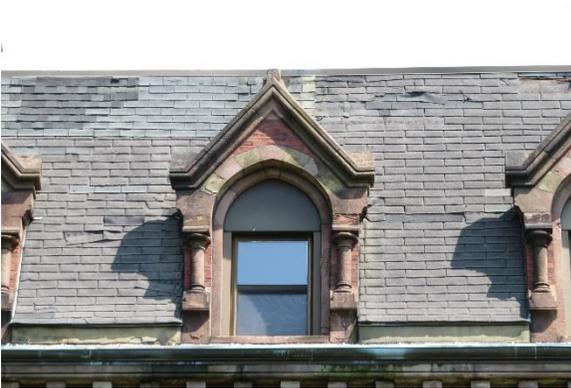
Photo 263. Roof: Loose shingles.

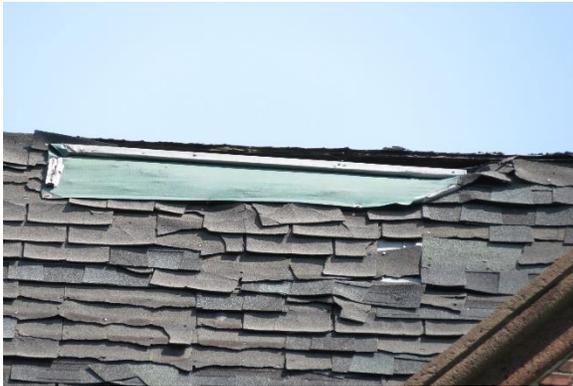
Photo 267. Roof: Damaged roofing. Failed previous roof patches.

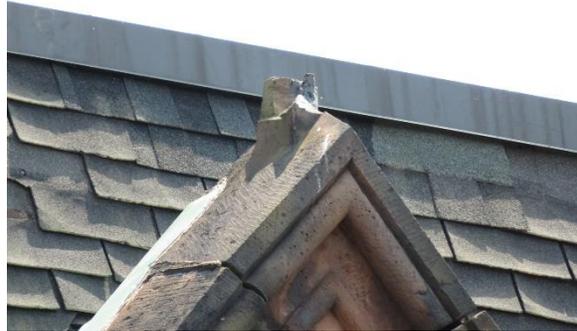
Photo 270. Roof: Missing finial.

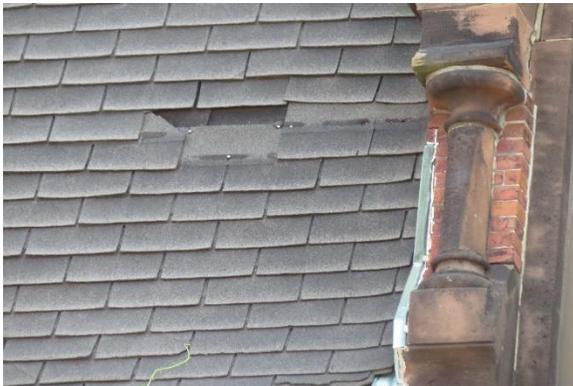
Photo 268. Roof: Missing shingles.

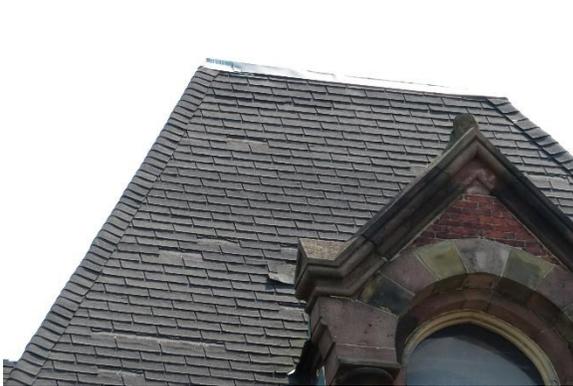
Photo 269. Roof: Missing / loose shingles.

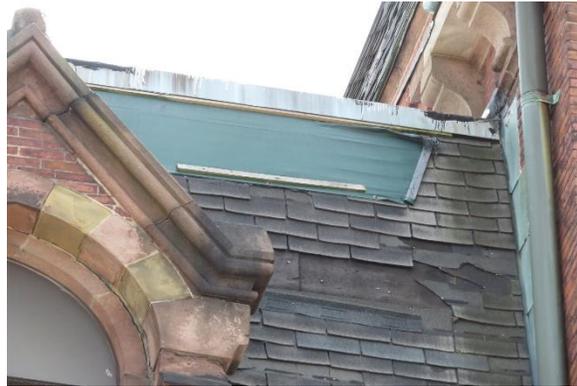
Photo 272. Roof: Missing / loose shingles. Failed previous roof patches.

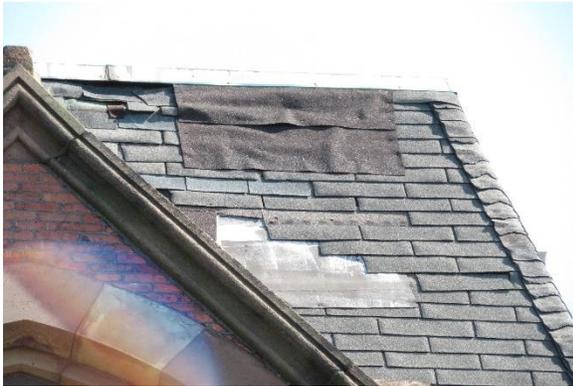
Photo 273. Roof: Damaged roofing. Failed previous roof patches.

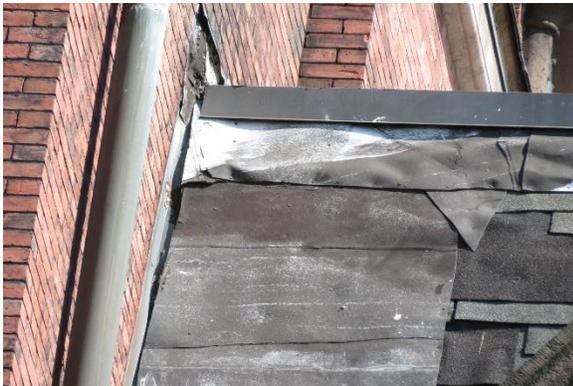
Photo 274. Roof: Damaged roofing. Failed previous roof patches.

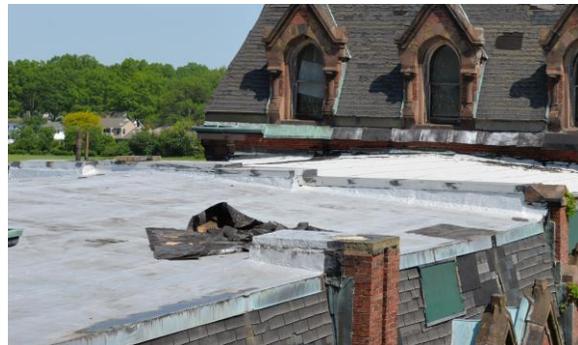
Photo 277. Roof: Ponding water. Open seams. Membrane beyond service life.

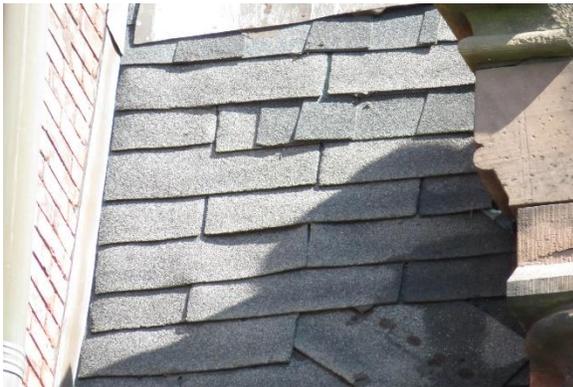
Photo 275. Roof: Loose shingles..

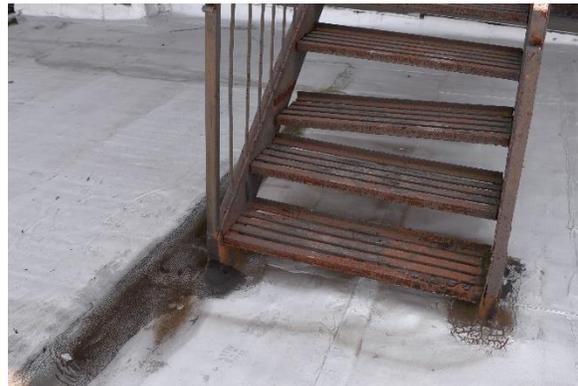
Photo 278. Roof: Ponding water. Open seams. Membrane beyond service life.

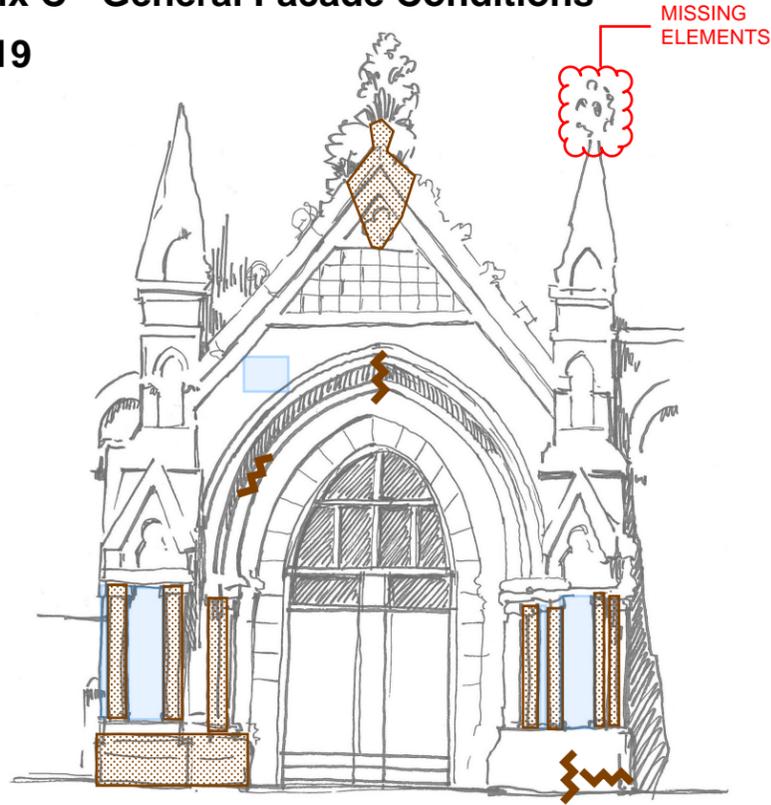
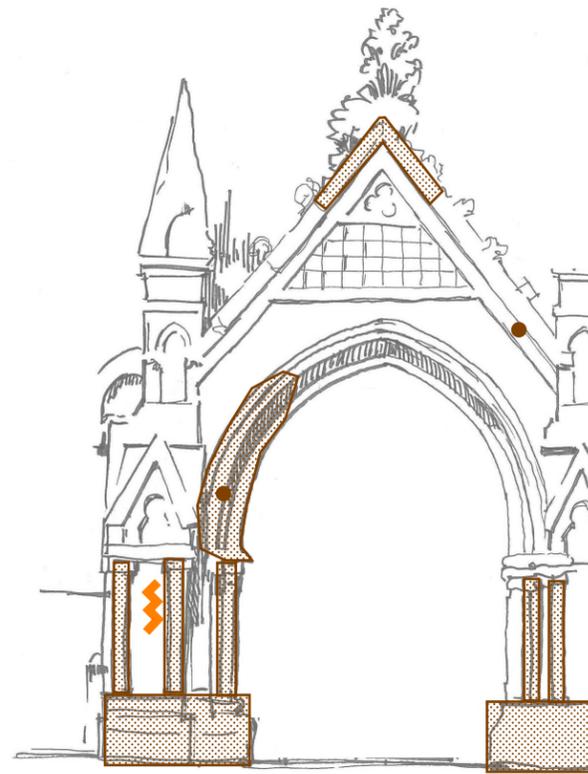
+ MULTIPLE BRICK AND STONE CRACKS ON THE INTERIOR FACE
 + STONE DELAMINATION AT ARCH UNDERSIDES
 + OPEN MORTAR JOINTS, TYPICAL.

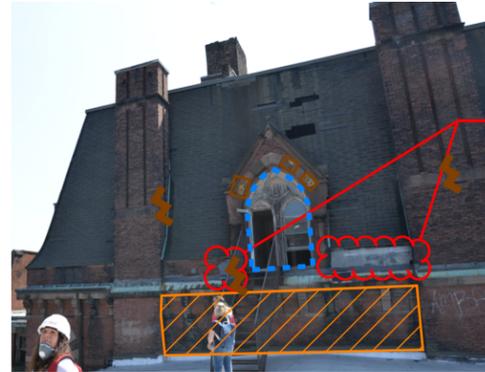
MASTIC
INSTALLED ON
BRICK MASONRY

MISSING
FINIAL

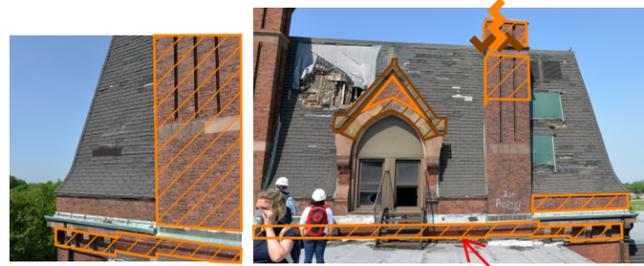
DAMAGED FLASHINGS

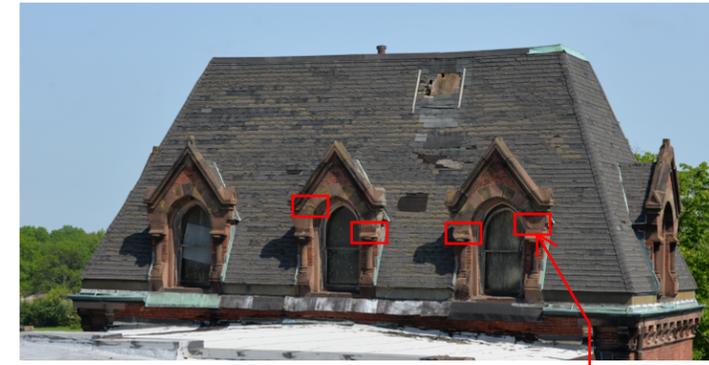
NORTH FACE

STONE CRACKS AND DELAMINATION, TYP.

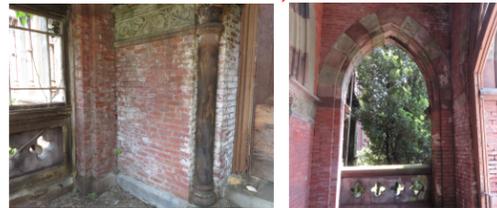
INSIDE THE PORTICO:
HEAVY EFFLORESCENCE,
STONE DELAMINATION,
DETERIORATED WOOD ELEMENTS,
LOOSE BRICKS,
OPEN JOINTS,
TYPICAL.

DISPLACED STEPS
OPEN JOINTS

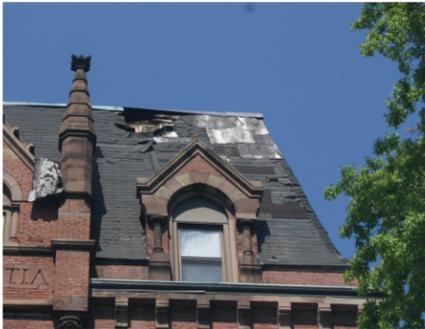
DAMAGED AND OPEN SECTION OF THE ROOF (ROCKAWAY AVENUE)

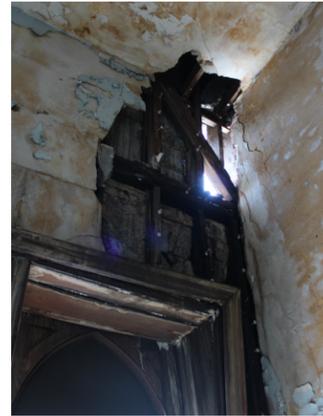
← INTERIOR CONDITION

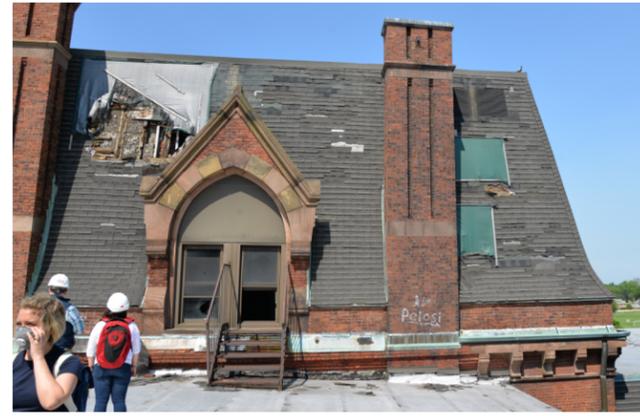
DAMAGED AND OPEN SECTION OF THE ROOF (EAST SIDE - WEST WING)

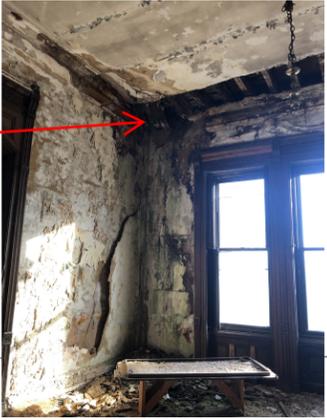
COMPROMISED CONNECTION
BETWEEN FLOOR JOISTS AT
2ND FLOOR FRAMING AND
FACADE BEARING WALL
